Collision with water involving Yakovlev Aircraft Factories Yak-52, VH-PAE

near South Stradbroke Island, Queensland, on 5 June 2019

AO-2019-027

Final – 24 February 2022

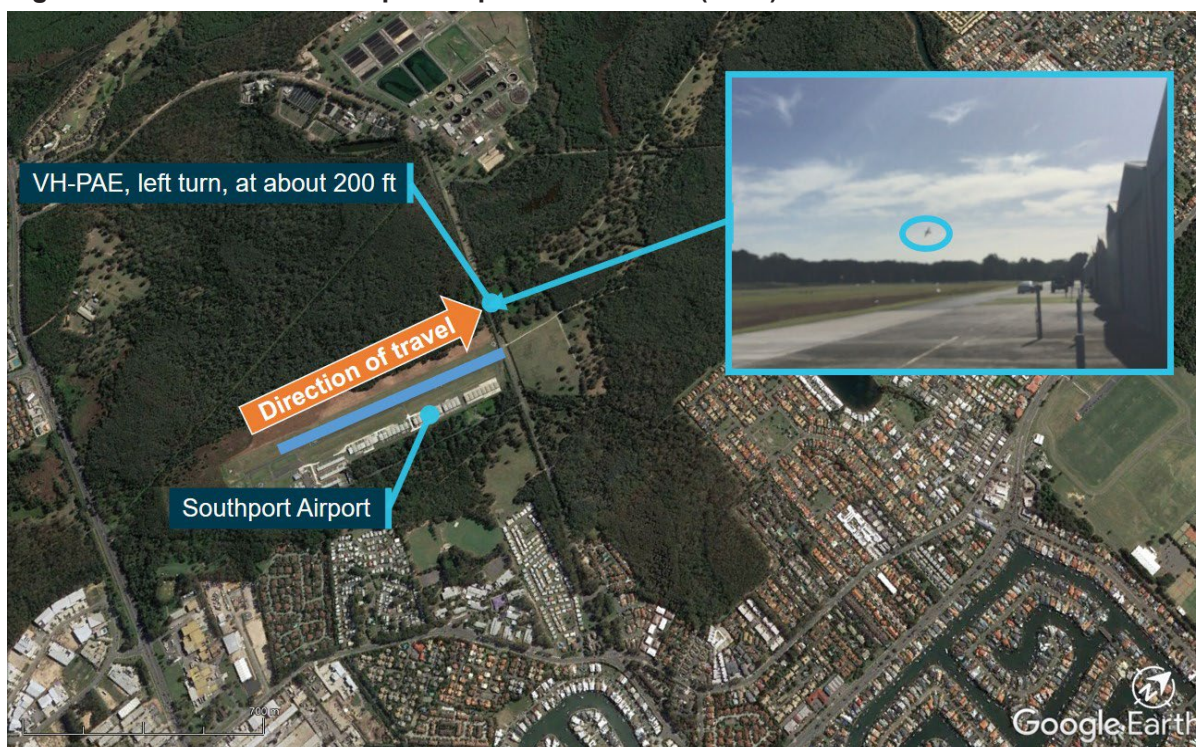
Figure 1: Take-off from Southport Airport and left turn (inset)

Prior to take-off, the pilot told a witness that a low-level turn over the trees would be more exciting for the passenger. The pilot also discussed taking off downwind on runway 01 and that the aircraft could accept the tailwind component. The second passenger provided video footage showing the aircraft departing Southport from runway 01 and conducting a left turn shortly after take-off. The ATSB's analysis of that video estimated the turn was conducted at about 200 ft above ground level (AGL) (Figure 1). This departure was described by a witness at Southport as being 'normal' for the pilot. The aircraft was held close to the ground after take-off to build up airspeed, which allowed a left turn to be performed just past the runway boundary.

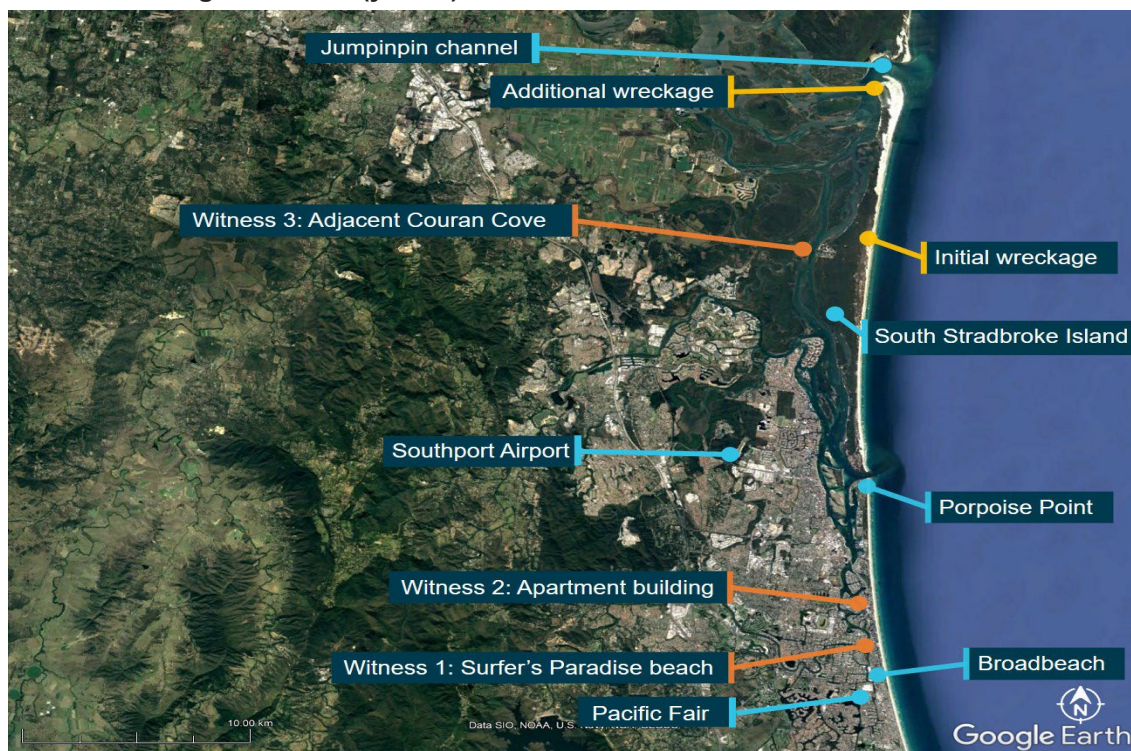
Figure 2: Location of areas of interest for the flight (blue), witness locations (orange), and aircraft wreckage locations (yellow)

Two witnesses reported observing the aircraft tracking on the planned scenic route. The first witness was at Surfers Paradise beach (Figure 2) and observed the aircraft flying from west to east, then northbound along the coast (refer to section titled Witness observations). The second witness was near South Stradbroke Island on the 12th floor of an apartment building. That witness saw the track north along the beach towards South Stradbroke Island with two people on board.

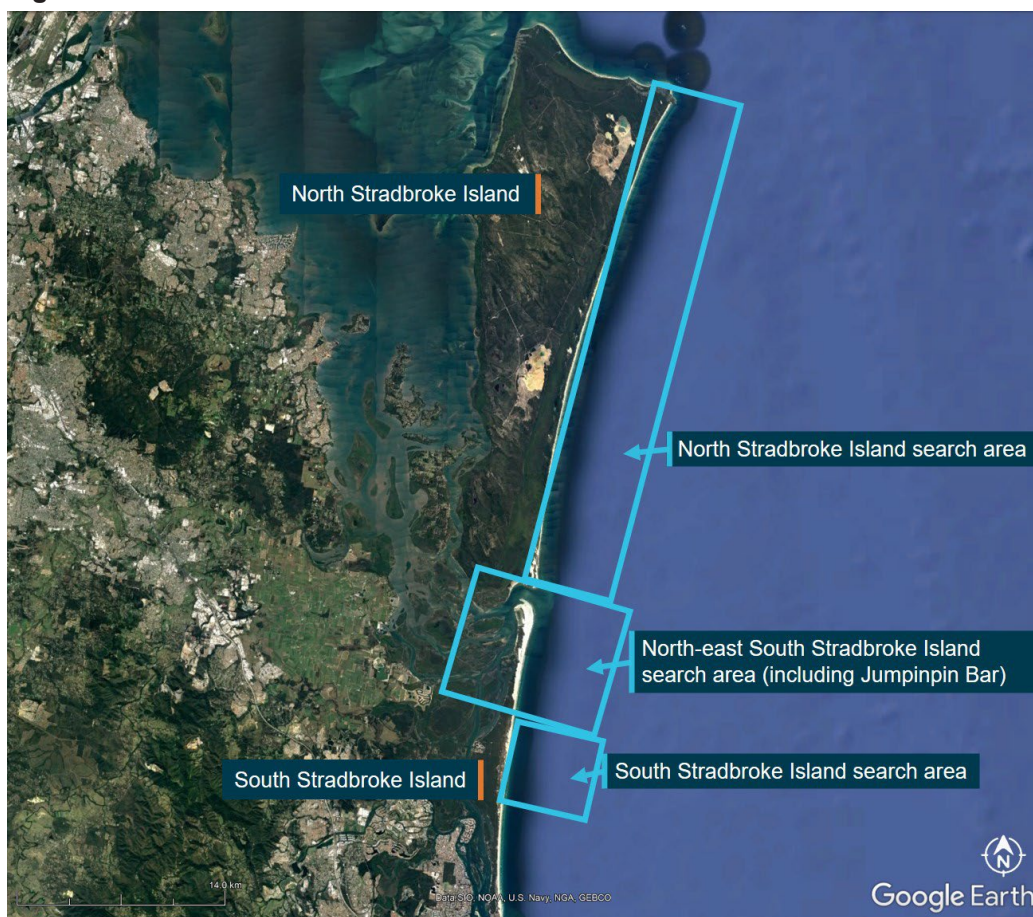
Figure 3: Search area

The Australian Maritime Safety Authority and Gold Coast Water Police initiated a search for the aircraft and occupants. The search zones were around North Stradbroke Island and to the north-east coastline of South Stradbroke Island, including the Jumpinpin channel (Figure 3). The search was interrupted for several days due to poor weather conditions. When the search resumed, it focussed on the South Stradbroke Island area, where most of the recovered wreckage was found.
