# Wirestrike and collision with terrain involving Robinson R44, VH-HNF

69 km south-east of Hay Airport (Steam Plains), New South Wales, on 31 July 2020

## **ATSB Transport Safety Report**

AO-2020-040

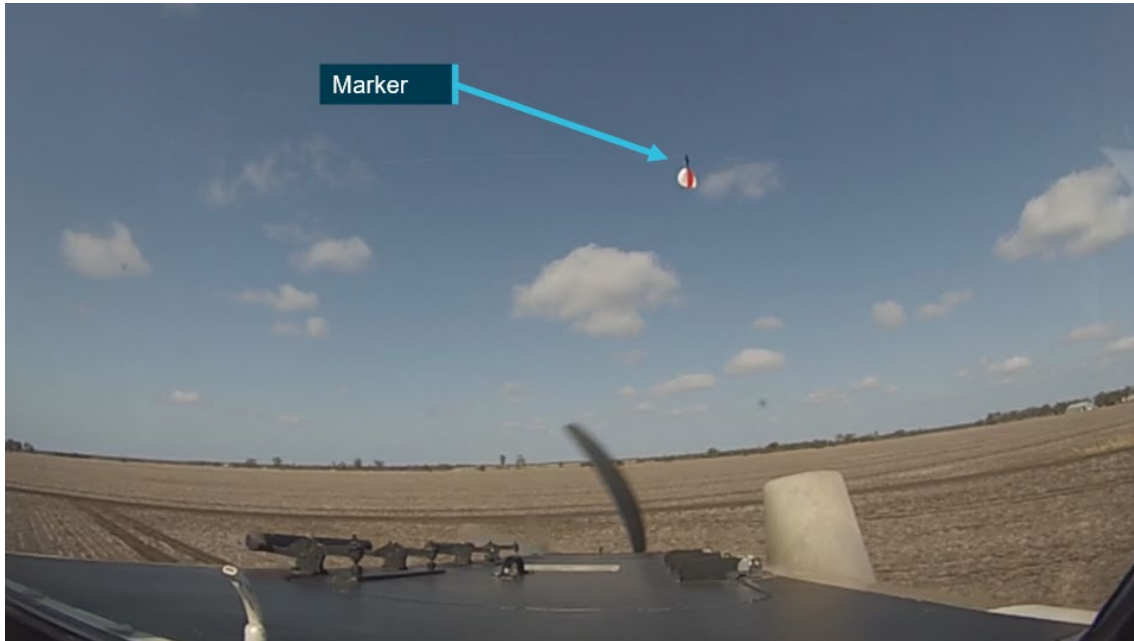
**Figure 2: Example of a wire aerial marker**

The powerline was not marked and was not required to be, according to Australian Standards 3891.1 and 3891.2.<sup>4</sup> Following a wirestrike of a powerline owned by Essential Energy, field workers assess the risk of another strike. If it is considered likely, at least one aerial marker (Figure 2) is fitted to the wire. It was assessed at the time that a subsequent wirestrike was unlikely to occur due to the remoteness of the location and because the helicopter was spraying weeds along the perimeter fence rather than crop spraying. As a result, no markers were fitted to the wire when it was restrung or subsequently.

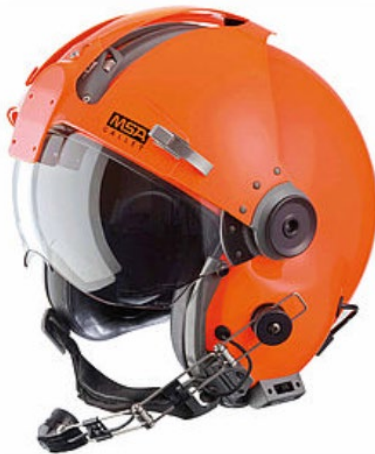
**Figure 8: MSA LH250 helmet**

Although the pilot was wearing a helmet, it did not attenuate the impact to survivable levels. Either the impact forces exceeded the helmet design specifications, or the helmet was not fitted, worn or maintained correctly.

The pilot of VH-HNF wore a MSA LH250 helmet (Figure 8). The manufacturer's brochure indicated that the helmet was for pilots/flight crew of helicopters, transport and training aircraft without ejection seats. The helmet was reported to meet or exceed:

To meet the specifications a helmet is designed for, it must be fitted correctly, worn properly and maintained in accordance with the manufacturer's requirements. The manufacturer of the pilot's MSA LH250 helmet advised wearers of the following.

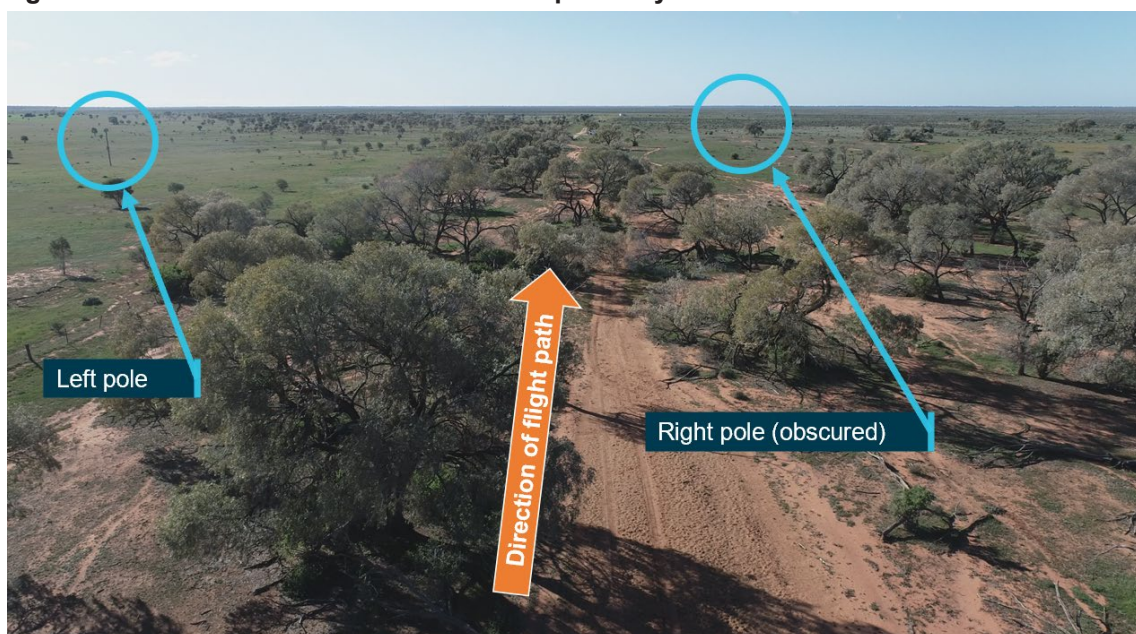
**Figure 14: RPA footage of reconstructed flight path showing location of poles left and right of track from about 160 and 350 m respectively**

Figure 13 shows the two closest power poles located either side of the helicopter's flight path. From ATSB RPA footage taken along the estimated flight path, at times, both poles were obscured by trees and lacked contrast and texture variation from their background (Figure 14 and Figure 15). The two power poles should have been visible within the pilot's peripheral vision, however it is likely that the pilot's visual acuity was affected by contrast sensitivity, resulting in the pilot being unable to discriminate the poles from their background. Additionally, based on the powerline's location on the pilot's map, the pilot may not have been looking for cues at that time.
