# Airspeed indication failure on take-off involving Airbus A330, 9M-MTK

Brisbane Airport, Queensland, 18 July 2018

Aviation Occurrence Investigation (Systemic)

AO-2018-053

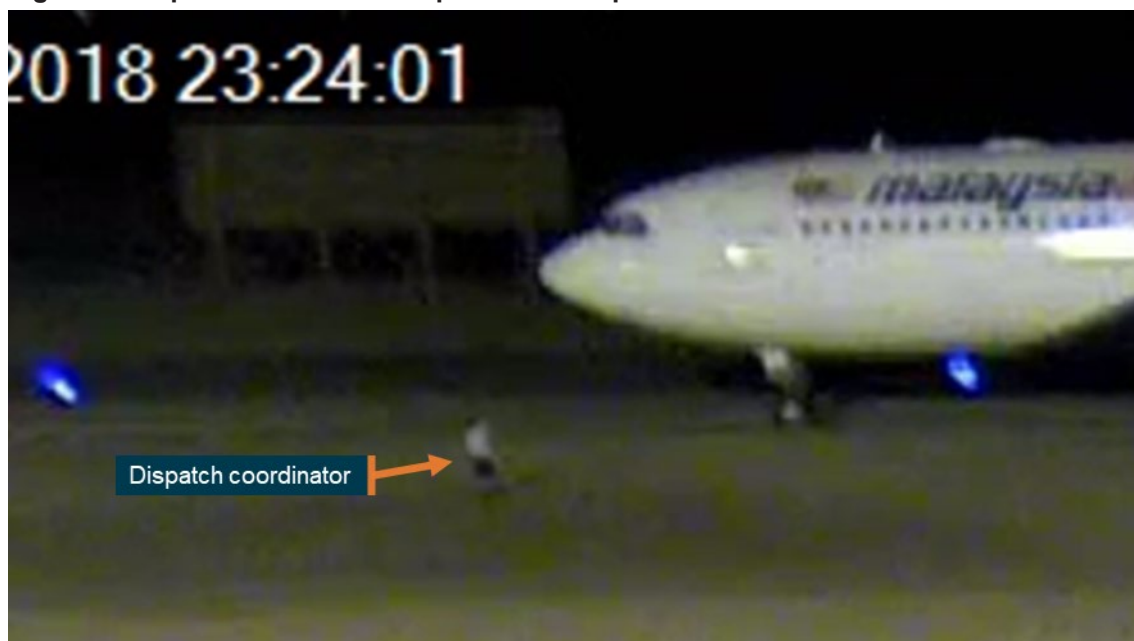
Figure 6: Dispatch coordinator in position after pushback

The towbar and dispatch coordinator's headset were then detached from the aircraft. CCTV footage from an adjacent bay showed the dispatch coordinator standing back from the left side nose of the aircraft showing the aircraft's nose gear steering pin to the flight crew, in accordance with procedure, as confirmation that it had been removed (Figure 6). The pitot probe cover streamers would have been visible from this position.

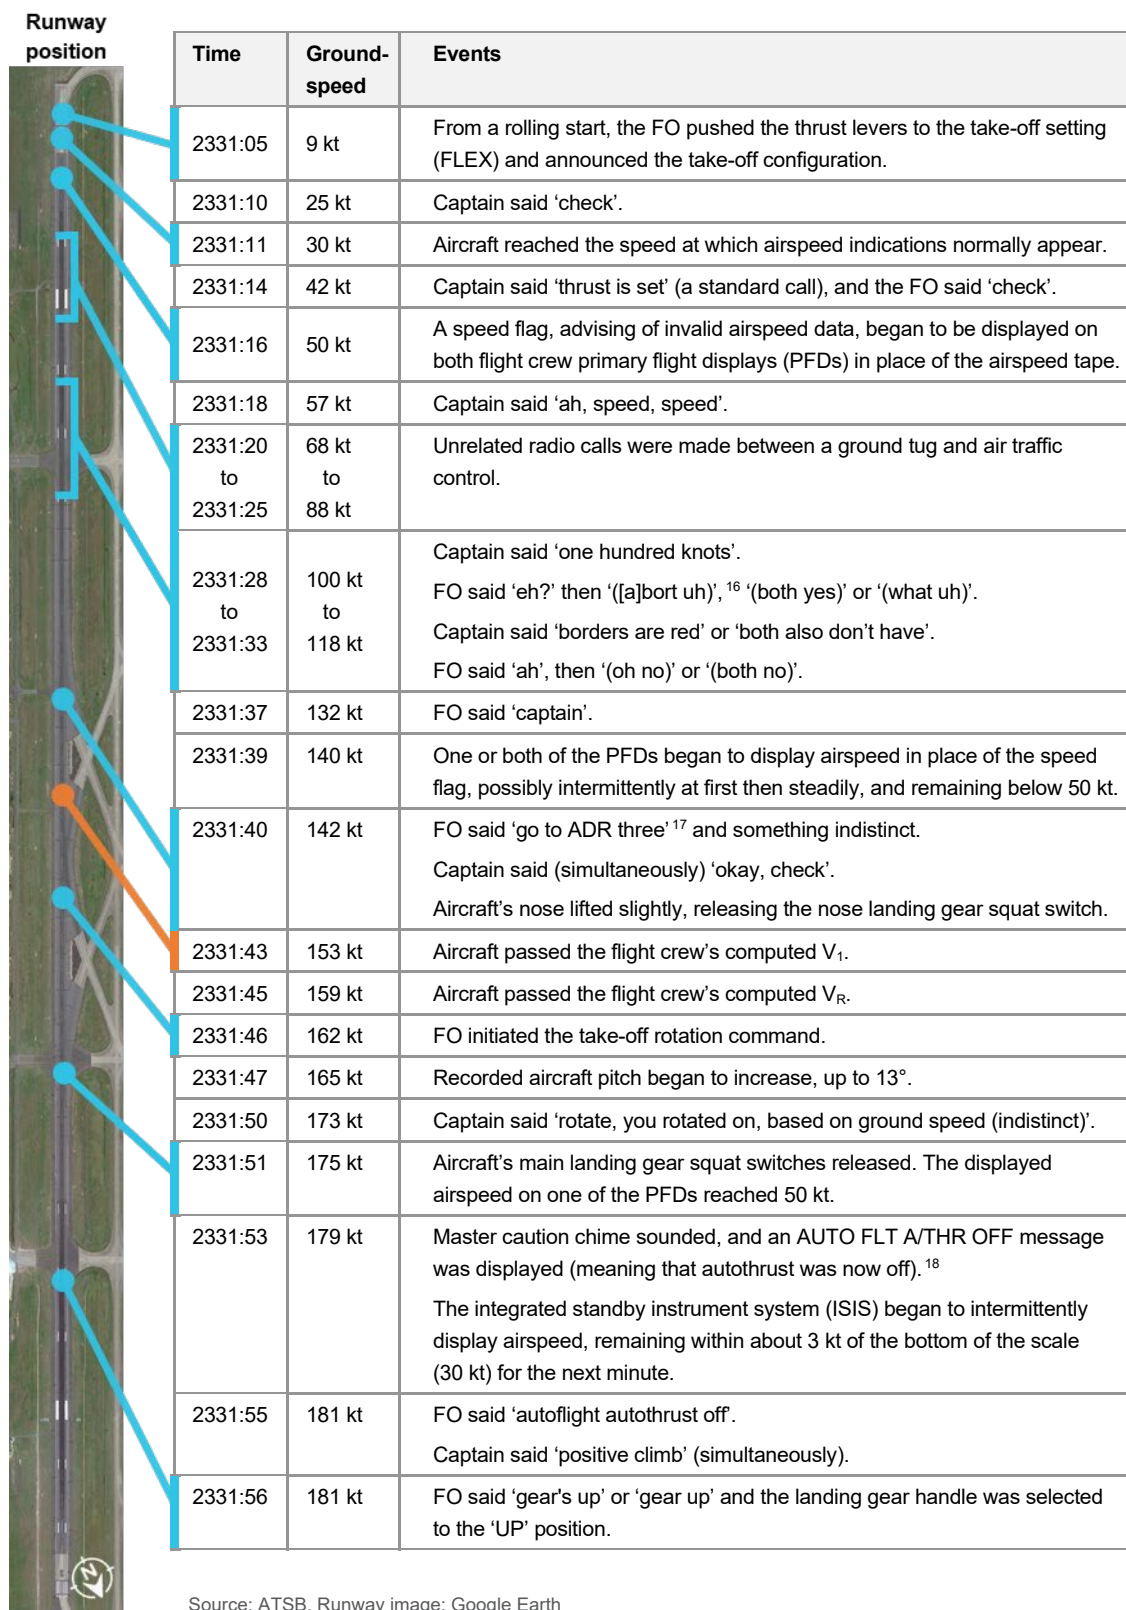
Figure 7: Sequence of events on take-off

Events throughout the take-off, based on recorded information and flight crew interviews, are listed and illustrated in Figure 7. Unclear utterances are marked in parentheses; some of these were recorded on multiple CVR channels and sounded different on each channel. In these cases, alternative interpretations are provided with the ATSB's assessment of the most likely interpretation provided first.<sup>15</sup> Further details and analysis of the data recordings and interpretation of the CVR is provided in Appendix C. Further information about the faults, warnings, and displays associated with the erroneous airspeed data is provided in *Aircraft information*.

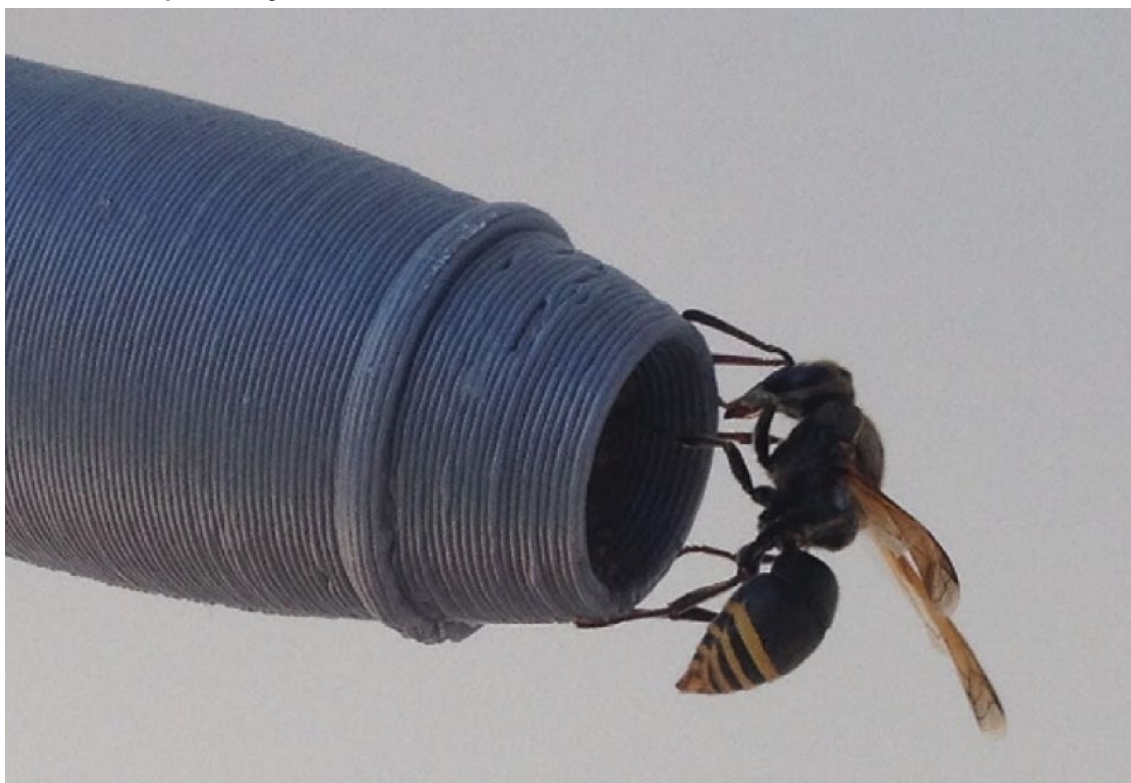
**Figure 13: Female keyhole wasp (*Pachodynerus nasidens*) on a replica DHC8 pitot probe, Brisbane Airport, May 2016**

Historically, mud wasps have been known to build nests in aircraft pitot probes, entering through the forward-facing opening (Figure 13). Nesting and food material placed in the cavity blocks the probe, to the point where it may no longer provide accurate airspeed information. A partial blockage, such as that caused by the first addition of mud for a nest, may be enough to cause anomalous airspeed readings as air flow is disturbed.

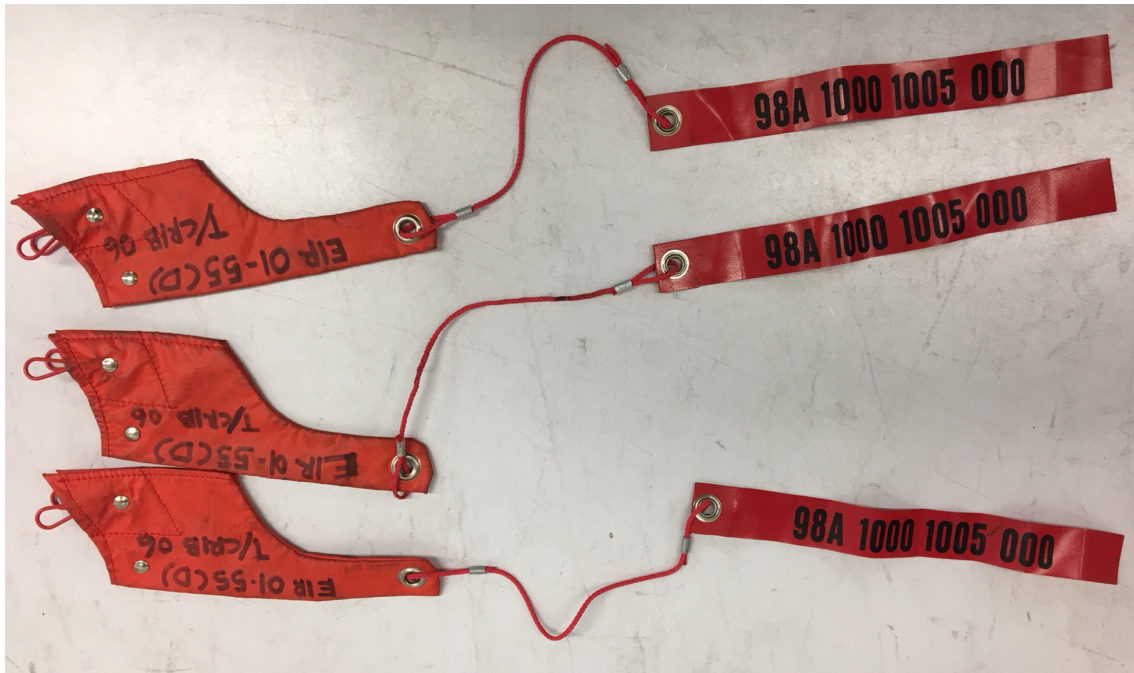
**Figure 33: Airbus-approved pitot probe covers supplied by Malaysia Airlines to AMSA**

At some time in 2018 prior to commencing flights to Brisbane, Malaysia Airlines supplied Aircraft Maintenance Services Australia (AMSA) with a set of Airbus-approved pitot probe covers (Figure 33). These were not fitted to the occurrence aircraft.

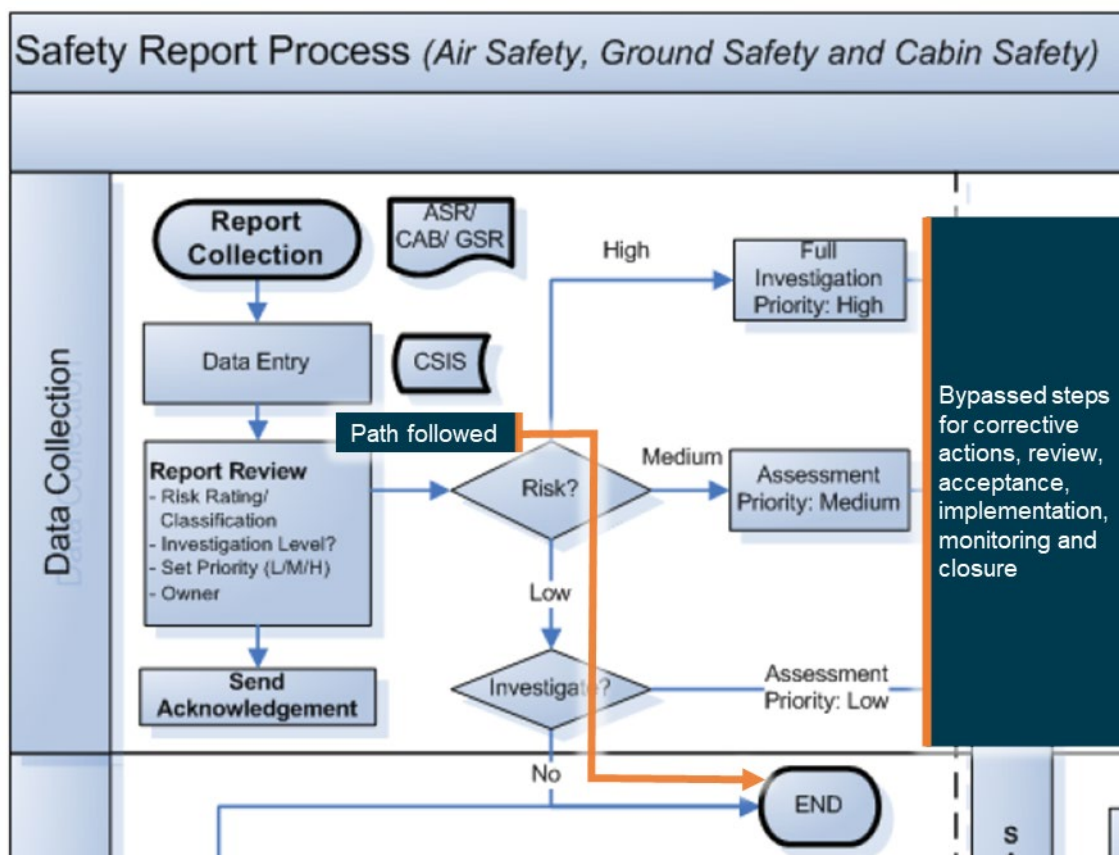
Figure 49: Part of the operator's safety risk management process, annotated

This may have been partly because the risk management process used a flowchart for the safety investigation process (Figure 49). This was specific to the safety reporting process, but it was used as the generic process for all other risk assessments. This required a substantial amount of interpretation by the user because several of its elements were only applicable to the safety reporting process and subsequent investigation.

From a safety investigation perspective, the 'risk?' decision point clearly referred to initial risk, because this part of the process would come before the investigation and identification of additional risk controls. However, from the perspective of a person applying the flowchart to risks identified by a change management process, the distinction between initial and residual risk is less clear. That is, the process did not clearly state whether the 'risk?' decision point should be based on initial or residual risk.

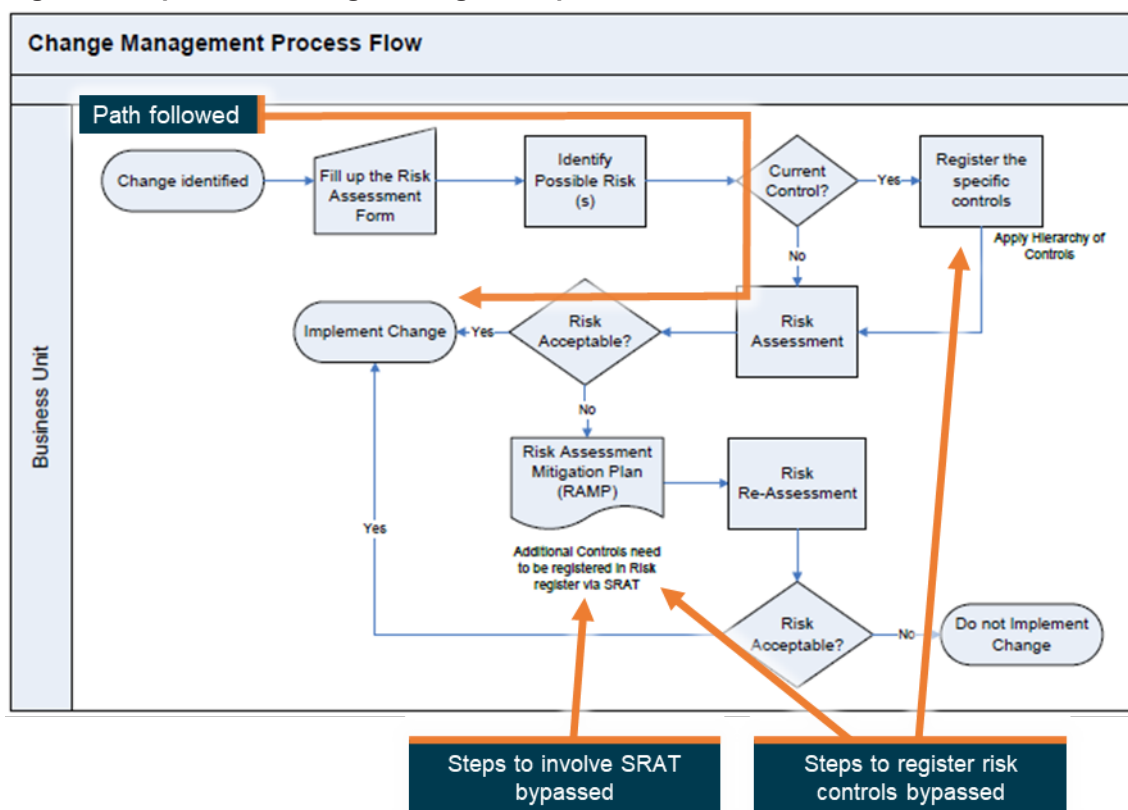
Figure 50: Operator's change management process flowchart, annotated

Separately, the change management process had a similar potential for misinterpretation (Figure 50). The intention of the flowchart appears to have been to:

- prompt a risk assessment
- prompt a mitigation plan and registration of controls if the initial risk was not acceptable
- enable the implementation of a change if the initial (untreated) or residual (treated) risk was acceptable (the pathways leading to 'Implement Change').

However, the flowchart may have unintentionally allowed the implementation of change based only on the residual (treated) risk in the following manner. A person conducting the assessment was prompted to propose risk controls when using either of the available risk assessment forms (the change management form or the risk assessment record form) as part of the 'Risk Assessment' step. This assessment would produce both an initial risk and a residual risk. There was no guidance on which of these should be used for the 'Risk Acceptable?' decision, allowing 'low' residual risks to be accepted without review even if the initial risk was moderate or above as the process probably intended. In fact, the pathway shown in Figure 50 was applied during the assessment for the resumption of Brisbane flights, although it is unclear whether the above reasoning was used in this instance.

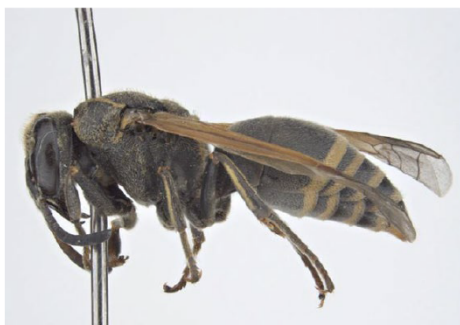
CASA had been notified of the Key Hole wasp hazard (*Pachodynerus nasidens*), by the Department of Agriculture and Water Resources (DoAWR). This species of wasp has been monitored by the National Biosecurity Consultative Committee (NMBCC). This wasp was first identified in Brisbane in 2010. DoAWR advised CASA that these wasps are not as aggressive as paper wasps but would try to sting if they were physically removed.

**Figure 1.** *Pachodynerus nasidens* or Keyhole wasp  
(Source: PaDIL Species Factsheet)

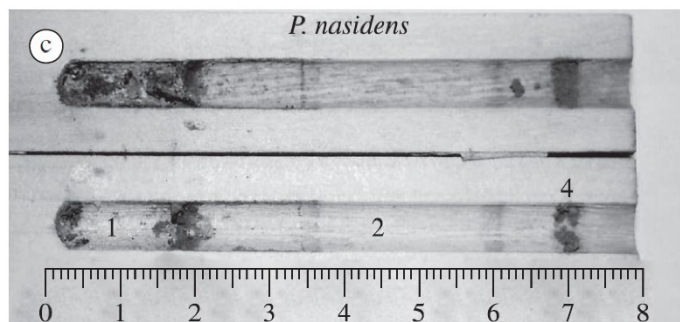
**Figure 2.** Keyhole wasp nest cell structure (1) Provisioned cell, (2) Vestibular cell, (3) Inter-calary cell and (4) Closure plug (Source [Biologic aspects of different species of Pachodynerus](#) (Hymenoptera; Vespidae; Eumeninae))

A wasp nest can completely block pitot tubes, fuel tank vents and drains.

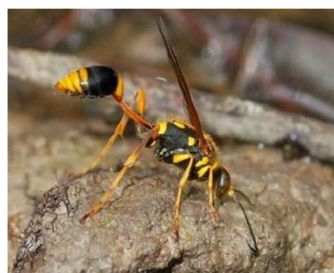
**Figure 4.** Australian Mud Dauber Wasp

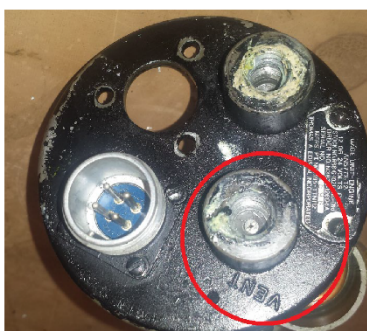
Figure 6.b.

Triplex fuel gauge in an Aerocommander 500s had a blockage in the external fuel vent line. The fuel pressure indication has a capsule which is ported overboard via this vent line. The vent line is common to both indications and because of the blockage both gauges indicated zero (Figure 6.a.).

Vent connection on rear of Triplex fuel gauge (Figure 6.b.)

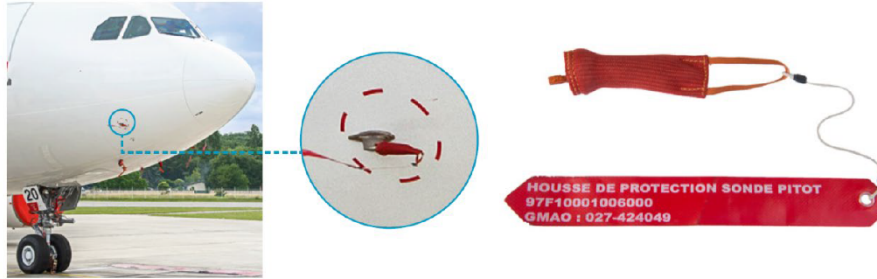
**Figure 8.** Aircraft pitot probe protective cover: Source Airbus

Regardless of whether the aircraft has only a short turn-around time or remains on the flight line, approved protective covers should be used. It is important to use the manufacturers approved probe cover which are a part of the flight kit for each aircraft. Other manufacturers' covers may not fit correctly nor offer complete protection.

Protective covers can be installed usually 30 minutes after engine shut down to allow the probes to cool sufficiently. After a period of 15 minutes the probe tip cools down to 70°C and 15 minutes after will reach ambient temperature.

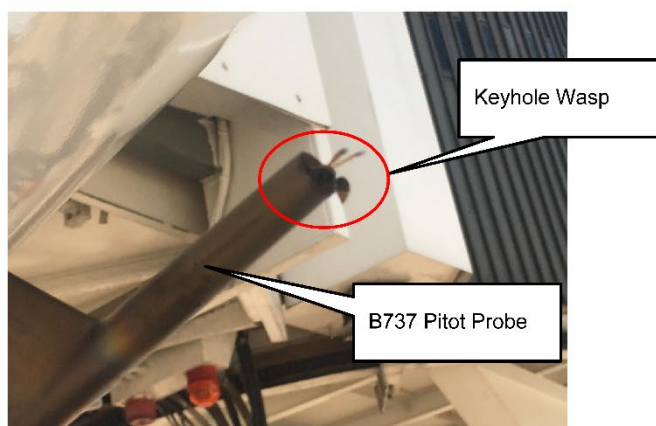
**Figure 10.** Keyhole Wasp seen leaving a B737 Pitot Probe

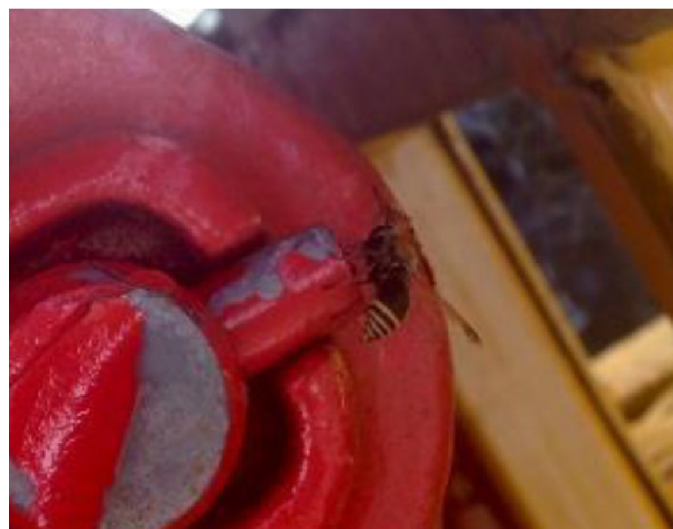
**Figure 12.** Keyhole Wasp on bay equipment

Airport authorities should have a wildlife hazard management plan which should include what mitigations are in place to detect or manage insect activity. Operators should report instances of in-service incidents to the local airport authority to help determine root causes to prevent further occurrences and track any trends of obstructions of pitot probes on ground.

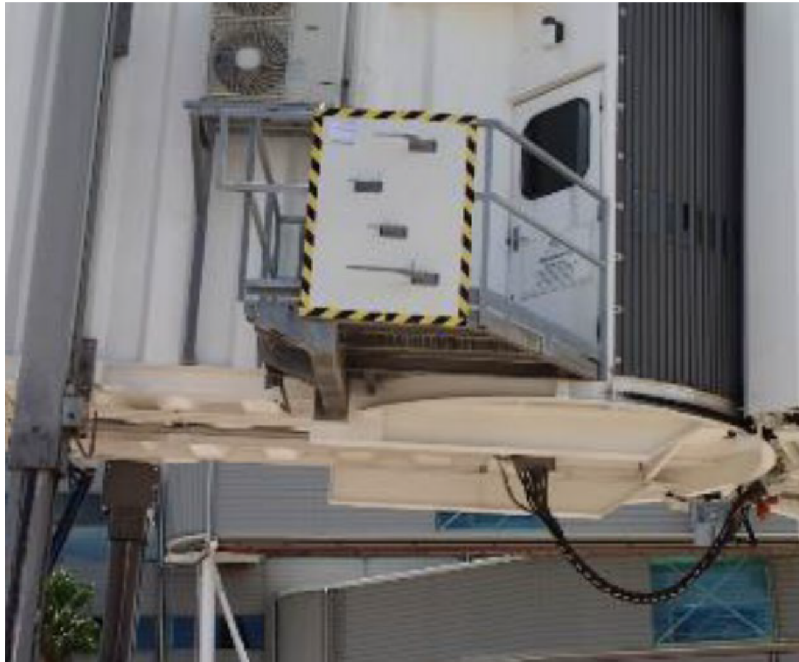
Simulation pitot probe panels have been installed at some areas at Brisbane airport to check for the presence of wasp nests, as part of the BAC sponsored study. The probes are regularly checked by Ecosure and/or BAC staff. The wasps are then sent to Queensland Museum for identification.

**Figure 13.** Simulation Pitot probe panels
