Airspeed indication failure on take-off involving Airbus A330, 9M-MTK

Brisbane Airport, Queensland, 18 July 2018

ATSB Transport Safety Report

AO-2018-053

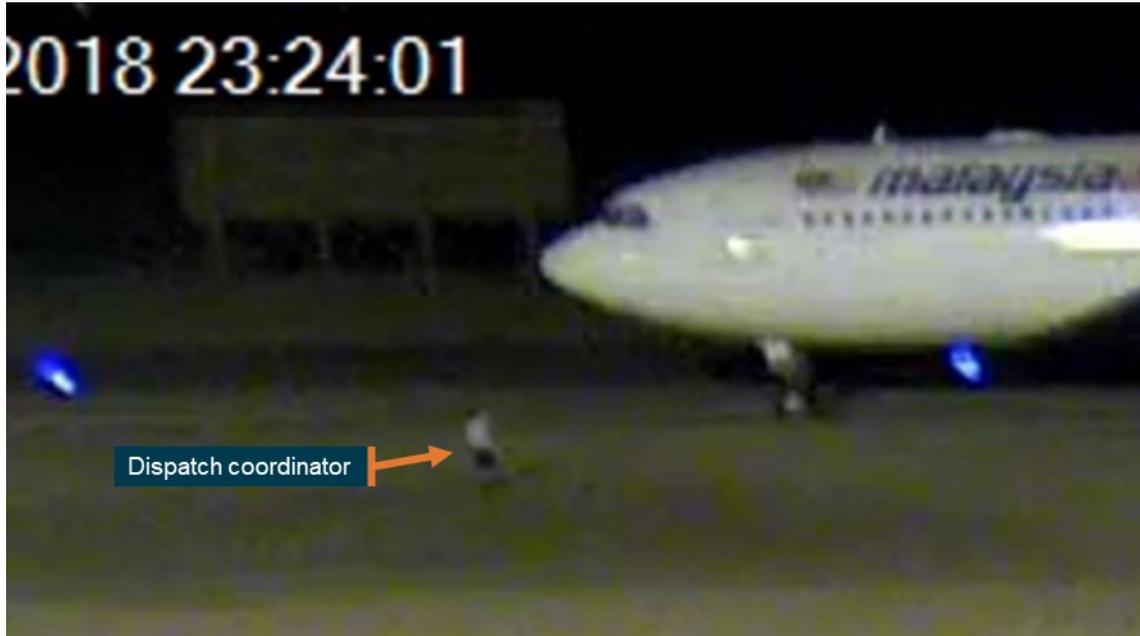
Figure 6: Dispatch coordinator in position after pushback

The towbar and dispatch coordinator's headset were then detached from the aircraft. CCTV footage from an adjacent bay showed the dispatch coordinator standing back from the left side nose of the aircraft showing the aircraft's nose gear steering pin to the flight crew, in accordance with procedure, as confirmation that it had been removed (Figure 6). The pitot probe cover streamers would have been visible from this position.

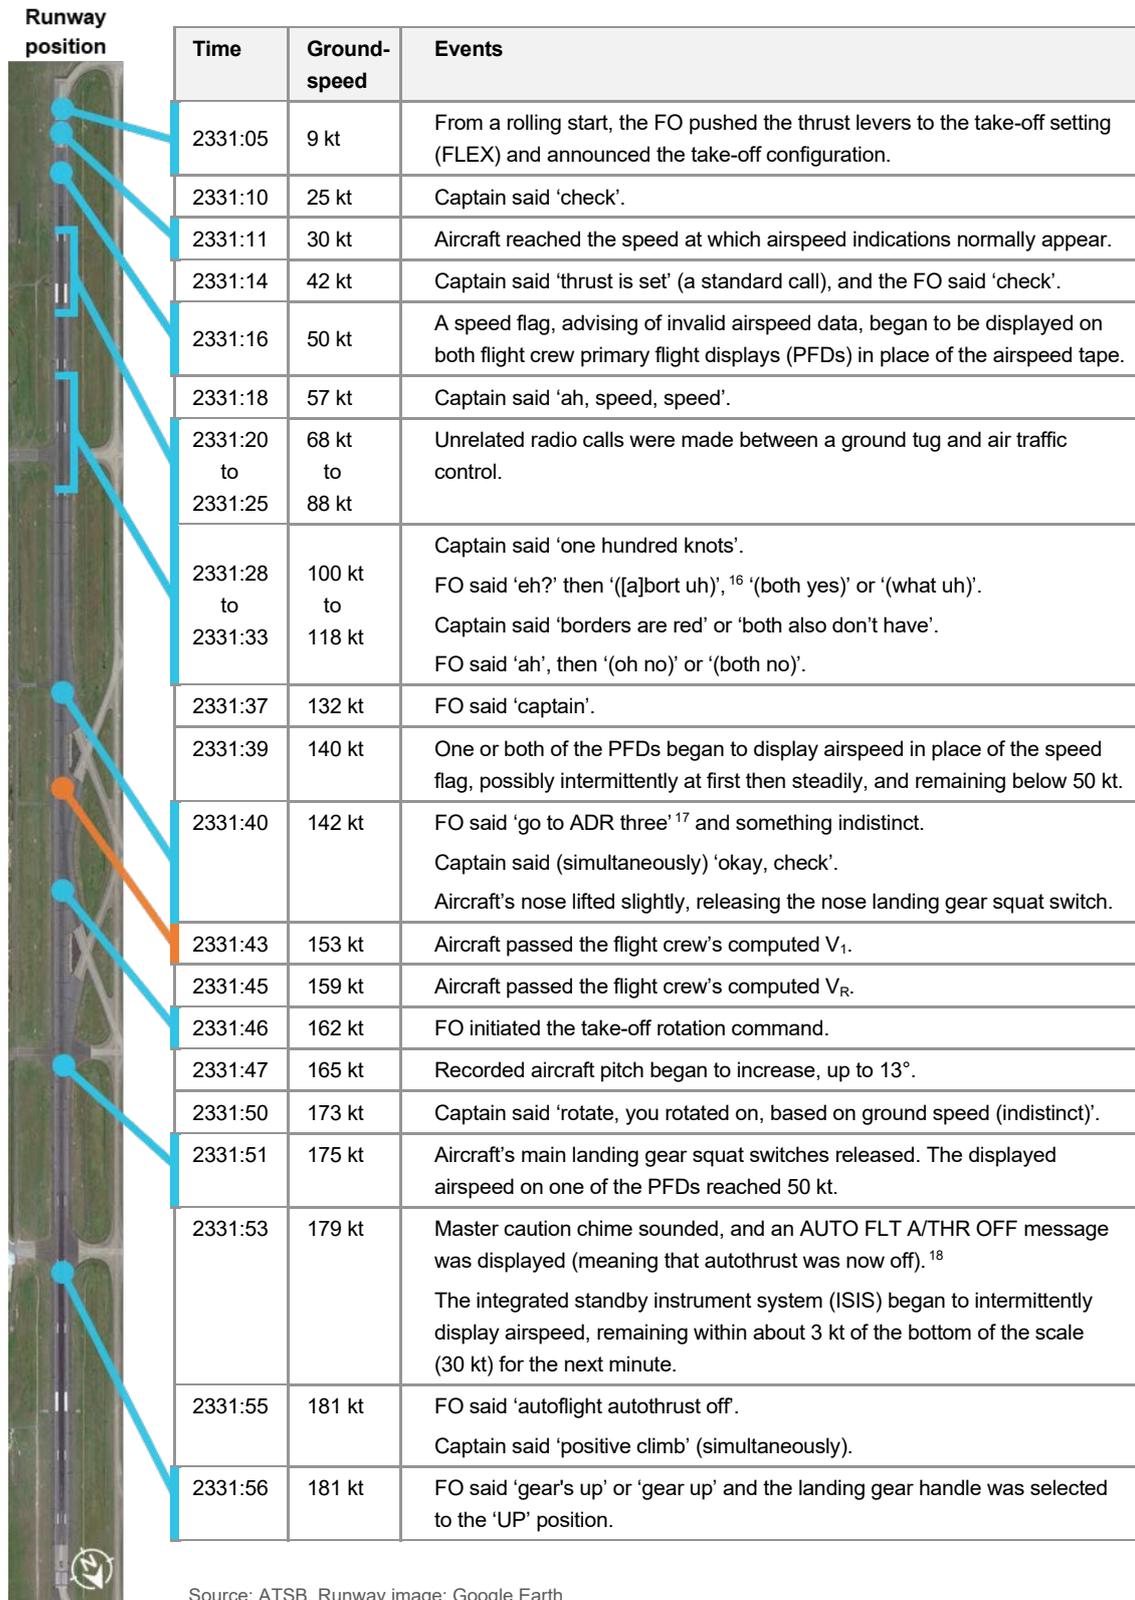
Figure 7: Sequence of events on take-off

Events throughout the take-off, based on recorded information and flight crew interviews, are listed and illustrated in Figure 7. Unclear utterances are marked in parentheses; some of these were recorded on multiple CVR channels and sounded different on each channel. In these cases, alternative interpretations are provided with the ATSB's assessment of the most likely interpretation provided first.¹⁵ Further details and analysis of the data recordings and interpretation of the CVR is provided in Appendix C. Further information about the faults, warnings, and displays associated with the erroneous airspeed data is provided in *Aircraft information*.

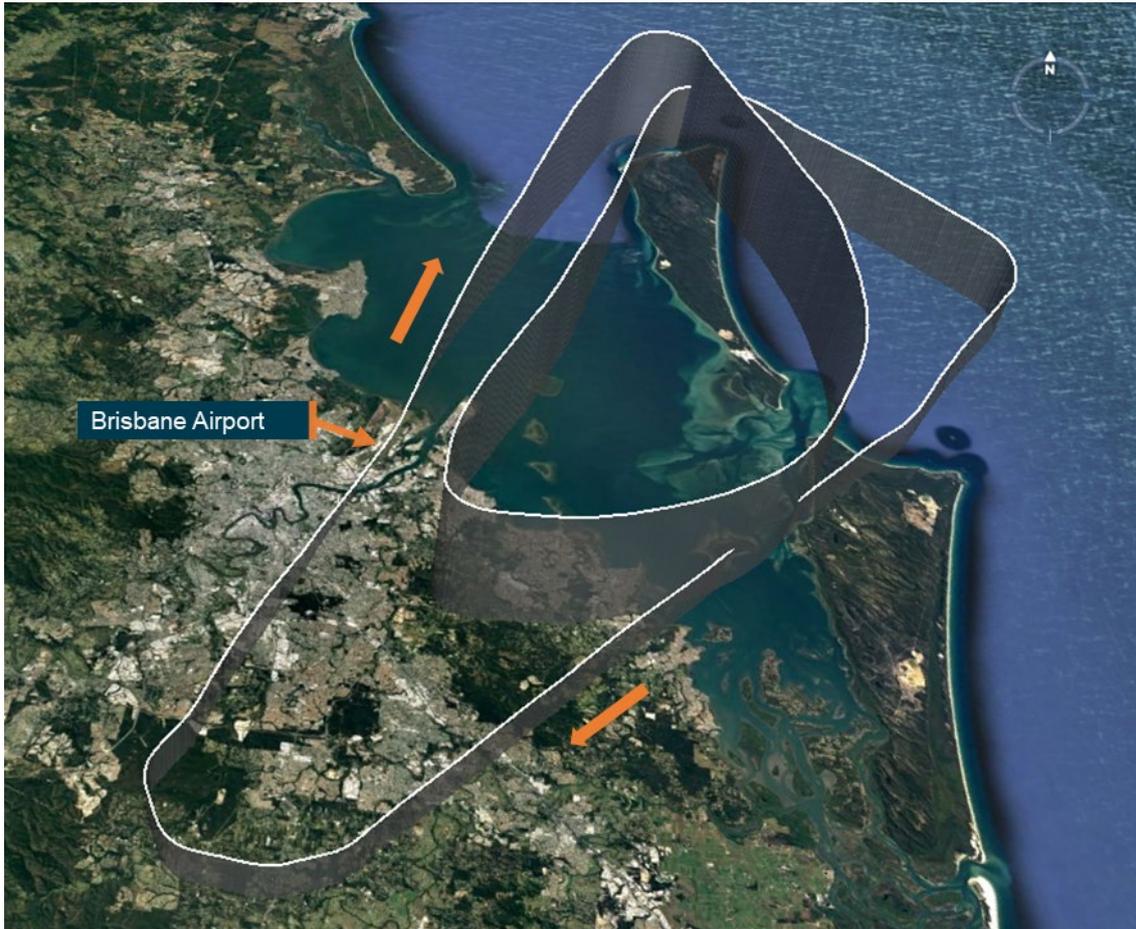
Figure 8: Flight path of 9M-MTK during take-off, turn-back and landing

The FO stabilised the aircraft in level flight at about FL110. A short time later the FO obtained an ATC clearance to remain at this altitude and to manoeuvre the aircraft to the east of Brisbane Airport (Figure 8).

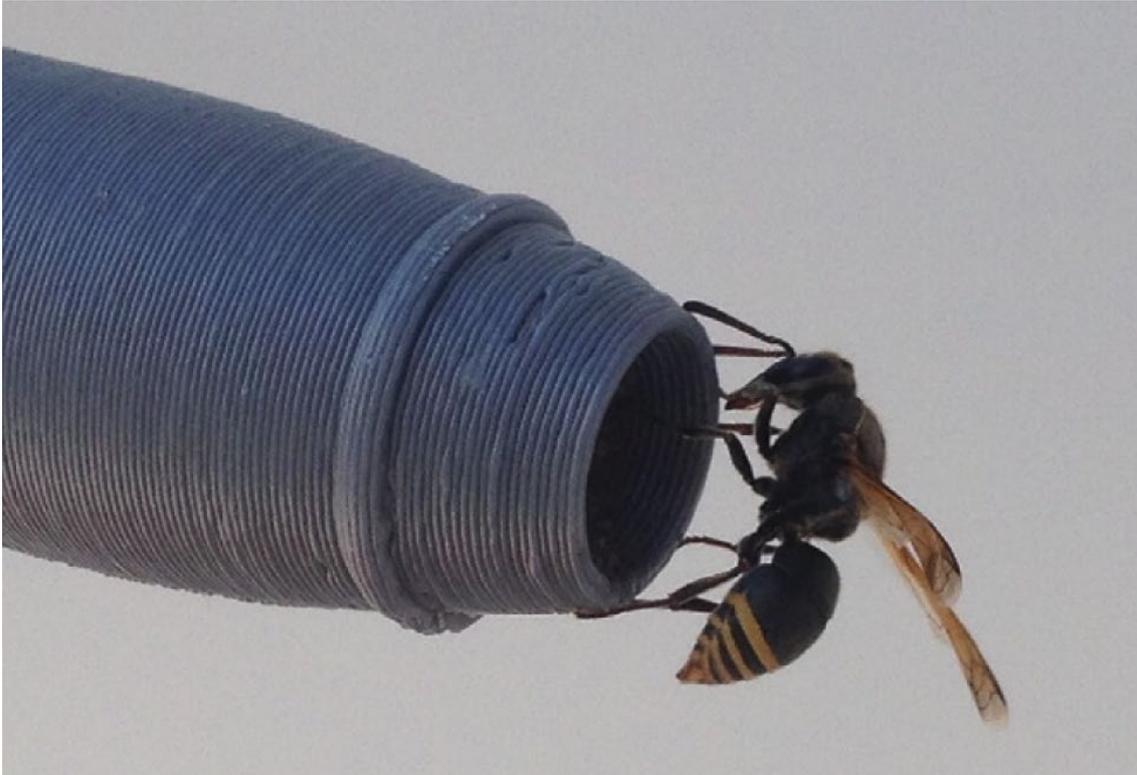
Figure 13: Female keyhole wasp (*Pachodynerus nasidens*) on a replica DHC8 pitot probe, Brisbane Airport, May 2016

Historically, mud wasps have been known to build nests in aircraft pitot probes, entering through the forward-facing opening (Figure 13). Nesting and food material placed in the cavity blocks the probe, to the point where it may no longer provide accurate airspeed information. A partial blockage, such as that caused by the first addition of mud for a nest, may be enough to cause anomalous airspeed readings as air flow is disturbed.

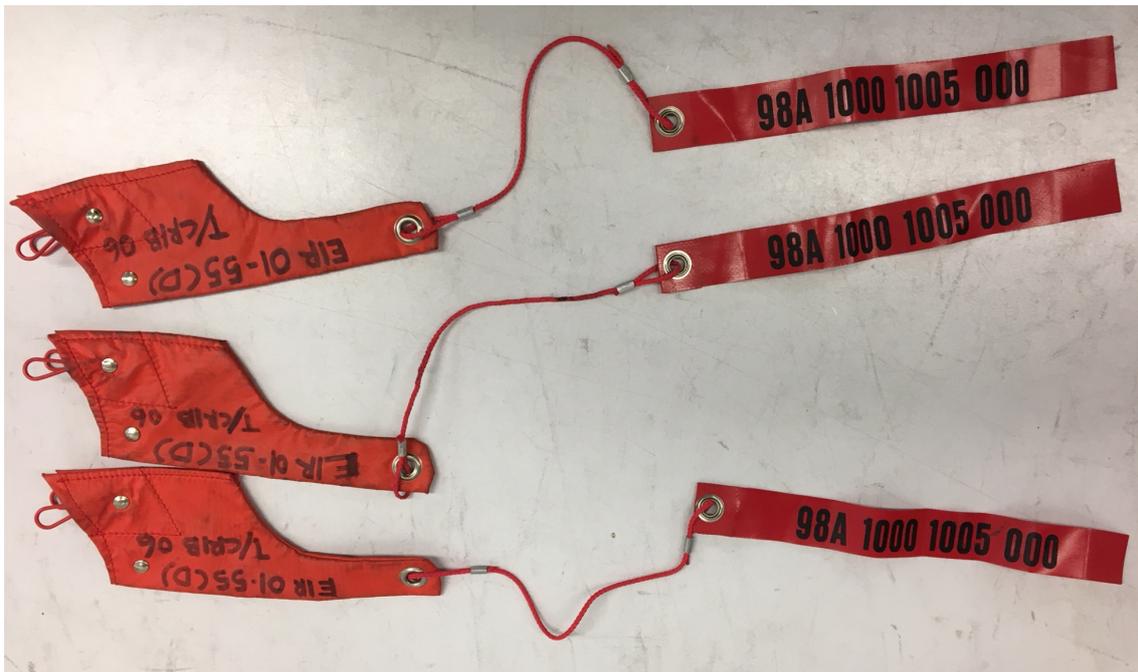
Figure 33: Airbus-approved pitot probe covers supplied by Malaysia Airlines to AMSA

At some time in 2018 prior to commencing flights to Brisbane, Malaysia Airlines supplied Aircraft Maintenance Services Australia (AMSA) with a set of Airbus-approved pitot probe covers (Figure 33). These were not fitted to the occurrence aircraft.

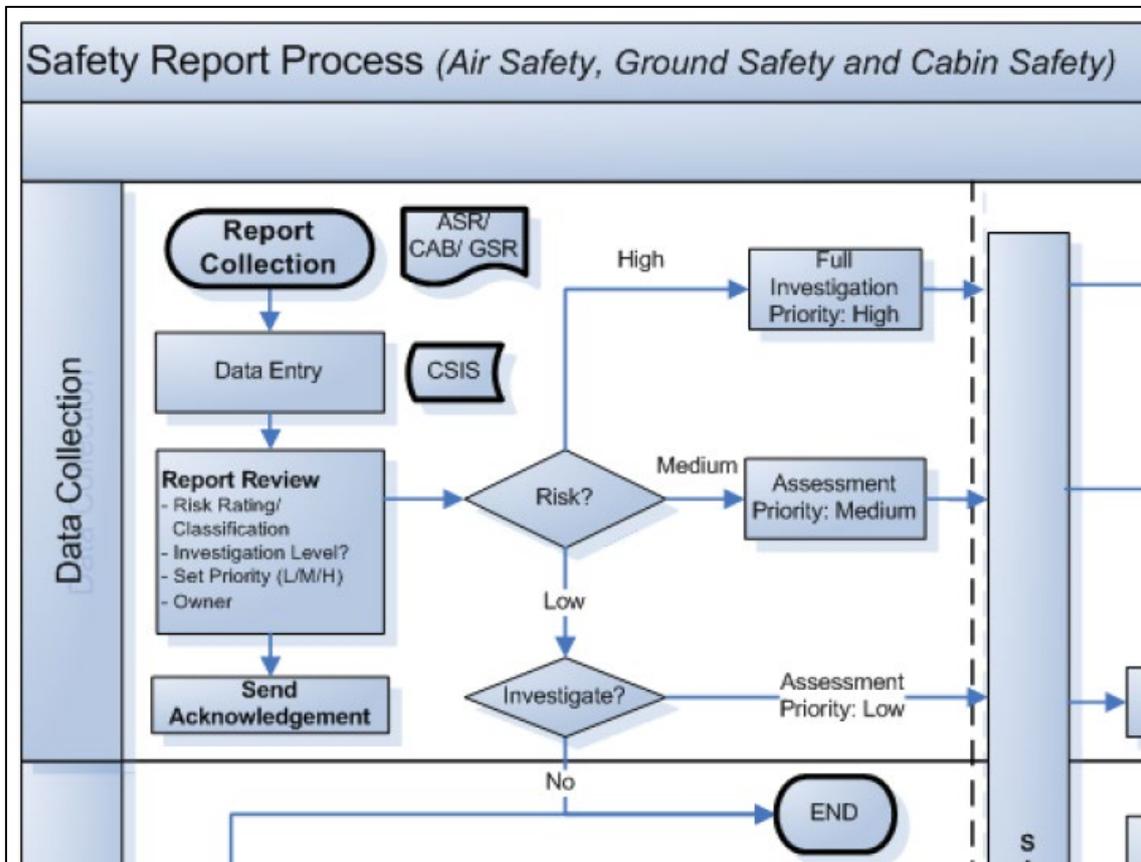
Figure 47: Part of the operator’s safety reporting process, also used for general safety risk management

The CSMM did not clarify whether the ‘risk’ decision point was to be based on initial or residual risk.

There was no guidance on identifying and involving stakeholders, and although the process listed ‘monitoring’ as a key step, there was no guidance for how this should be accomplished.

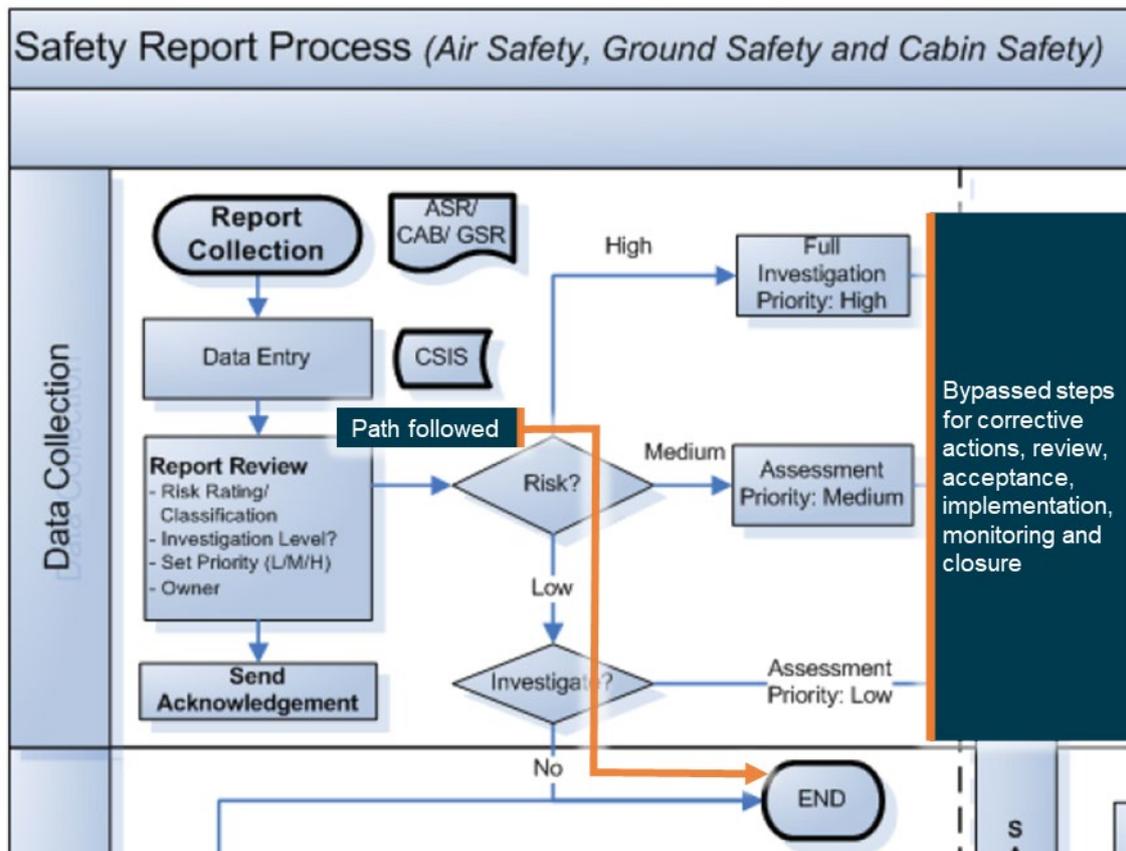
Figure 49: Part of the operator’s safety risk management process, annotated

This may have been partly because the risk management process used a flowchart for the safety investigation process (Figure 49). This was specific to the safety reporting process, but it was used as the generic process for all other risk assessments. This required a substantial amount of interpretation by the user because several of its elements were only applicable to the safety reporting process and subsequent investigation.

From a safety investigation perspective, the ‘risk?’ decision point clearly referred to initial risk, because this part of the process would come before the investigation and identification of additional risk controls. However, from the perspective of a person applying the flowchart to risks identified by a change management process, the distinction between initial and residual risk is less clear. That is, the process did not clearly state whether the ‘risk?’ decision point should be based on initial or residual risk.

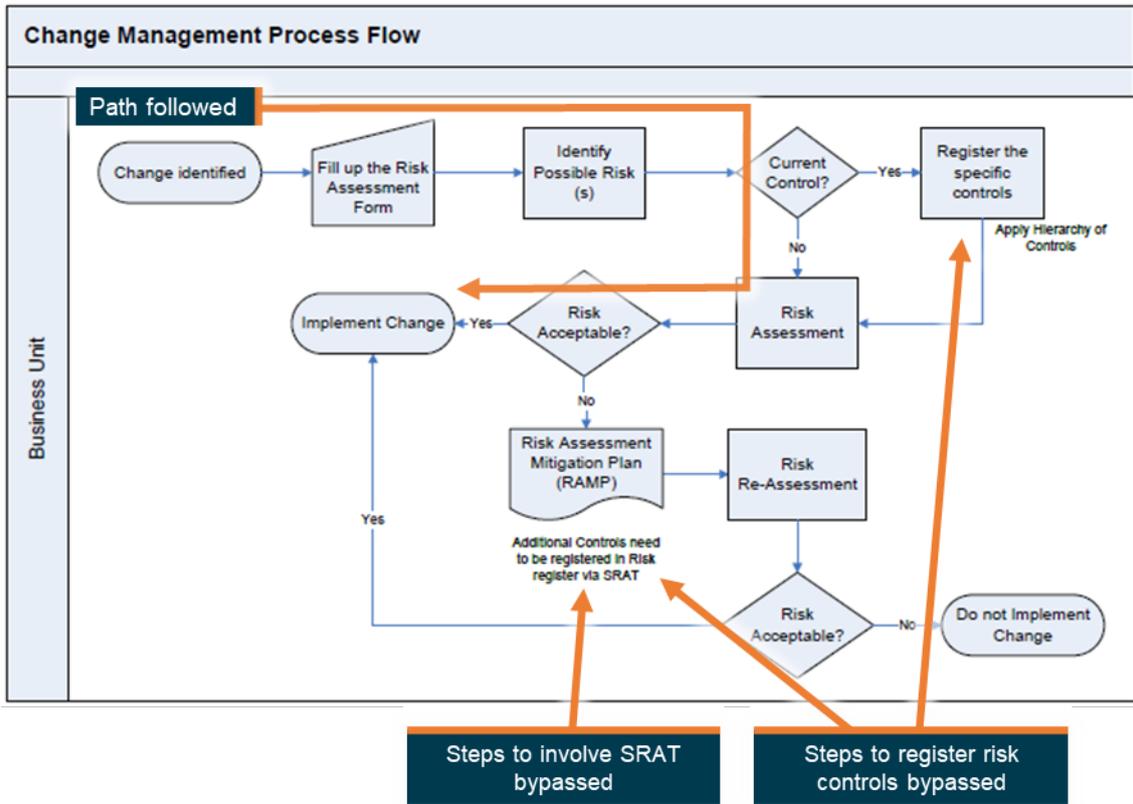
Figure 50: Operator’s change management process flowchart, annotated

Separately, the change management process had a similar potential for misinterpretation (Figure 50). The intention of the flowchart appears to have been to:

However, the flowchart may have unintentionally allowed the implementation of change based only on the residual (treated) risk in the following manner. A person conducting the assessment was prompted to propose risk controls when using either of the available risk assessment forms (the change management form or the risk assessment record form) as part of the ‘Risk Assessment’ step. This assessment would produce both an initial risk and a residual risk. There was no guidance on which of these should be used for the ‘Risk Acceptable?’ decision, allowing ‘low’ residual risks to be accepted without review even if the initial risk was moderate or above as the process probably intended. In fact, the pathway shown in Figure 50 was applied during the assessment for the resumption of Brisbane flights, although it is unclear whether the above reasoning was used in this instance.

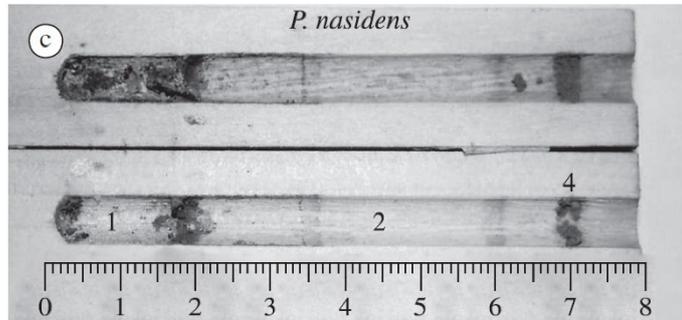
Figure 2. Keyhole wasp nest cell structure (1) Provisioned cell, (2) Vestibular cell, (3) Inter-calary cell and (4) Closure plug (Source [Biologic aspects of different species of Pachodynerus](#) (Hymenoptera; Vespidae; Eumeninae))

A wasp nest can completely block pitot tubes, fuel tank vents and drains.

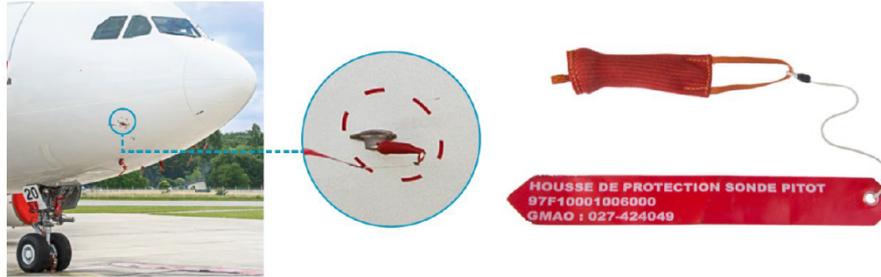
Figure 8. Aircraft pitot probe protective cover: Source Airbus

Regardless of whether the aircraft has only a short turn-around time or remains on the flight line, approved protective covers should be used. It is important to use the manufacturers approved probe cover which are a part of the flight kit for each aircraft. Other manufacturers' covers may not fit correctly nor offer complete protection.

Protective covers can be installed usually 30 minutes after engine shut down to allow the probes to cool sufficiently. After a period of 15 minutes the probe tip cools down to 70°C and 15 minutes after will reach ambient temperature.

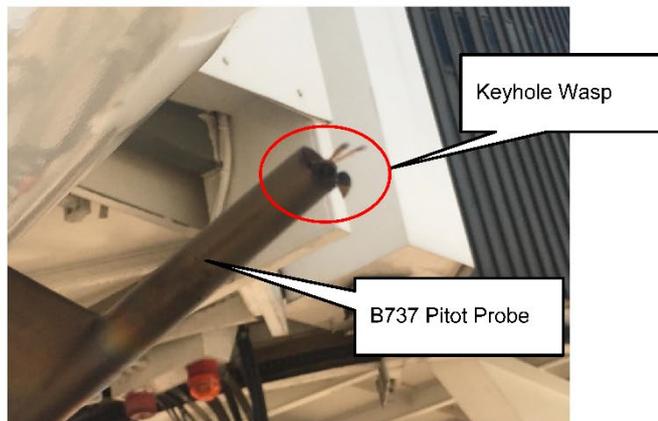
Figure 10. Keyhole Wasp seen leaving a B737 Pitot Probe

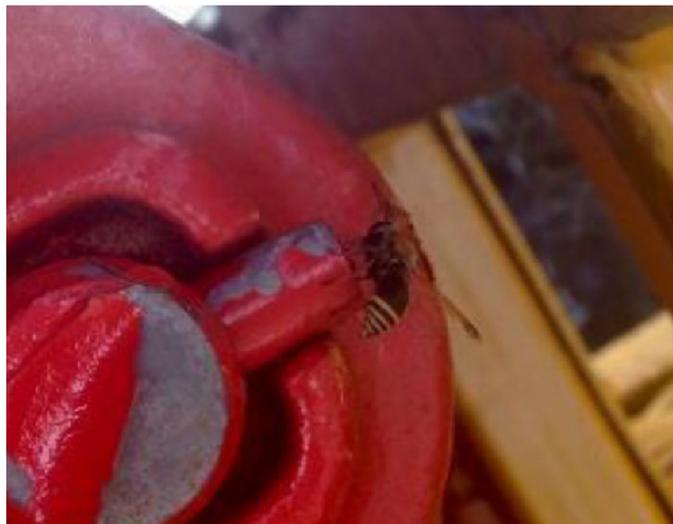
Figure 12. Keyhole Wasp on bay equipment
