Signal DP29 passed at danger involving suburban passenger train DW17 and near collision with another suburban passenger train

Park Road Station, Queensland, on 25 March 2019

ATSB Transport Safety Report

RO-2019-009

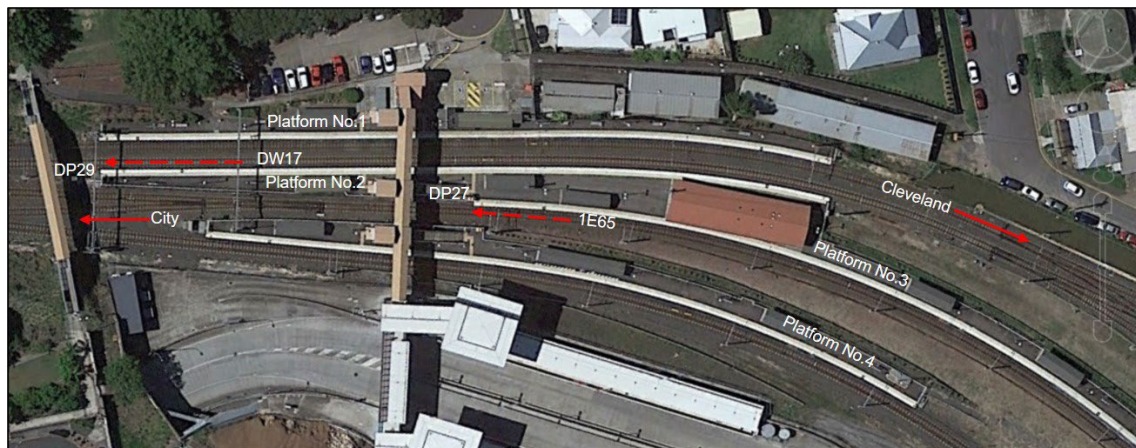
Figure 4: Platform configuration at Park Road Station

Park Road is an interchange station for the Gold Coast and Cleveland lines. It is located about 4.3 rail km south-east of Roma Street Station and serves the Brisbane suburb of Woolloongabba. The station has 4 platforms (Figure 4) and caters mainly for medium to high frequency suburban passenger traffic.

The image shows the platform configuration at Park Road, relevant signals, and the direction of travel of trains DW17 and 1E65. Source: Google maps, modified by the ATSB
