Mid-air collision involving Piper PA-44-180 Seminole, VH-JQF and Beech D95A Travel Air, VH-AEM

8 km south of Mangalore Airport, Victoria on 19 February 2020

ATSB Transport Safety Report

AO-2020-012

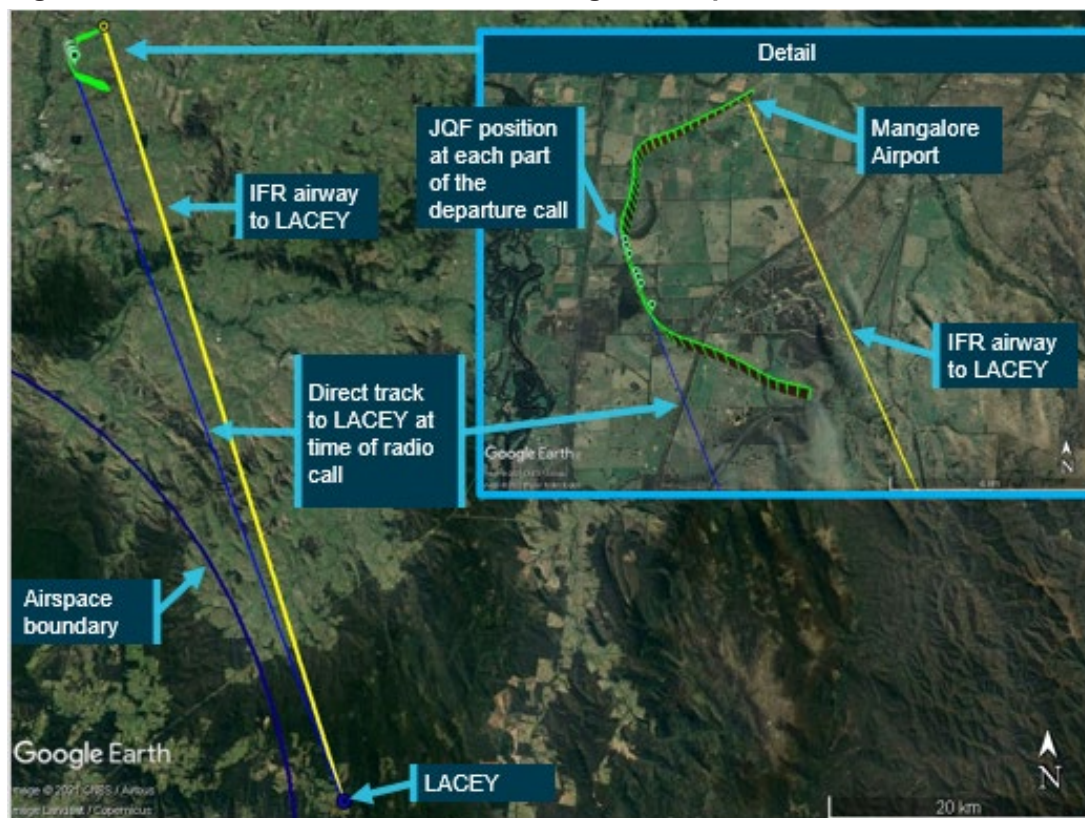
Figure 8: Track of JQF after take-off from Mangalore Airport

JQF commenced the take-off roll from runway 23 at Mangalore just prior to 1120. The aircraft initially departed in an extended upwind direction, before commencing a series of left turns that resulted in the aircraft tracking towards the planned route to LACEY (Figure 8).

The pilot under examination made a departure call to the Melbourne Centre controller with the first communication commencing at 1122:19. At the time of this call, during which the pilots were provided traffic information about AEM, the track maintained by JQF was direct to LACEY. This may have been intentional, or co-incidental due to the increased workload of the student during the take-off phase and climb phase and managing the radio during the Melbourne Centre call. It was at this time the controller reviewed the velocity vectors that were based on the track of the aircraft not the flight planned track, and assessed that JQF would pass behind AEM (see the section titled *Short term conflict alert*). However, at the end of the radio communication, JQF resumed the turn towards the planned route to LACEY via route W481.

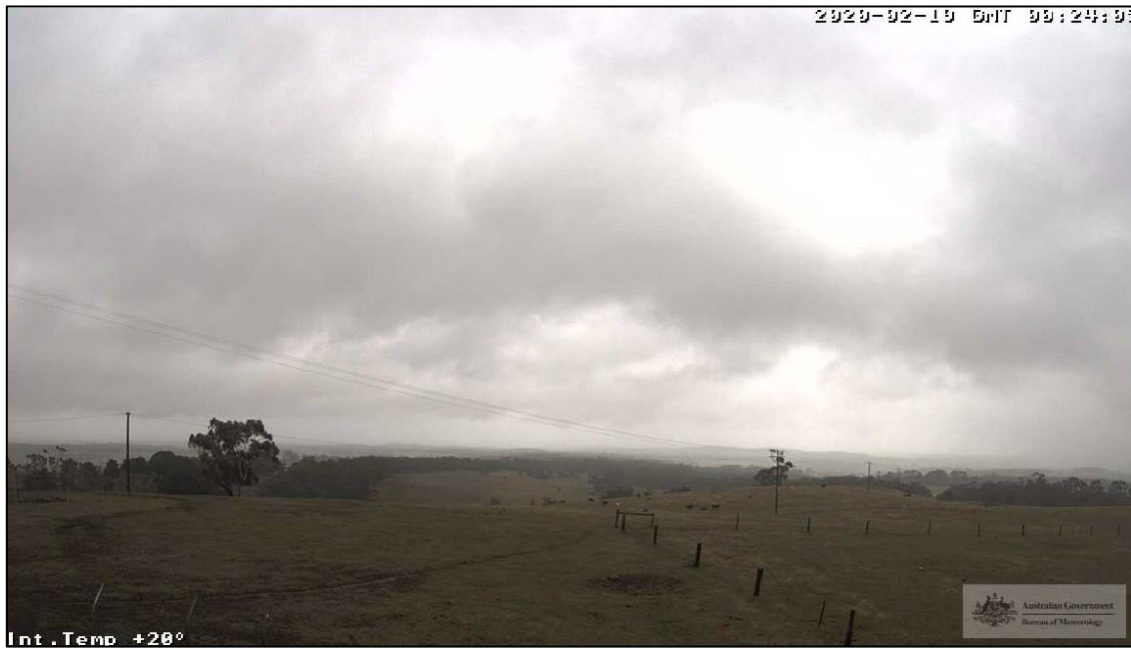
Figure 17: Weather camera image from Kilmore Gap facing towards Mangalore Airport

Figure 17 shows an image recorded by a BoM weather camera at Kilmore Gap (elevation 1,731 ft), looking north towards Mangalore Airport at the time of the collision.

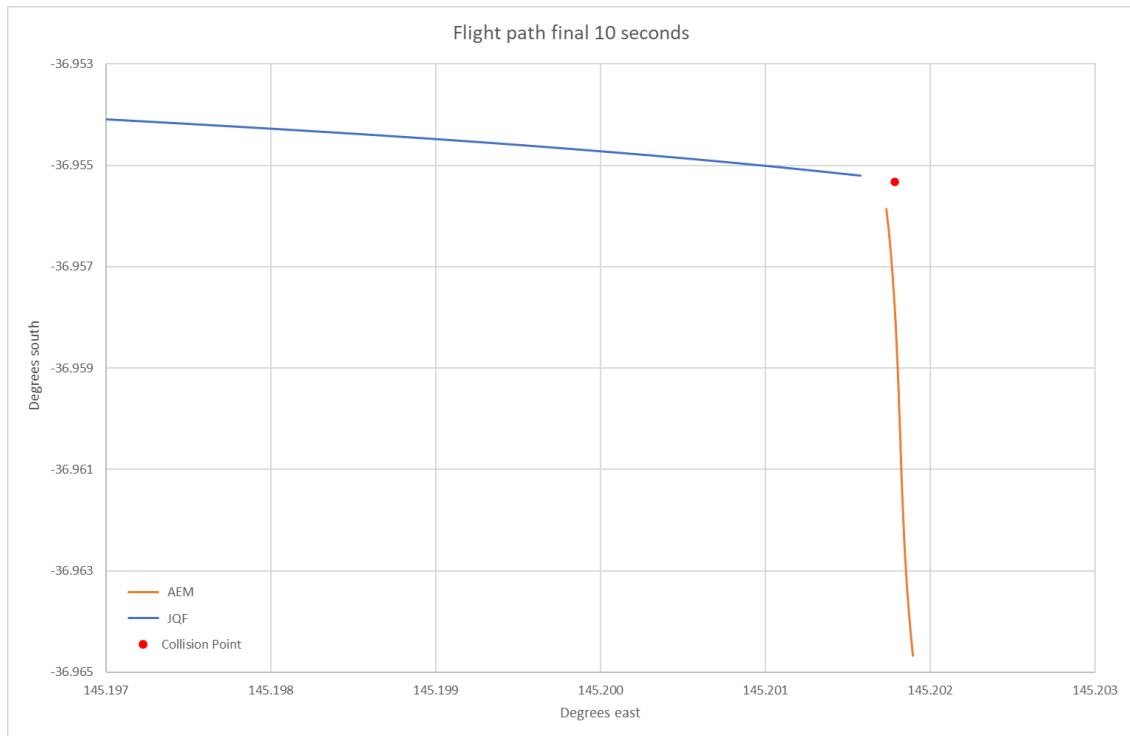
Figure 20: Aircraft position for AEM and JQF

The raw ADS-B data was analysed to determine how the two aircraft came together. The data indicated that approximately 0.55 seconds before the collision AEM was on a true heading of 352° and JQF on a true heading of 132°, giving a relative heading angle of 140° (Figure 20). At this time JQF and AEM were estimated to be at the same level, 4,125ft, with JQF maintaining altitude and AEM descending on approach to Mangalore (Figure 21, Figure 22). The groundspeeds of JQF and AEM, considering all available wind information and limitations in the ADS-B data, were around 94 kt and 192 kt respectively with a closing speed just prior to the collision of approximately 245 kt.

Note: Due to wind, the angle of approach (track angle) will appear smaller than the angle of collision (heading angle).

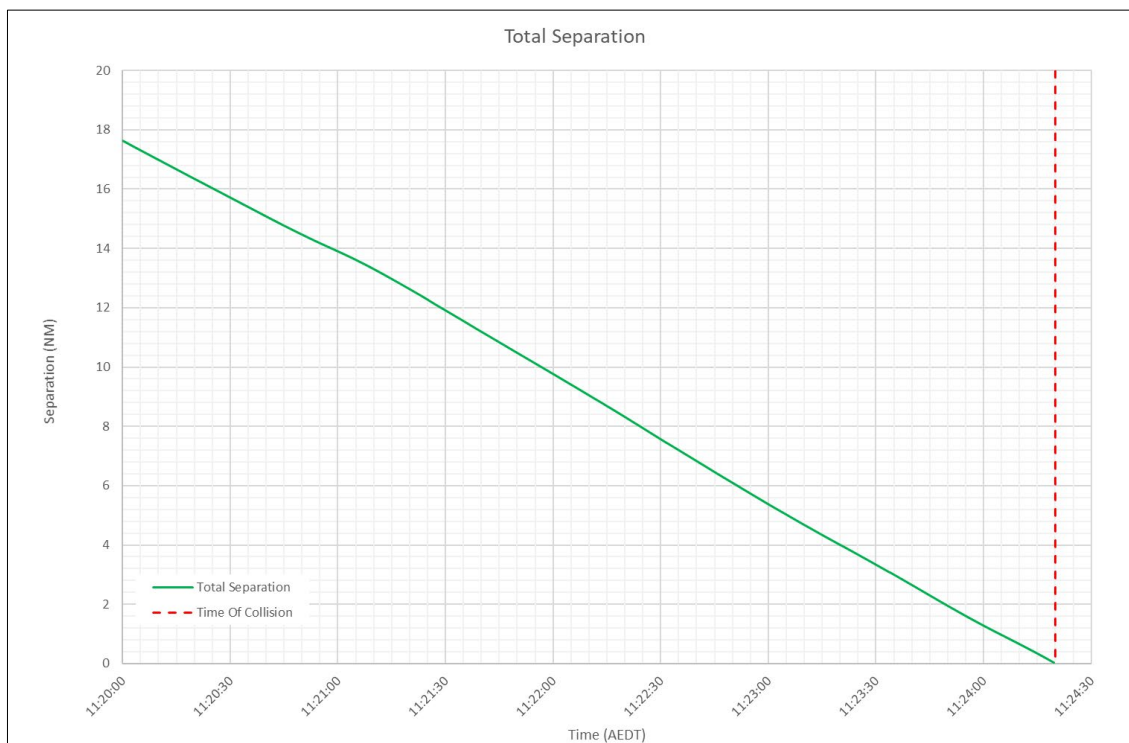
Figure 22: Total separation between AEM and JQF in nautical miles

The data for AEM showed very little variation in track and the data for JQF showed a slow turn towards the flight planned track to LACEY. Based on the lack of rapid or pronounced change in the aircrafts' flight paths it is unlikely that an evasive manoeuvre was initiated by the pilots in either aircraft. Figure 22 shows the total separation, including both lateral and vertical components, of AEM and JQF after the time of JQF's take-off from Mangalore. This illustrates that the two aircraft remained on a collision course for most of the flight.
