# Collision between coal trains MB526 and AH378

Kooragang, New South Wales, on 29 July 2020

**ATSB Transport Safety Report**  
Rail Occurrence Investigation (Short)  
RO-2020-013  
Final – 4 April 2022

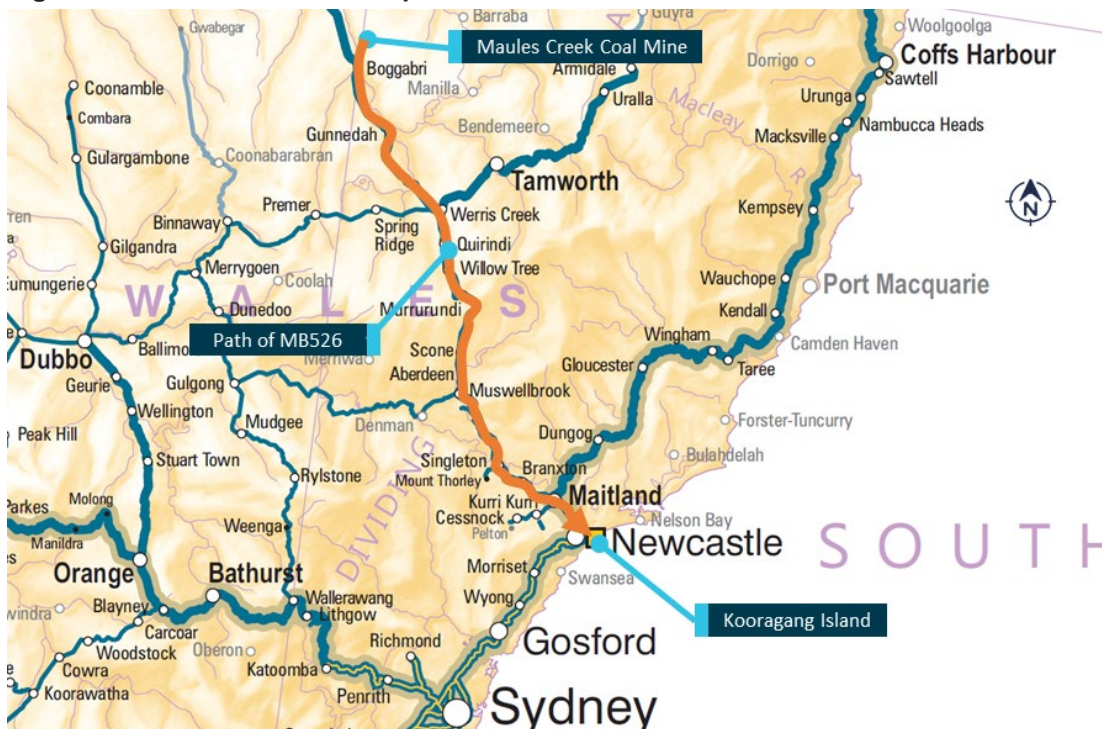
**Figure 1: Incident location and path of MB526**

At 0352, MB526 approached Lochinvar Station (202.600 km) and made a 35 % brake application. The crew identified no issues with the brakes at the time. At approximately the same time, AH378 commenced discharging at number 3 dump station (177.288 km<sup>3</sup>). The journey of MB526 is illustrated in Figure 1.

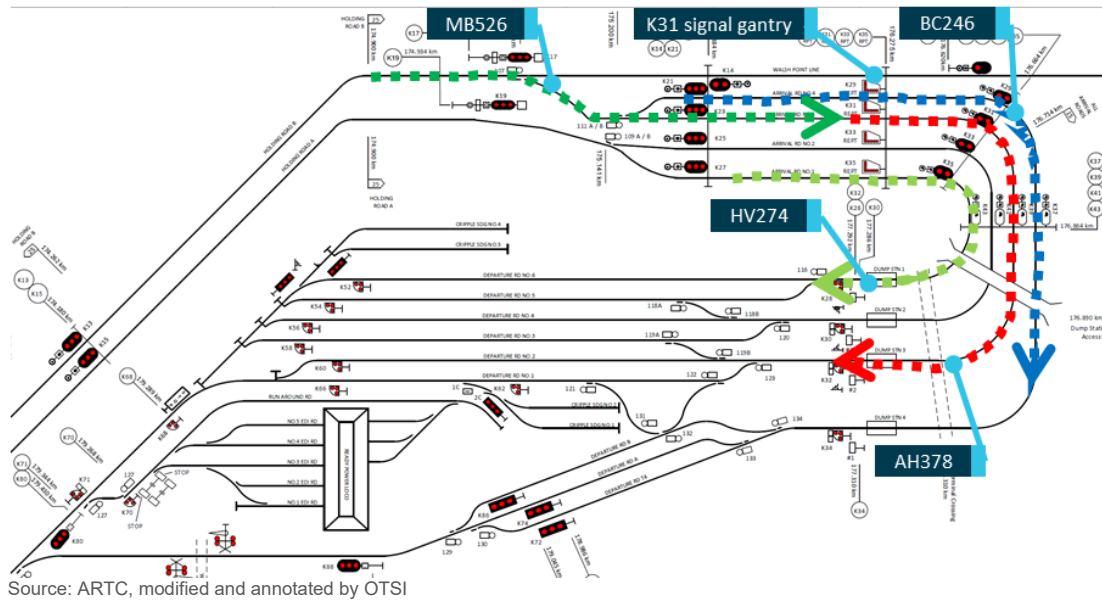
Figure 2: Kooragang Island with approximate location of trains at time of incident

At 0508:49, MB526 collided with the rear wagon of AH378 on arrival road 3 at Kooragang Coal Terminal, between signals K23 and K31 and came to a stop at approximately at 176.160 km (Figure 2).
