In-flight break-up involving Robinson R44 Raven I, VH-HGU

31 km east of Goulburn Airport, New South Wales, on 2 December 2020

ATSB Transport Safety Report

AO-2020-061

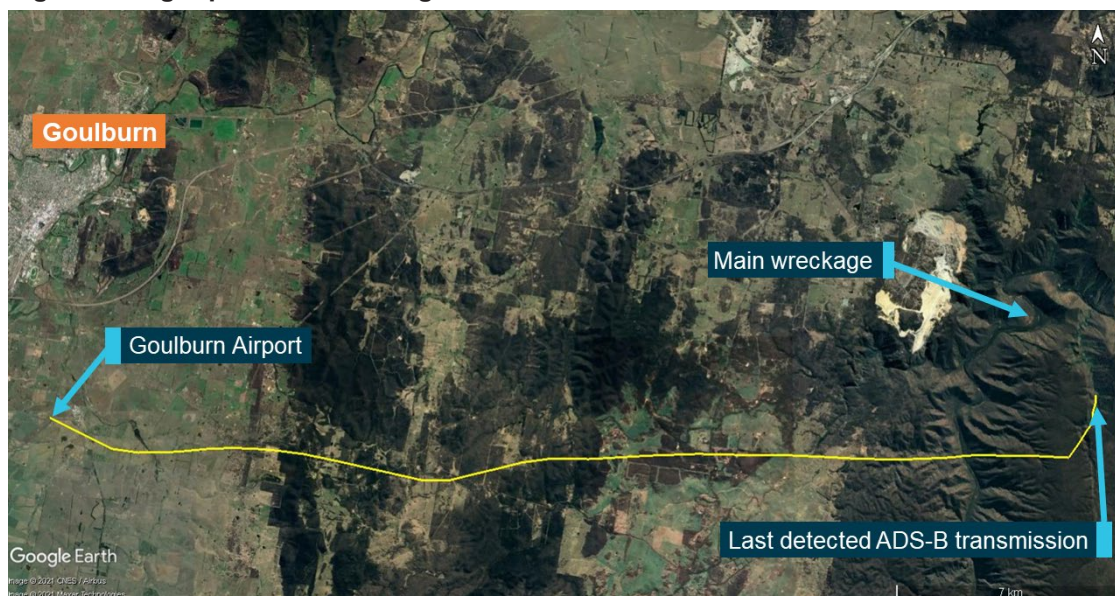
Figure 1: Flight path and wreckage location of VH-HGU

During the search, JRCC provided the chief pilot with the helicopter's last known location—the last recorded automatic dependent surveillance broadcast (ADS-B)—which had detected it descending into a valley in the Bungonia State Conservation Area at 1611. At about 2000, the chief pilot located the helicopter's wreckage 4 km north-west of its last ADS-B transmission, which was in a valley approximately 31 km east of Goulburn Airport (Figure 1). The pilot then provided the wreckage location to emergency services. The helicopter's engine and fuselage had been exposed to a fire at the main wreckage site, which had self-extinguished before emergency services arrived. Both pilots had been fatally injured.

The aircraft track was calculated from ADS-B data.
 Source: Google Earth, FlightAware, annotated by the ATSB

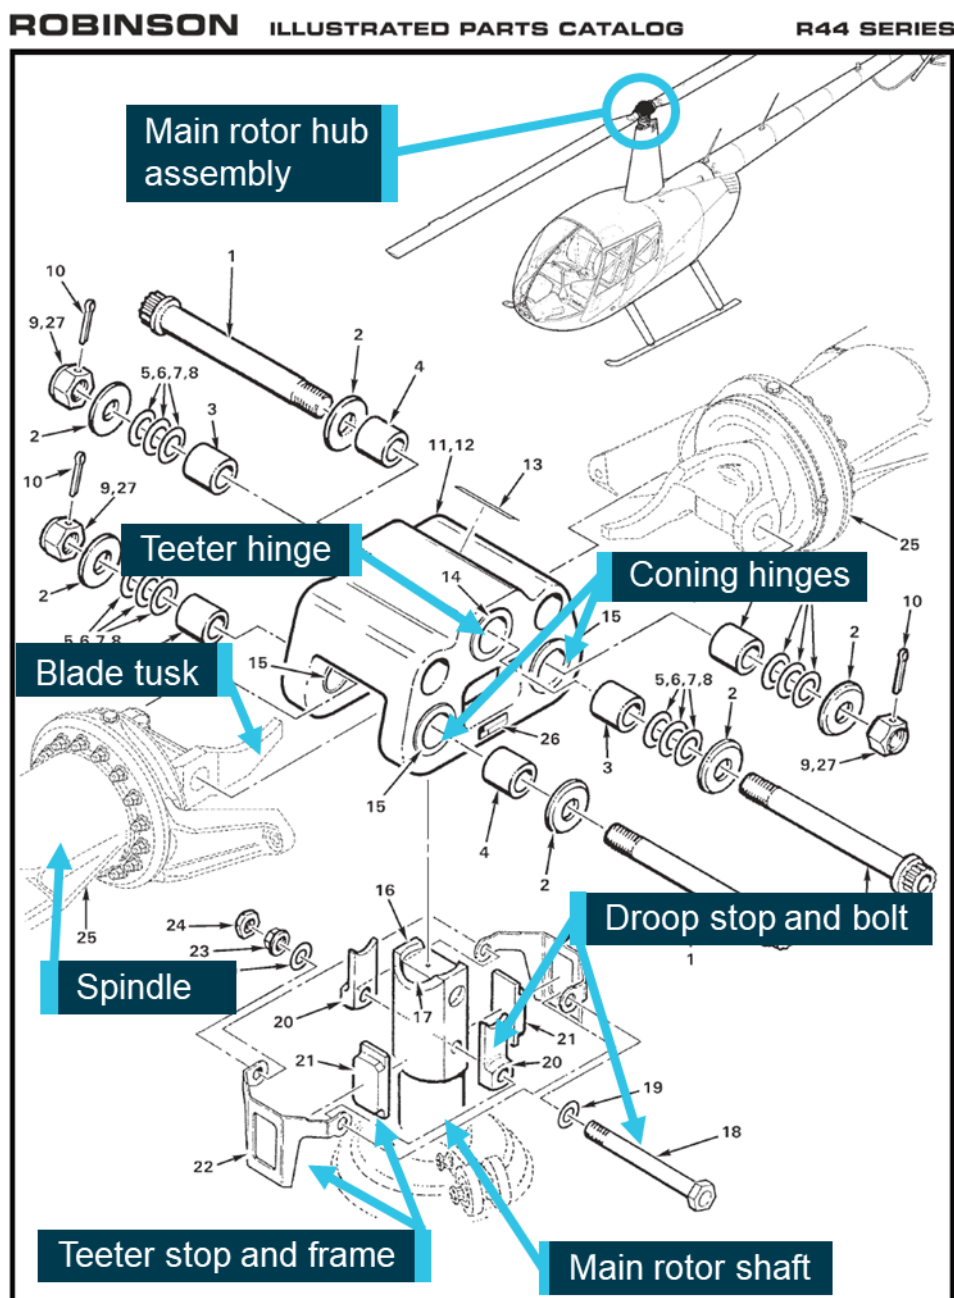
Figure 2: R44 main rotor hub assembly

The Robinson R44 main rotor hub assembly design is a semi-rigid rotor head, otherwise known as a teetering rotor head (Figure 2). Bolts secure the blades to the hub at the coning hinges. During stopping and starting of the main rotor, when rpm is low, the blade tusks rest against the droop stops, restricting teetering and preventing the blades from drooping. As the main rotor rpm increases, the blades become rigid and straighten due to rotational forces, and the tusks shift off the droop stop as the blades lift. During normal flight, the rotor is free to teeter and flap around its designed flight axis via the teeter hinge, while polyurethane teeter stops limit the degree of teetering.

Under certain specific flight conditions, semi-rigid rotor systems are susceptible to extreme teetering where the blades teeter beyond their normal operational range, resulting in a what is commonly known as ‘mast bumping’. Mast bumping is the act of the inboard end of the blade (the spindle) contacting the main rotor shaft. In R44 helicopters, this can generally be identified by extensive damage to the teeter stops and varying degrees of damage to the main rotor shaft. Extreme teetering will also result in failure of one or both pitch links,⁴ allowing uncontrolled pitching of the blade(s). This allows the blade(s) to deviate from their normal path of rotation.
