# Collision with terrain involving Robinson R44, VH-IDW

King River, Northern Territory, on 28 February 2022

**ATSB Transport Safety Report**

AO-2022-009

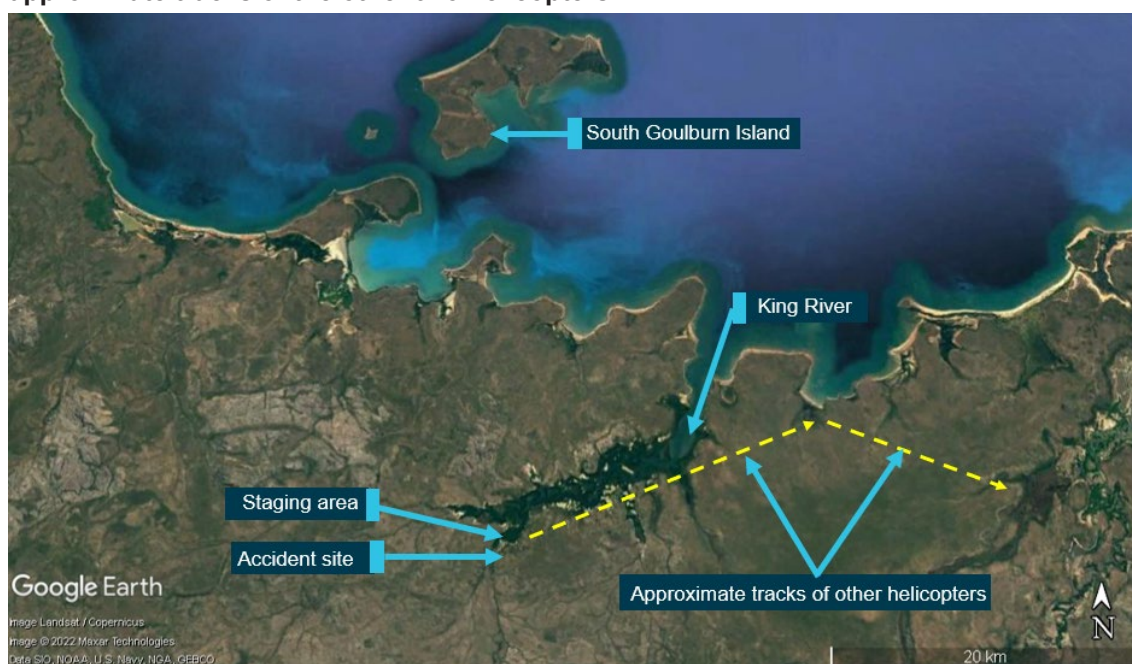
The helicopters departed from the drum site at about 0830 and tracked to the King River staging area, where the crews prepared to commence egg collection operations (Figure 1). Recorded OzRunways<sup>2</sup> data for two of the helicopters recorded their arrival at the staging area at 0850. The pilot and sling person of VH-IDW planned to start the egg collection from a nest located close to the staging area. At about 0900, the other two helicopters departed the staging area for their crew to commence collecting eggs about 12 km to the north-east. Data recorded for the egg collection showed that the crew of those two helicopters collected eggs from nine nests between 0911 and 1014.

The location of the accident was in the vicinity of the first target nest for egg collection by the crew of VH-IDW. No eggs had been collected, indicating that the accident probably occurred about 90 minutes before it was found. A handheld emergency position indicating radio beacon and the helicopter's emergency locator transmitter, which was not mounted in the installed airframe rack or armed in case of emergency, were subsequently found in helicopter. Neither was activated to alert rescue personnel at the time of the accident.

**Figure 1: Accident area including King River, staging area, accident site and the approximate tracks of the other two helicopters**
