Collision with terrain involving Airbus Helicopters EC130 T2, VH-XWD

near Mount Disappointment, Victoria, on 31 March 2022

ATSB Transport Safety Report
Aviation Occurrence Investigation
AO-2022-016
Preliminary – 12 May 2022

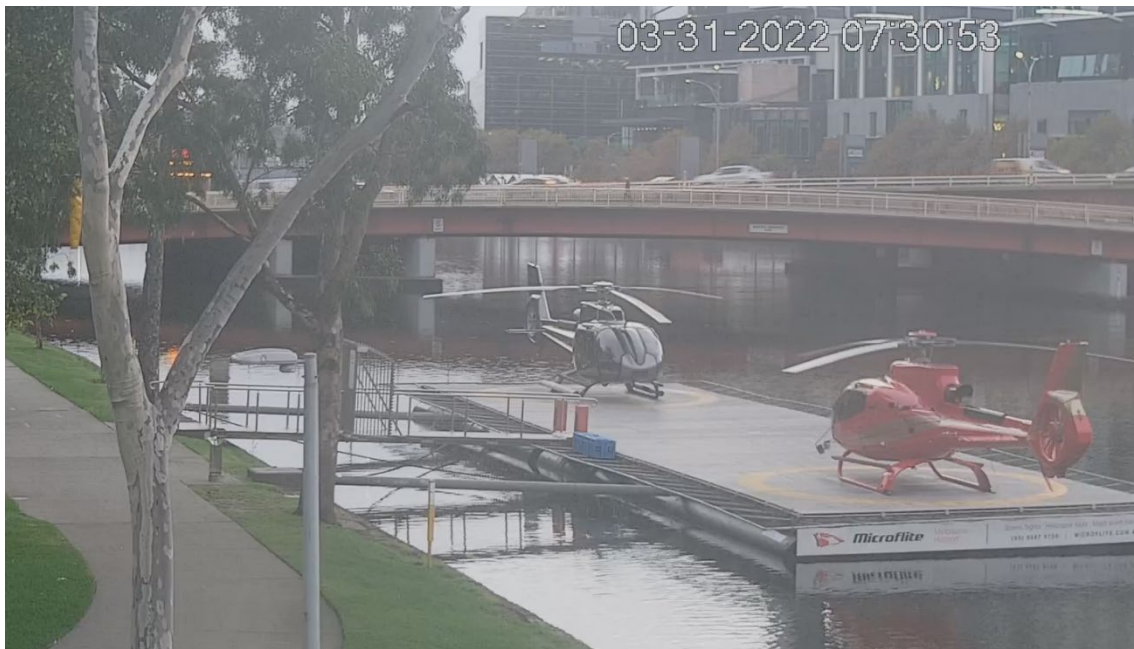
Figure 1: VH-XWD (left) and VH-WVW (right) at Batman Park Heliport

At about 0717, the helicopters landed at Batman Park and were shut down (Figure 1). The pilots then proceeded to the operator’s heliport office to meet a charter group of 8 passengers for a business trip. They provided the passengers with a safety briefing and escorted them to the helicopters where they were divided into 2 smaller groups of 4 passengers for each helicopter.

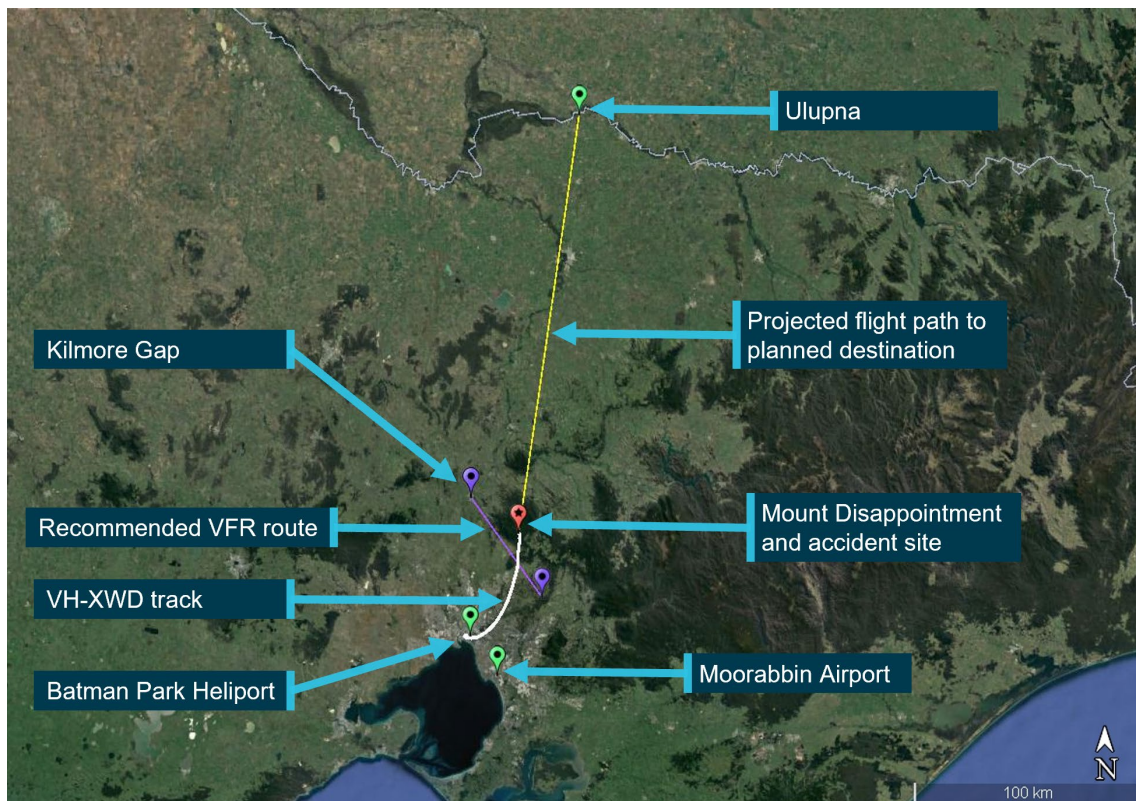
Figure 2: VH-XWD flight track and key locations

At interview, the pilot on board WVV recalled that there was scattered⁵ cloud at 1,500 ft on the forecast that would not allow them to track below cloud via the recommended VFR route to Kilmore Gap (elevation 1,200 ft AMSL). Therefore, they elected to take a more direct track to their destination, which took them over Mount Disappointment, to the east of Kilmore Gap (Figure 2). While tracking north towards Mount Disappointment, the helicopters were above a layer of scattered cloud with an estimated top of 2,500-3,000 ft and below a layer of broken cloud with an estimated base of about 4,500 ft. The pilot of WVV reported that they could see areas of sunlight striking the ground ahead of them, and therefore considered the weather ahead suitable to continue.

As they approached Mount Disappointment, XWD was in a 1.5 NM (3 km) trail behind WVV, and the helicopters were cruising at an altitude of about 3,500 ft and 120 kt ground speed. At this stage, the pilot of WVV noted the layer of scattered cloud below them was becoming broken,⁵ that the tops were rising, and that the base of the cloud above them appeared to be lowering, resulting in the 2 layers of cloud appearing to converge ahead of them.
