# Collision with water involving EC135 P2+ helicopter, VH-ZGA

37 km north-north-west of Port Hedland, Western Australia, on 14 March 2018

## **ATSB Transport Safety Report**

AO-2018-022

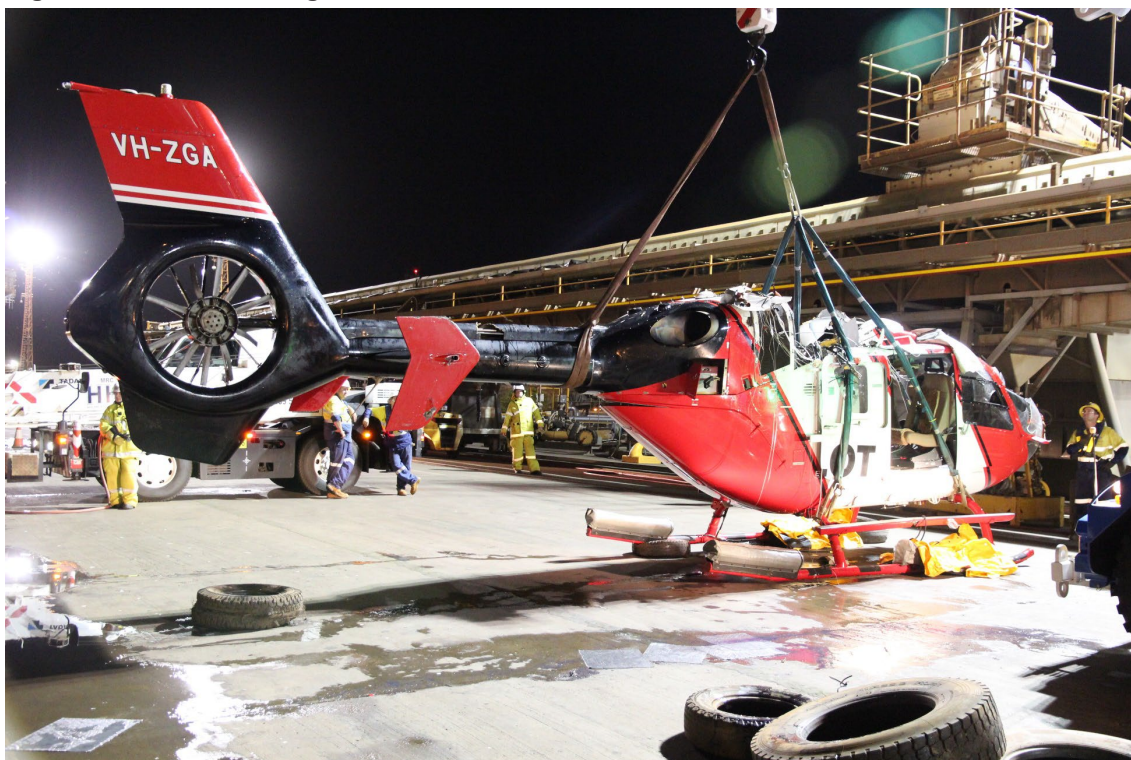
**Figure 16: VH-ZGA being lifted onto the dock**

The Pilbara Ports Authority and their contractors recovered the helicopter wreckage from the seabed during 18 and 19 March 2018 (Figure 16). The wreckage was moved into secure storage where it was examined by the ATSB.

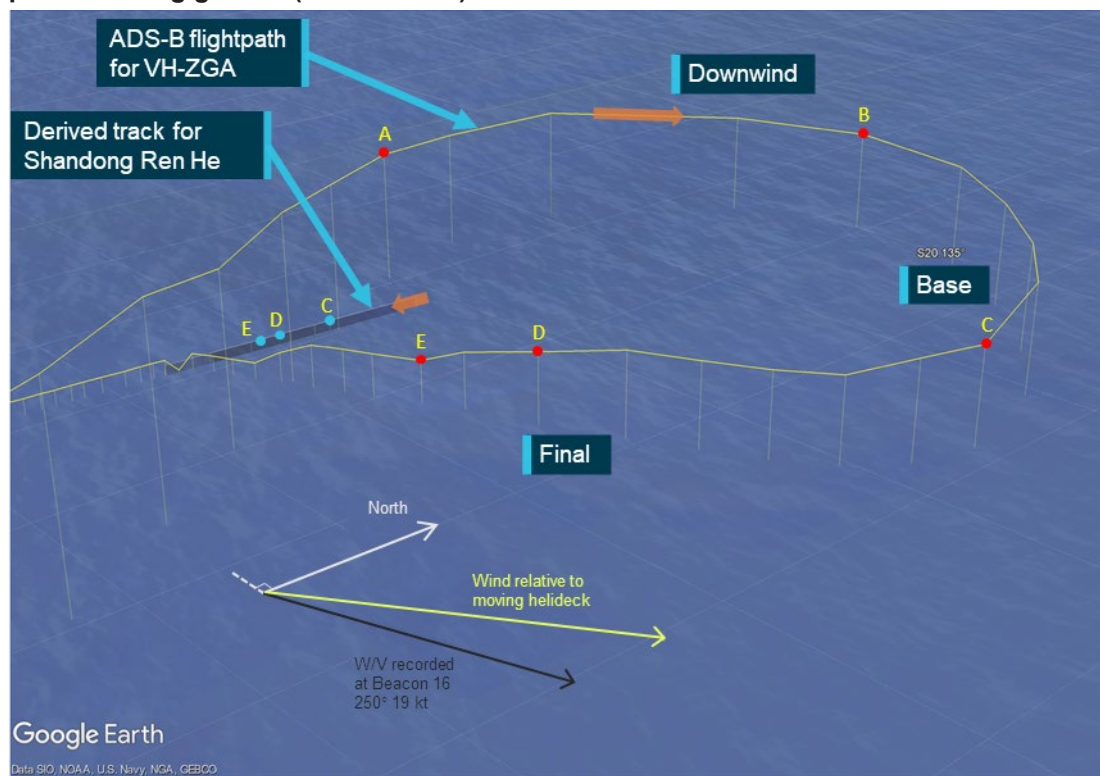
**Figure 25: ADS-B data for VH-ZGA, during a night approach to *Shandong Ren He* at the pilot boarding ground (first transfer)**

For the first transfer, the helicopter departed from the heliport at 0152 and transited to *Shandong Ren He* at the pilot boarding ground. Figure 25 depicts the flight path flown by the helicopter in vicinity of the bulk carrier. ADS-B and derived data at the alphabetically labelled points 'A' to 'E' is depicted in Table 15. The ADS-B and derived data is graphically depicted in Figure 26. On arrival, the helicopter flew past the ship and then circled at 800 ft to join final approach at 600 ft and 60 kt. The descent profile on final approach was not constant, with the descent rate varying between 0 and 1,000 ft/min (Figure 26).

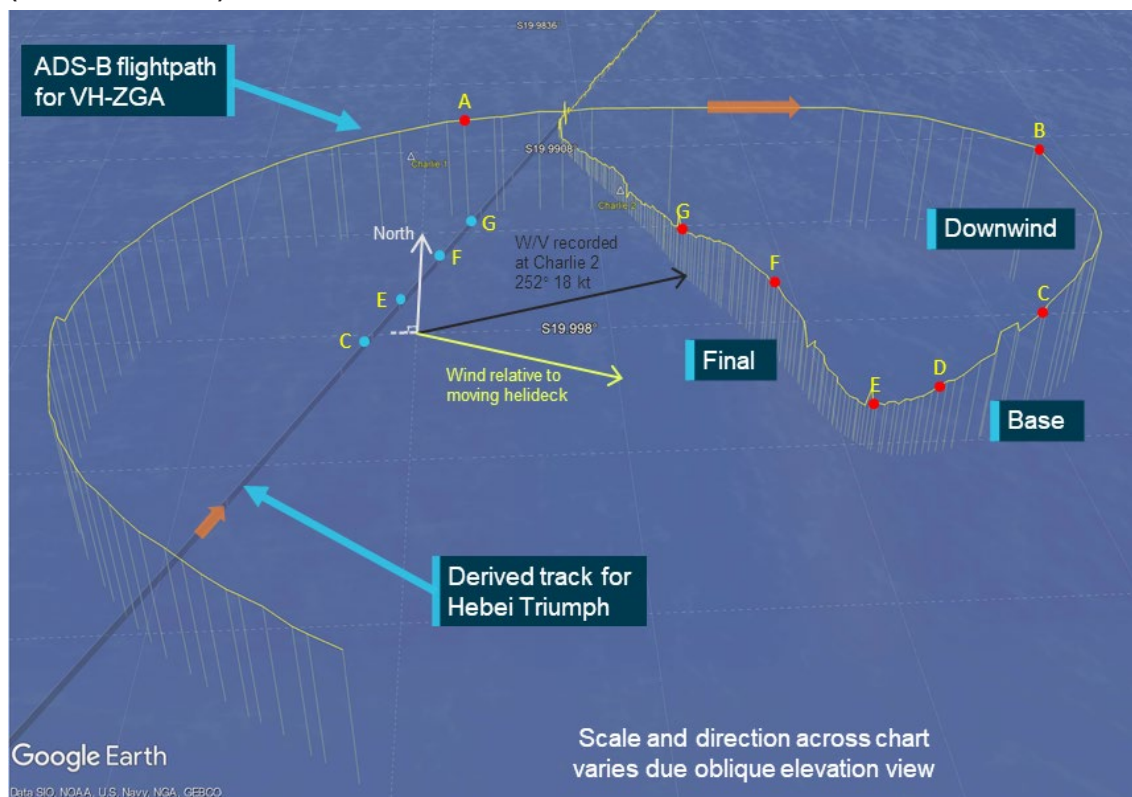
**Figure 27: ADS-B data for VH-ZGA, during a night approach to *Hebei Triumph* at C1/C2 (second transfer)**

The flight to conduct the second transfer departed from the heliport at 0230 to pick up a marine pilot from the departing vessel *Hebei Triumph*, near C1/C2. Late in the transit the helicopter climbed to 2,200 ft then descended at up to 2,000 ft/min to circuit height. Late downwind it climbed to 900 ft then descended in the base turn at up to 1,500 ft/min with reducing airspeed to turn final below 500 ft and 30 kt. The descent profile on final approach was not stable, with the descent rate

and airspeed decay moderating after 300 ft (see Figure 27, Table 16 and Figure 28).

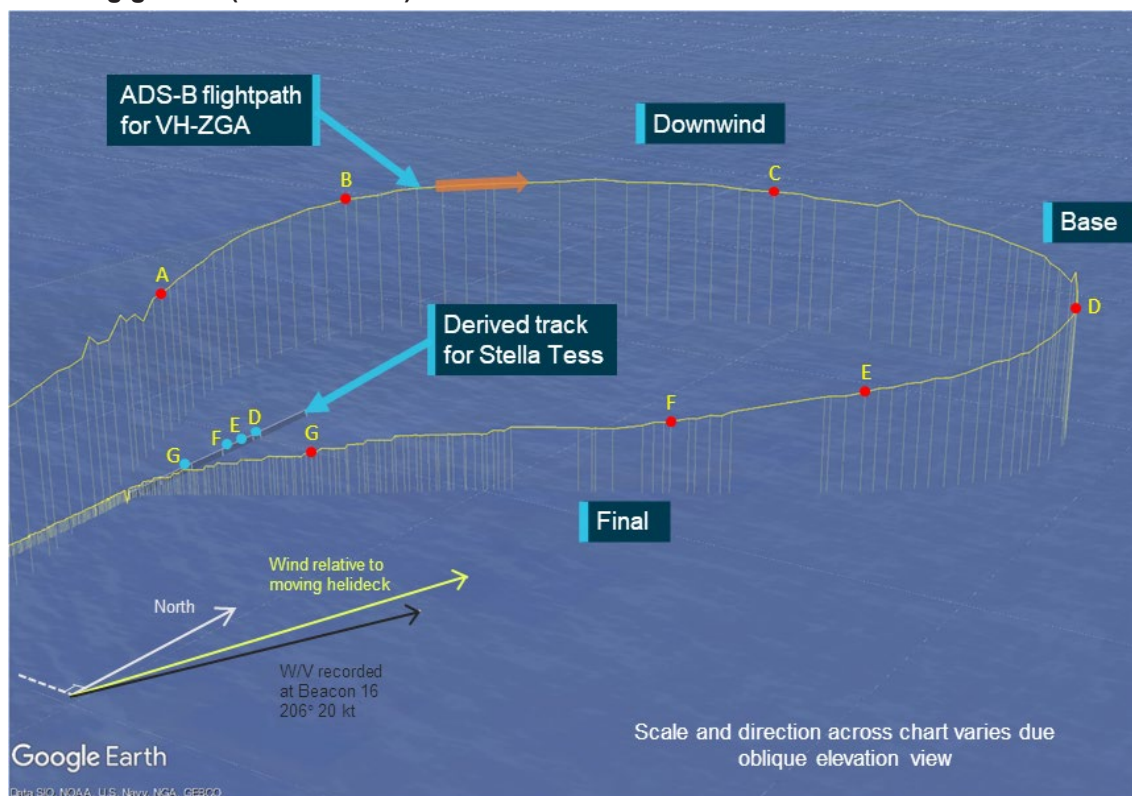
**Figure 29: ADS-B data for VH-ZGA during a night approach to *Stella Tess* at the pilot boarding ground (third transfer)**

The helicopter departed the heliport at 0305 and the transit to the pilot boarding ground was flown at 1,100 ft, which was below the lowest safe altitude (LSALT) for conducting flight at night under the VFR. After flying past the inbound vessel at 1,100 ft, the helicopter entered a climb (of maximum 900 ft/min) for about 30 seconds then descended in the circuit at between 400–500 ft/min. The entry into the climb would have occurred soon after the instructor lost visual reference with the vessel (see Figure 29, Table 17 and Figure 30).

Late in the base turn, the helicopter was still at 1,000 ft with rate of descent of about 900 ft/min and a derived airspeed of about 85 kt. The descent profile on final approach varied between 9–18° (short final) with a variable descent rate moderating from mid-final.

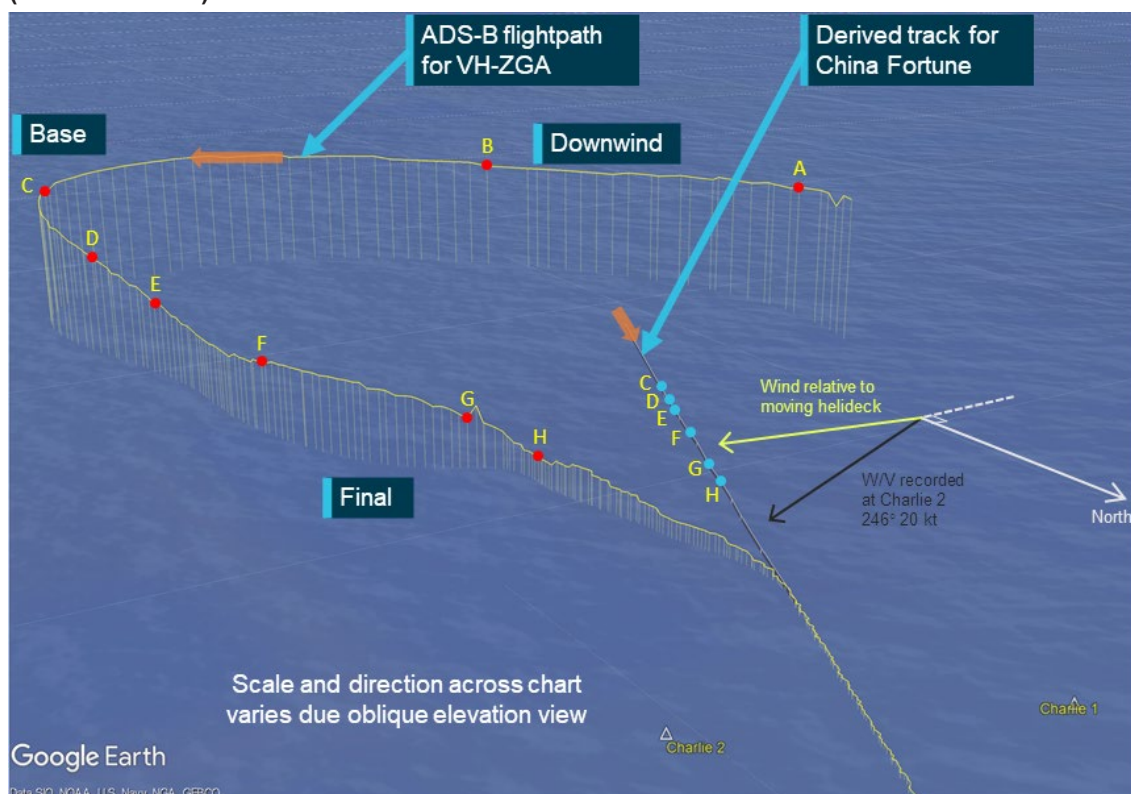
**Figure 31: ADS-B data for VH-ZGA, during a night approach to *China Fortune* at C1/C2 (fourth transfer)**

After disembarking the marine pilot to the vessel at the pilot boarding ground, the helicopter departed and climbed to 2,000 ft for the transit to *China Fortune*, which was approaching C1/C2. The helicopter commenced descent as it approached the vessel, joining the circuit at an altitude of about 900 ft mid downwind. Before and during the base turn there was a slight climb then descent increasing to 1,350 ft/min turning finals. This transitioned into a climb of 500 ft/min then a descent at 1,100 ft/min at around 300 ft and about 40 kt airspeed. The descent profile on final approach continued to be unstable (see Figure 31, Table 18 and Figure 32).

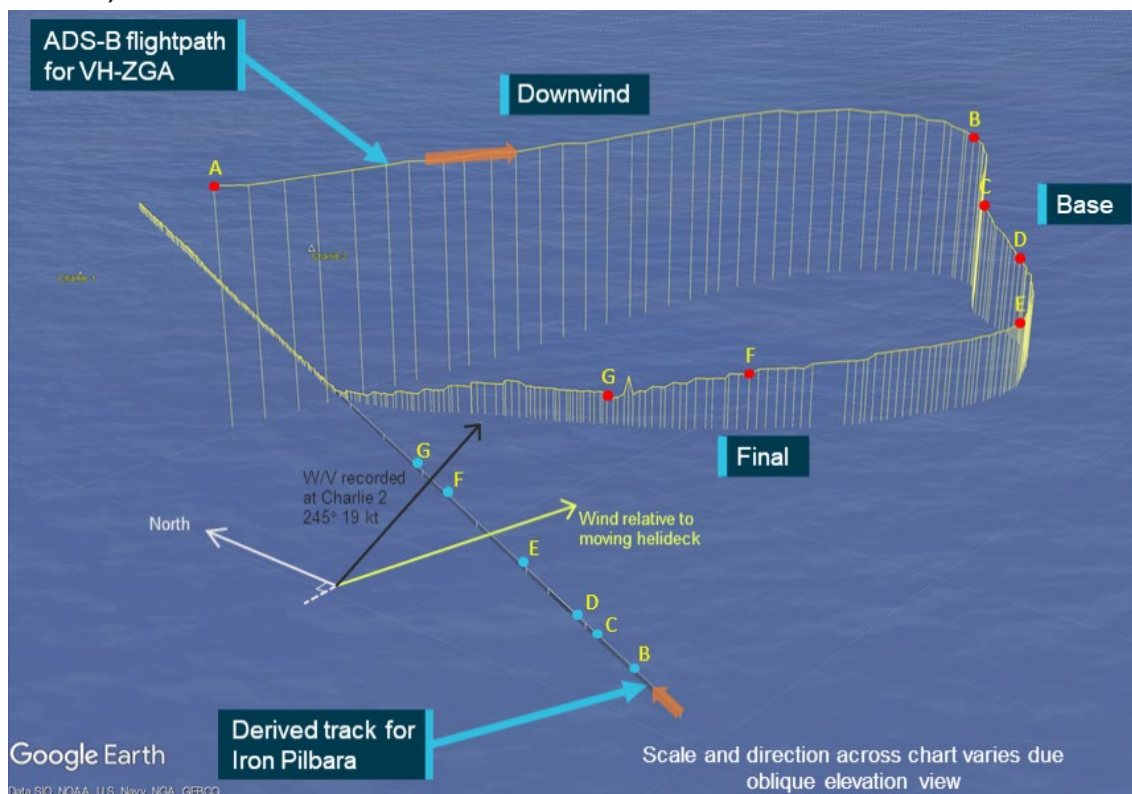
**Figure 33: ADS-B data for VH-ZGA, during a night approach to *Iron Pilbara* at C1/C2 (fifth transfer)**

The fourth flight (transfer 5) departed the heliport at 0355 to pick up a marine pilot from *Iron Pilbara* near C1/C2. The helicopter overflowed the ship at 1,375 ft on descent and joined the circuit to be 1,250 ft by mid downwind. As the helicopter descended in the base turn the descent rate briefly reached 1,700 ft/min at about 700 ft then reduced back to level flight to be established on final approach at 375 ft and airspeed below 40 kt. The descent profile flown during base and final was unstable (see Figure 33, Table 19 and Figure 34).

Representation of ADS-B data (ASA) while VH-ZGA was being operated by the instructor at night under the night VFR in vicinity of Iron Pilbara as it approached C1/C2. Data relevant to the annotated labels A to G is presented in Table 19 and marked as labelled index points in Figure 34.

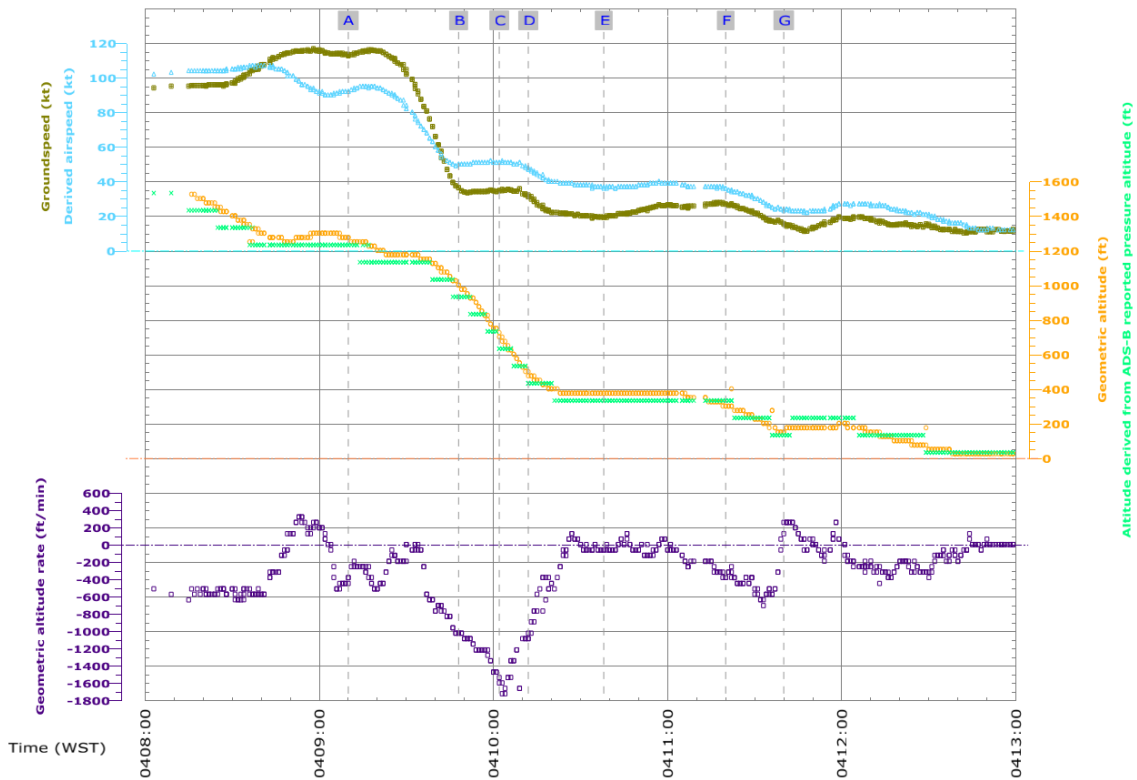
**Figure 34: Derived airspeed, ADS-B reported altitudes and geometric altitude rate of change during a night approach to Iron Pilbara at C1/C2 (fifth transfer)**

Graphical summary of aggregated ADS-B and derived data while VH-ZGA was being operated by the instructor at night under the night VFR in vicinity of Iron Pilbara as it approached C1/C2. The airspeed of the helicopter is derived from the ADS-B groundspeed and ground track using the wind velocity and atmospheric pressure recorded by meteorological equipment at a nearby channel marker and corrected for temperature. The helicopter altitude cross-references the ADS-B geometric altitude and the independently measured pressure altitude, adjusted for surface pressure. The geometric altitude is reported in 25 ft increments, the pressure altitude is reported in 100 ft increments. The geometric altitude rate of change was broadcast by the helicopter's ADS-B equipment, in increments of 6.25 ft/min. Breaks in the continuity of the data indicate periods where ADS-B broadcasts were not being received. The labelled time markings correspond with the positions depicted for the helicopter in Figure 33 and Table 19.

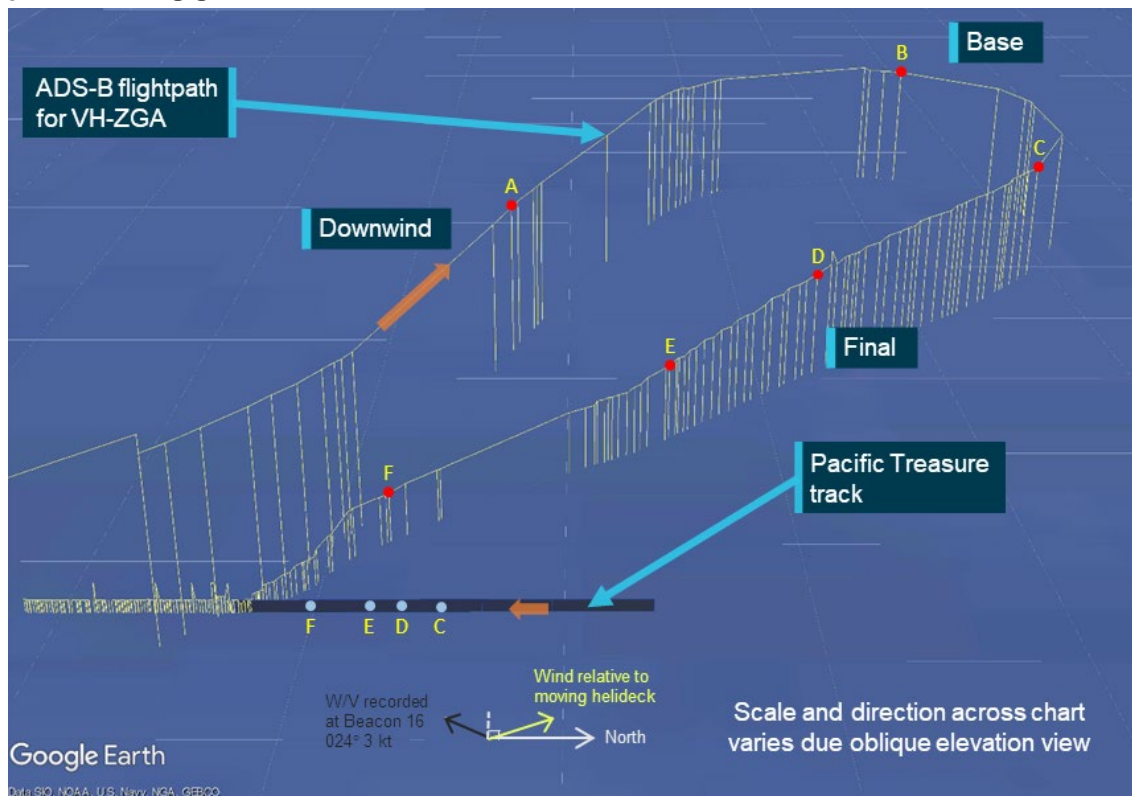
Figure 35: ADS-B data for VH-ZGA, during a night approach to *Pacific Treasure* at the pilot boarding ground

Representation of ADS-B data (ASA) while VH-ZGA was being operated at night under the night VFR in vicinity of Pacific Treasure as it approached the pilot boarding ground. On board the helicopter was the instructor and the operator's chief pilot. The flight was recorded as either a line check for the instructor or a night VFR flight review for the chief pilot. Data relevant to the annotated labels A to F is presented in Table 20 and marked as labelled index points in Figure 36.

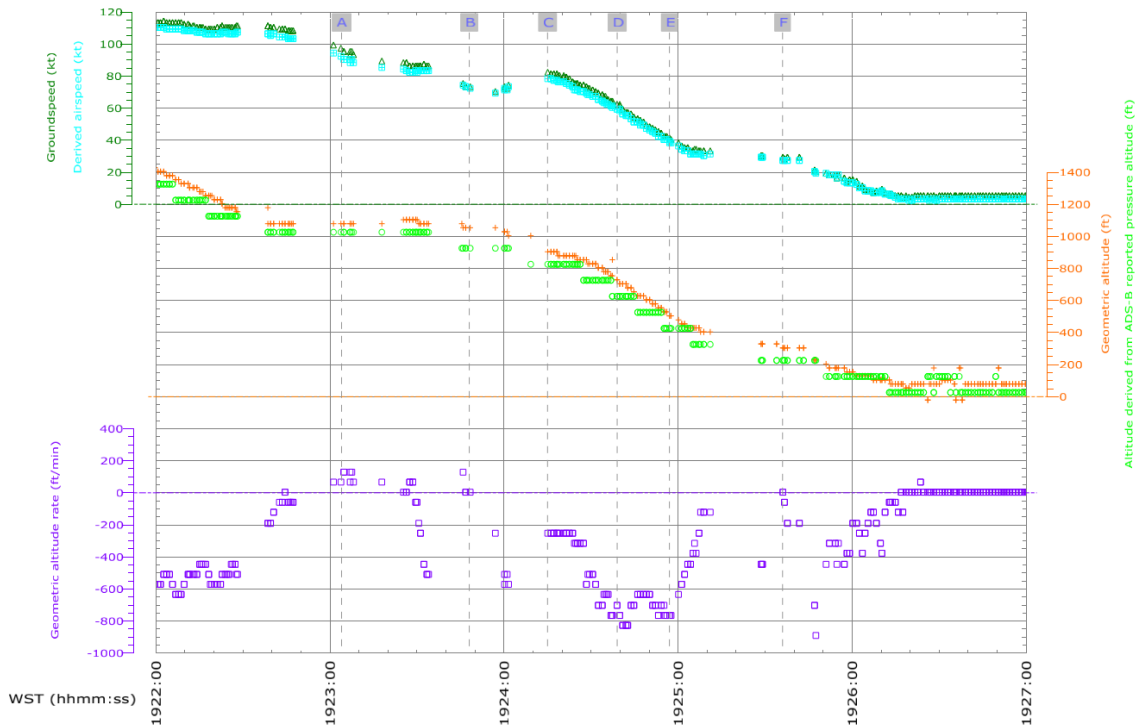
**Figure 36: Derived airspeed, ADS-B reported altitudes and geometric altitude rate of change during a night approach to *Pacific Treasure* at the pilot boarding ground**

Graphical summary of aggregated ADS-B and derived data while VH-ZGA was being operated at night under the night VFR in vicinity of *Pacific Treasure* as it approached the pilot boarding ground. On board the helicopter was the instructor and the operator's chief pilot. The airspeed of the helicopter is derived from the ADS-B groundspeed and ground track using the wind velocity and atmospheric pressure recorded by meteorological equipment at a nearby channel marker and corrected for temperature. The helicopter altitude cross-references the ADS-B geometric altitude and the independently measured pressure altitude, adjusted for surface pressure. The geometric altitude is reported in 25 ft increments, the pressure altitude is reported in 100 ft increments. The geometric altitude rate of change was broadcast by the helicopter's ADS-B equipment, in increments of 6.25 ft/min. Breaks in the continuity of the data indicate periods where ADS-B broadcasts were not being received. The labelled time markings correspond with the positions depicted for the helicopter in Table 20 and Figure 35.

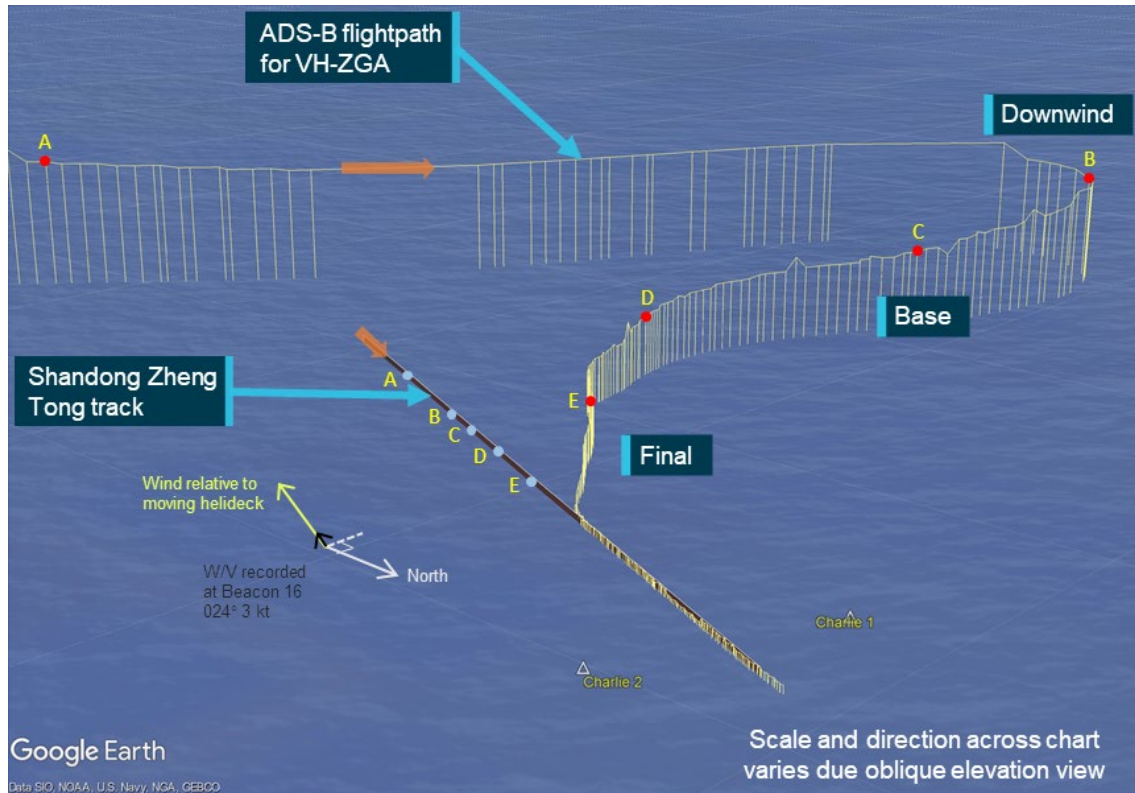
**Figure 37: ADS-B data for VH-ZGA, during a night approach to Shandong Zheng Tong at C1/C2**

Representation of ADS-B data (ASA) while VH-ZGA was being operated at night under the night VFR in vicinity of Shandong Zheng Tong as it approached C1/C2. On board the helicopter was the instructor and the operator's chief pilot. The flight was recorded as either a line check for the instructor or a night VFR flight review for the chief pilot. Data relevant to the annotated labels A to E is presented in Table 21 and marked as labelled index points in Figure 38.  
Source: Google Earth, annotated by the ATSB

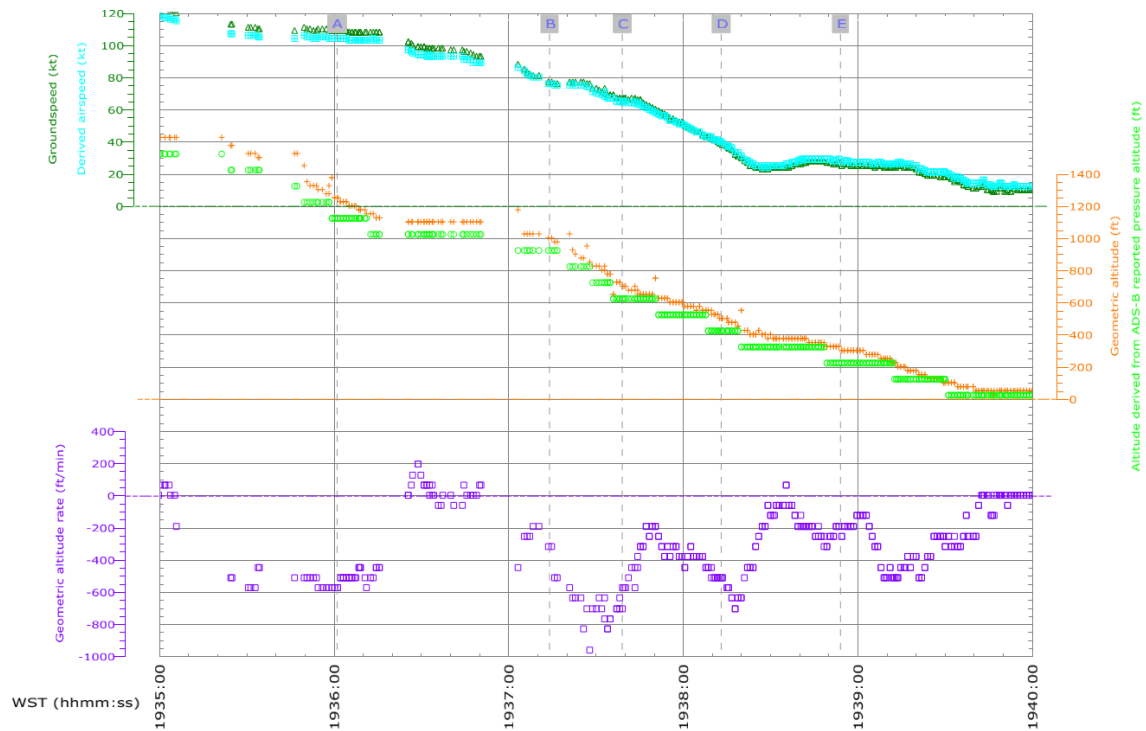
**Figure 38: Derived airspeed, ADS-B reported altitudes and geometric altitude rate of change during a night approach to *Shandong Zheng Tong* at C1/C2**

Graphical summary of aggregated ADS-B and derived data while VH-ZGA was being operated at night under the night VFR in vicinity of Shandong Zheng Tong as it approached C1/C2. On board the helicopter was the instructor and the operator's chief pilot. The airspeed of the helicopter is derived from the ADS-B groundspeed and ground track using the wind velocity and atmospheric pressure recorded by meteorological equipment at a nearby channel marker and corrected for temperature. The helicopter altitude cross-references the ADS-B geometric altitude and the independently measured pressure altitude, adjusted for surface pressure. The geometric altitude is reported in 25 ft increments, the pressure altitude is reported in 100 ft increments. The geometric altitude rate of change was broadcast by the helicopter's ADS-B equipment, in increments of 6.25 ft/min. Breaks in the continuity of the data indicate periods where ADS-B broadcasts were not being received. The labelled time markings correspond with the positions depicted for the helicopter in Table 21 and Figure 37.
