ATSB TRANSPORT SAFETY REPORT Occurrence Investigation Report AO-2008-063 Final

Controlled flight into terrain 56 km NNE of Scone Airport, NSW 14 September 2008 VH-JDO Cessna Aircraft Co. U206A

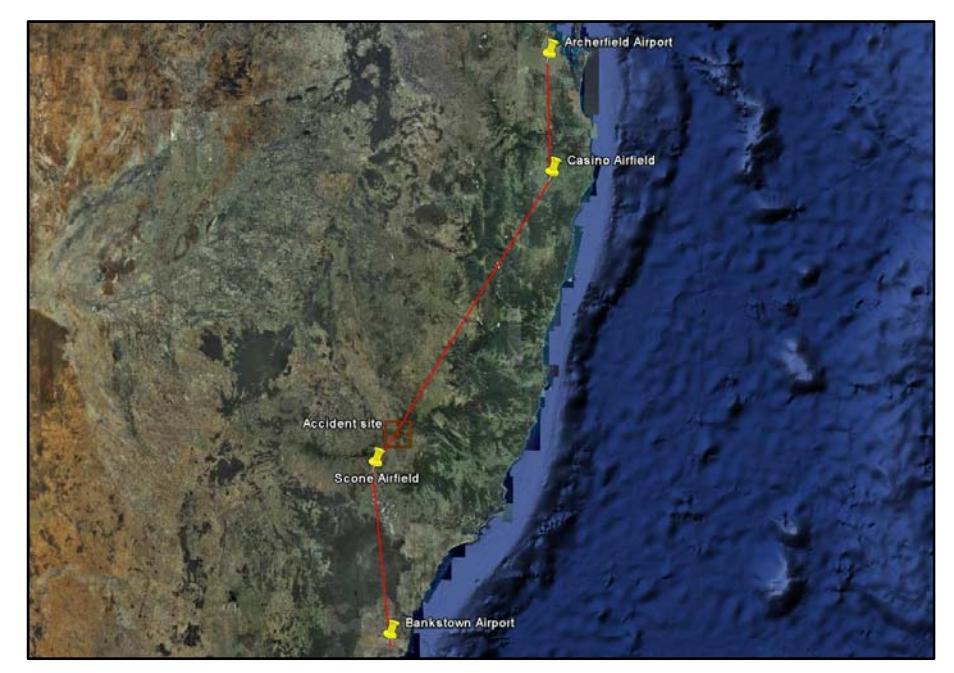
Figure 2: Aircraft's proposed track and accident site location

The route selected by the pilot, to track from Scone to Archerfield via Casino, meant that the aircraft would track over the Great Dividing Range for most of the flight (Figure 2). The topography of most of that area was rugged, with thickly forested, mountainous terrain, at elevations greater than 4,000 ft (1,219 m) above mean sea level (AMSL). The areas available for an emergency landing were limited.

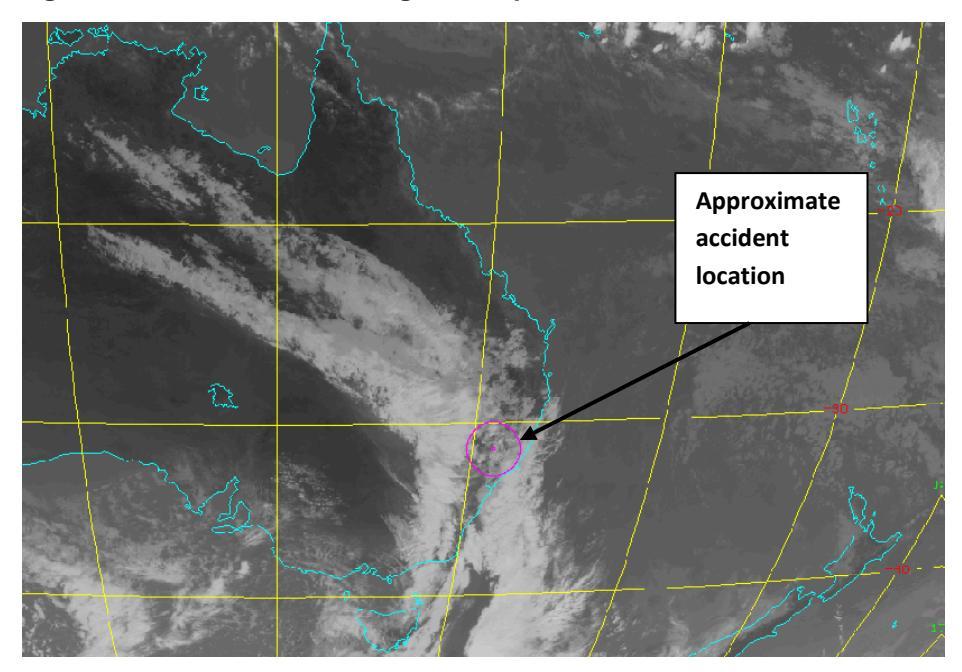
Figure 3: Infrared satellite image, 14 September 2008, 1030 EST

On the day of the incident, a major cloud mass associated with the trough extended over the eastern half of NSW, including the incident location. These are evident in satellite images taken around the time of the incident (Figure 3).

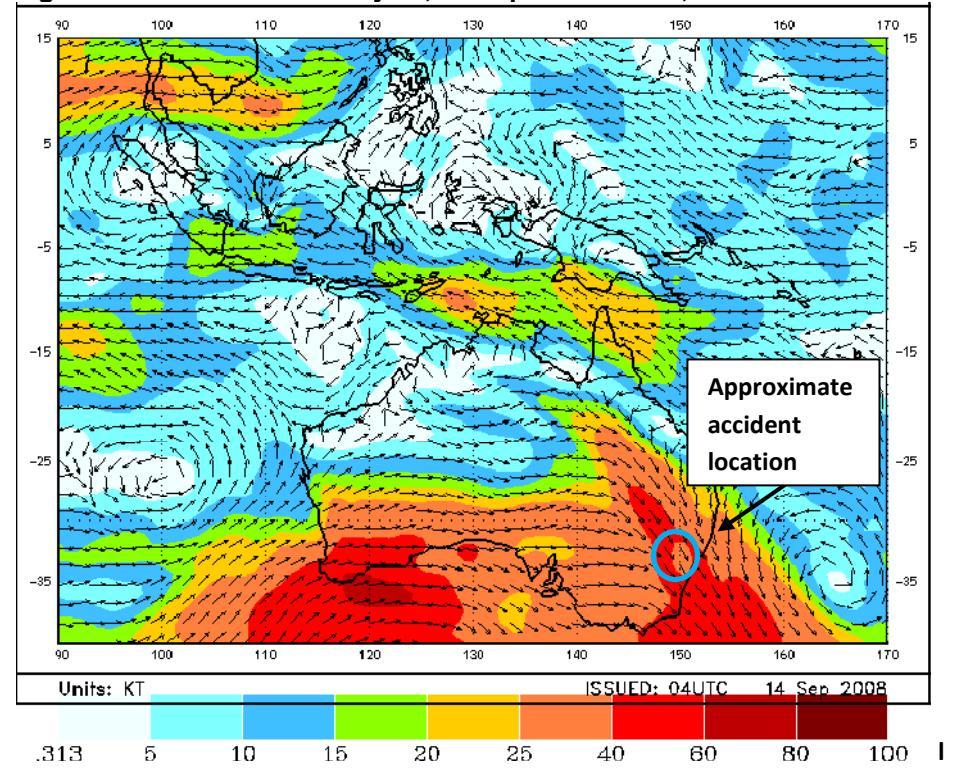
Figure 4: 850 hPa Wind Analysis, 14 September 2008, 10:00 EST

Wind analysis at 900 hectopascals (equivalent to approximately 2,000 ft above mean sea level) show winds between 25 and 40 knots and between 40 and 60 knots at 850 hectopascals (approximately 5,000 feet above mean sea level) at the accident location (Figure 4).
