ATSB TRANSPORT SAFETY REPORT
Occurrence Investigation Report AO-2007-046
Final

Collision with terrain
Doongan Station, WA
25 September 2007
VH-HCN
Robinson Helicopter Company R22
Beta II

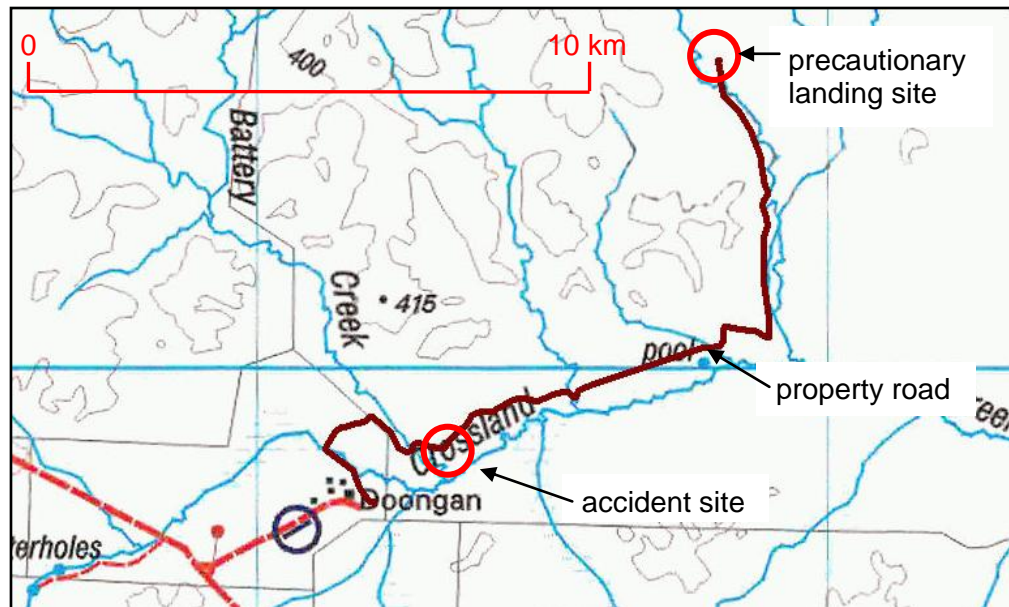
Figure 2: Accident site location

After walking about 11 km, the passenger saw smoke and flames and, upon reaching the source of the smoke, discovered the wreckage of the helicopter adjacent to the road. The helicopter had been destroyed by impact forces and fire and the pilot had been fatally injured.

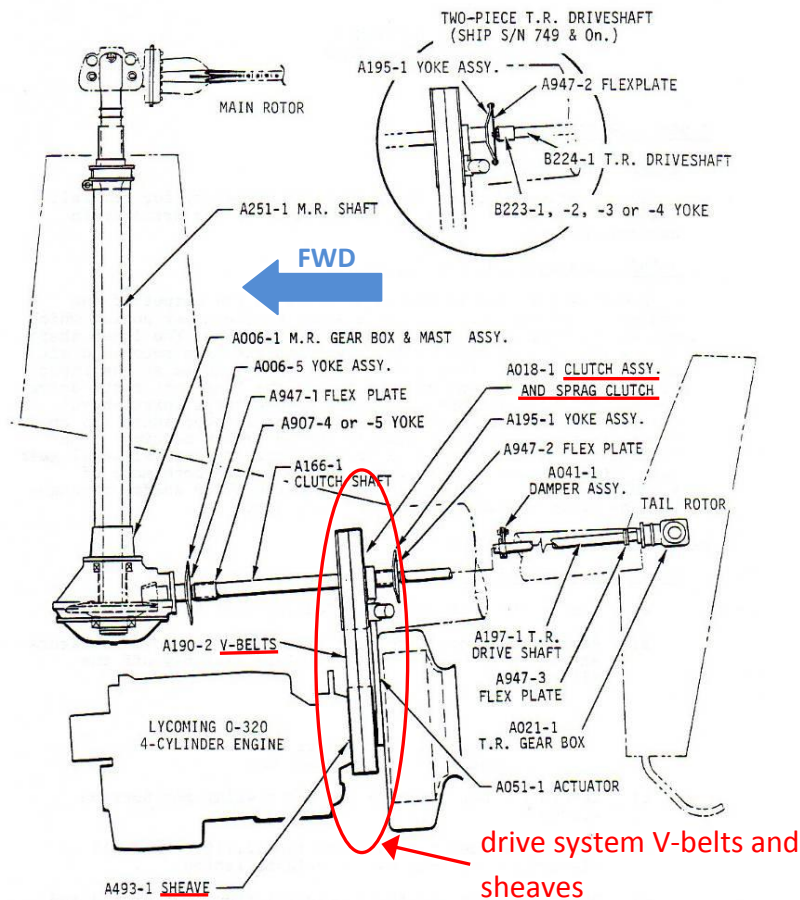
Figure 3: R22 drive belt system

On the R22 helicopter, engine power was transmitted to the rotor system through a drive-belt system that consisted of two rubber double V-belts, running on matching multi-grooved sheaves (Figure 3). Both the upper and lower sheaves were constructed of aluminium alloy; with a thermally-sprayed, metallised coating applied to improve wear resistance.

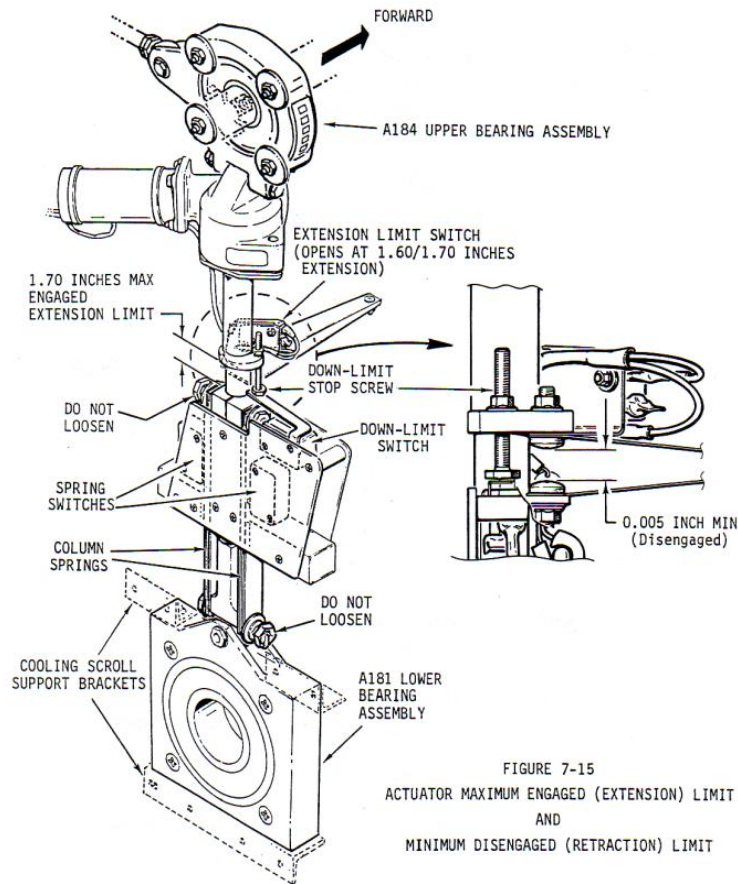
Figure 4: Electric clutch actuator

The upper drive sheave was mounted on the clutch shaft adjacent to a flexible coupling and could be moved relative to the engine-mounted drive sheave by means of an electric clutch actuator (Figure 4). That movement had the effect of varying the tension being applied to the belts.
