ATSB TRANSPORT SAFETY REPORT  
Aviation Occurrence Investigation AO-2007-044  
Final

Go-around event  
Melbourne Airport, Victoria  
21 July 2007  
VH-VQT, Airbus Industrie A320-232

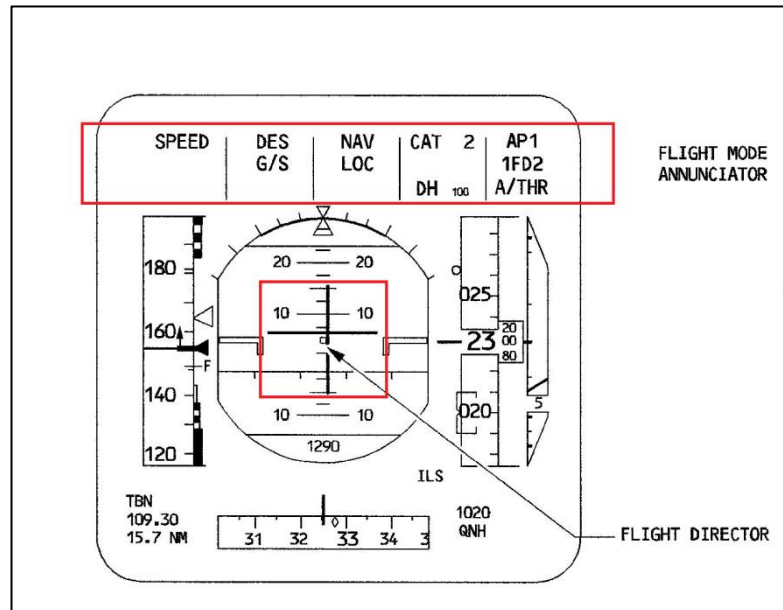
**Figure 2: Primary flight display with flight mode annunciator and flight director indicated (highlight added by ATSB)**

The aircraft manufacturer included a standard go-around procedure in its flight crew operating manual (FCOM). That procedure required a check and an announcement (call) of the FMA data (Figure 2) so that crews were aware of the current flight modes of the aircraft at item 3 (ROTATION) (Figure 3).
