Procedures-related event

Launceston Airport, Tas. – 12 March 2008

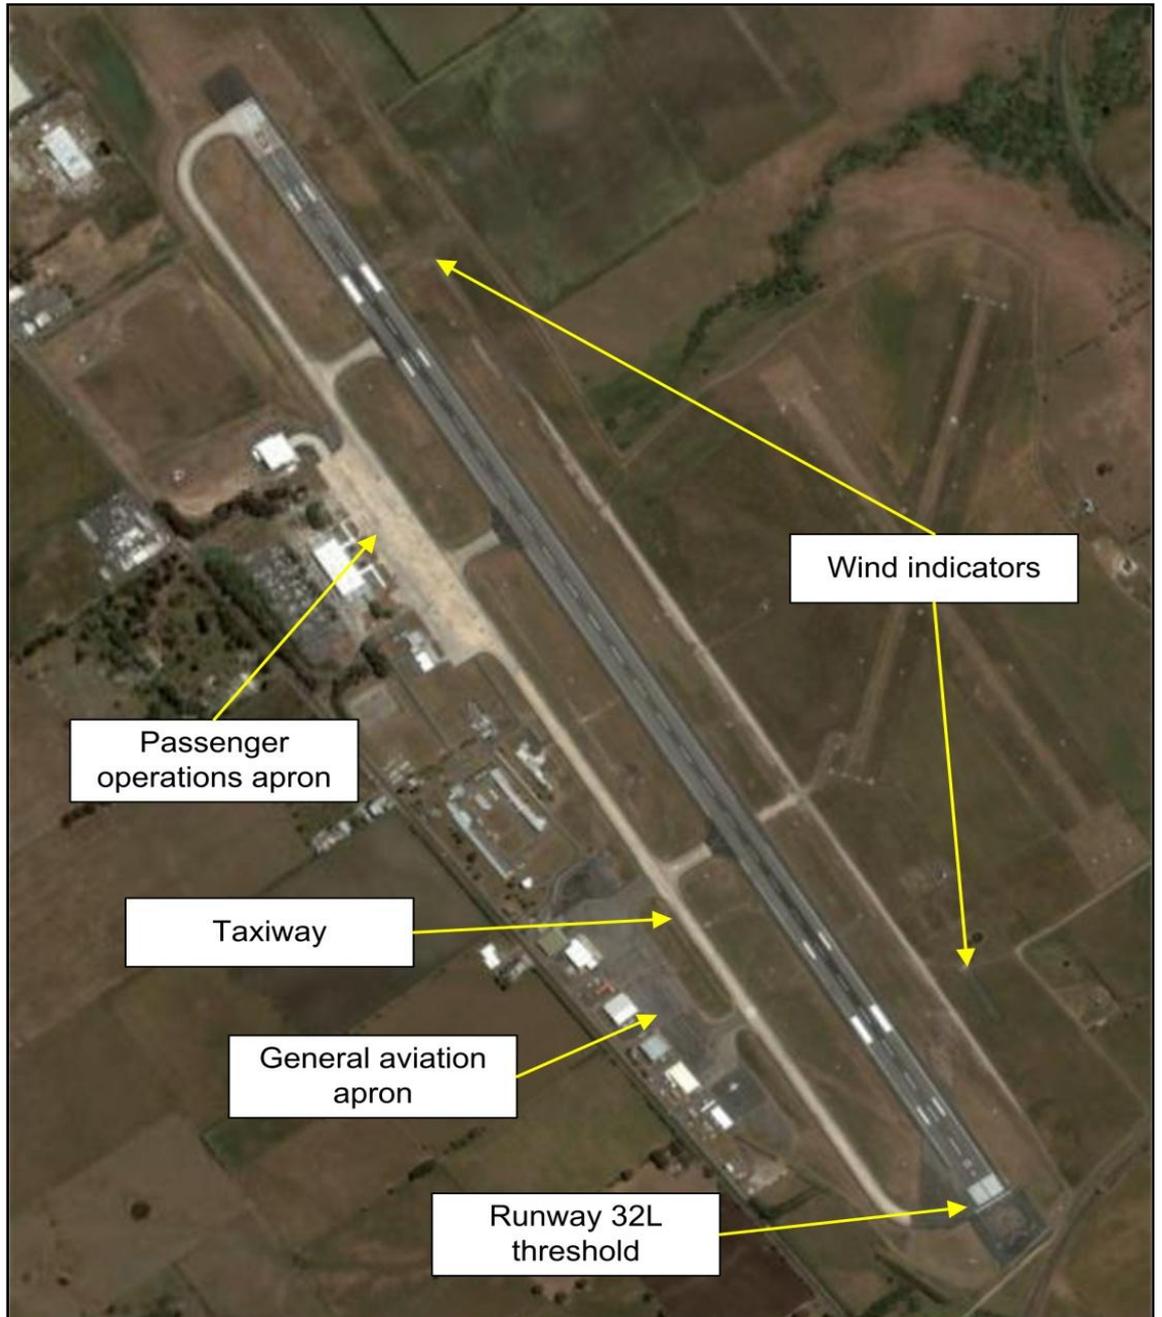
Figure 1: Launceston airport²

Launceston Airport had one runway suitable for A320 operations, runway 14R/32L. The runway was 1,981 m long and 45 m wide. A taxiway ran parallel to the runway. Figure 1 shows the basic layout of the airport.
