# Loss of containers from *Pacific Adventurer* off Cape Moreton, Queensland 11 March 2009

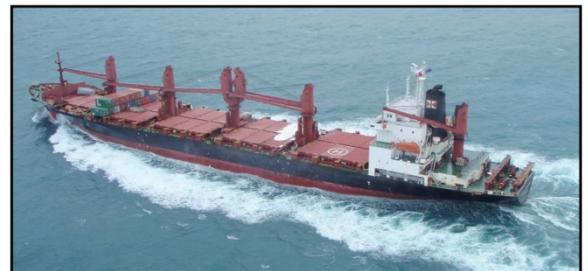
Figure 1: *Pacific Adventurer*

*Pacific Adventurer* has an overall length of 184.9 m, a breadth of 27.6 m and a deadweight of 25 561 tonnes at its summer draught of 10.57 m.

*Pacific Adventurer* (Figure 1) is a Hong Kong registered container ship. It is owned by Swire Navigation/Bluewind Shipping, Hong Kong and managed by Swire Navigation, Hong Kong. At the time of the incident, the ship was classed with Lloyd's Register (LR).

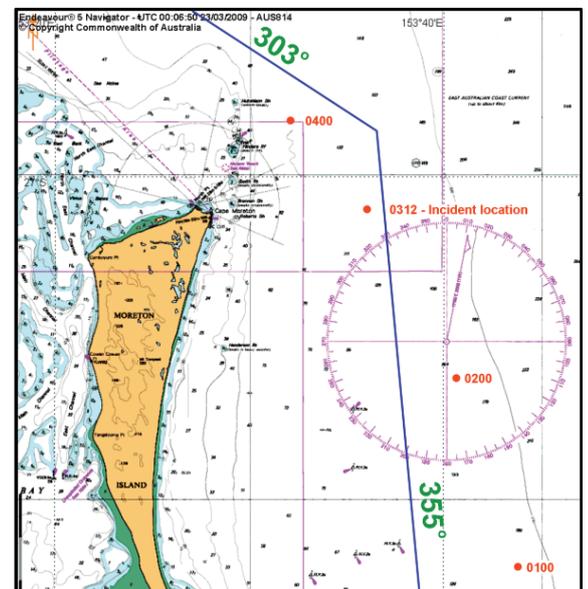
**Figure 2: Section of navigational chart Aus 814 showing the ship's planned track and actual positions as it approached Cape Moreton**
