ATSB TRANSPORT SAFETY INVESTIGATION REPORT

Aviation Occurrence Investigation – AO-2007-017

Fuel starvation – Jundee Airstrip, WA – 26 June 2007

Empresa Brasileira de Aeronáutica S.A., EMB-120ER

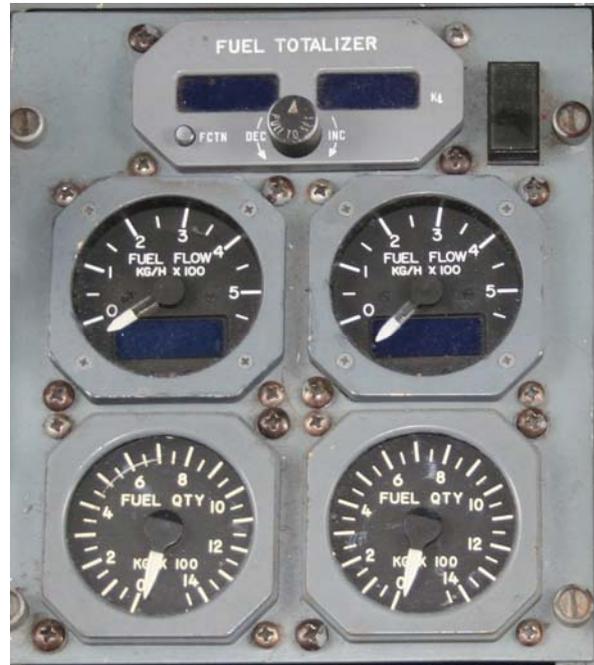
Two cockpit fuel quantity indicators, one for each wing, displayed, in kilograms, the total fuel quantity in the corresponding wing (Figure 1). A fuel totaliser display was positioned immediately above the fuel quantity indicators. It displayed digitally

the total amount of fuel used or the total amount remaining, depending on the function selected by the flight crew.

Figure 1: Fuel indicating panel in the cockpit centre console instrument group.

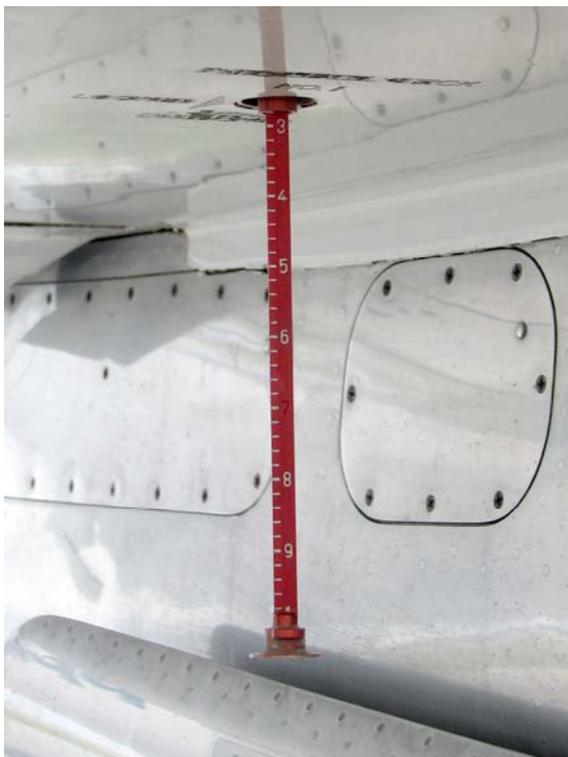
The aircraft was also equipped with driplless measuring sticks (sometimes referred to as 'magna sticks') that enabled the manual measurement of the fuel quantity in each wing. There were three driplless measuring sticks for each outboard tank, and one for each inboard tank. The driplless stick system consisted of a magnet floating on the surface of the fuel in the tank and a calibrated stick. The sticks were unlocked via access points on the lower surface of the wing and allowed to lower until the floating magnet attracted the upper end of the stick (Figure 2). That enabled the level of the fuel to be determined. A conversion table carried on the aircraft was used to convert the value indicated on the stick to fuel tank quantity in kg. Accurate quantity measurement using the driplless sticks required the aircraft to be laterally level.

Figure 2: Showing a driplless stick in the lowered position, indicating 2.8 on the measurement scale.

When using the magna sticks, significant variations may occur if the aircraft is not level. A check of level may be made on the EADI. A pitch of $\pm 2^\circ$ is allowable. The recommended practice when using the magna sticks is the [sic] take the reading then immediately return the stick to the locked position.
