SUMMARY

The Panamanian registered bulk carrier *Starfish* sailed from Port Walcott, Western Australia on 22 March 1991 with 53549 tonnes of iron ore fines for the Polish port of Swinoujscie.

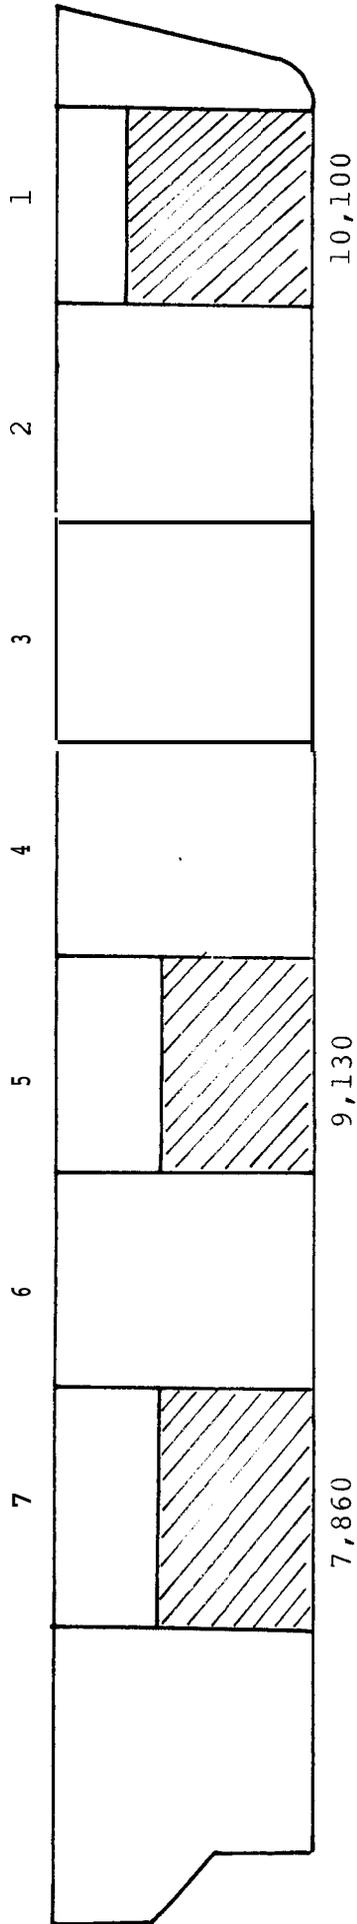
SEQUENCE AS LOADED

SITUATION CARGO HALF LOADED

| Attachment 4: Loading Sequences | |

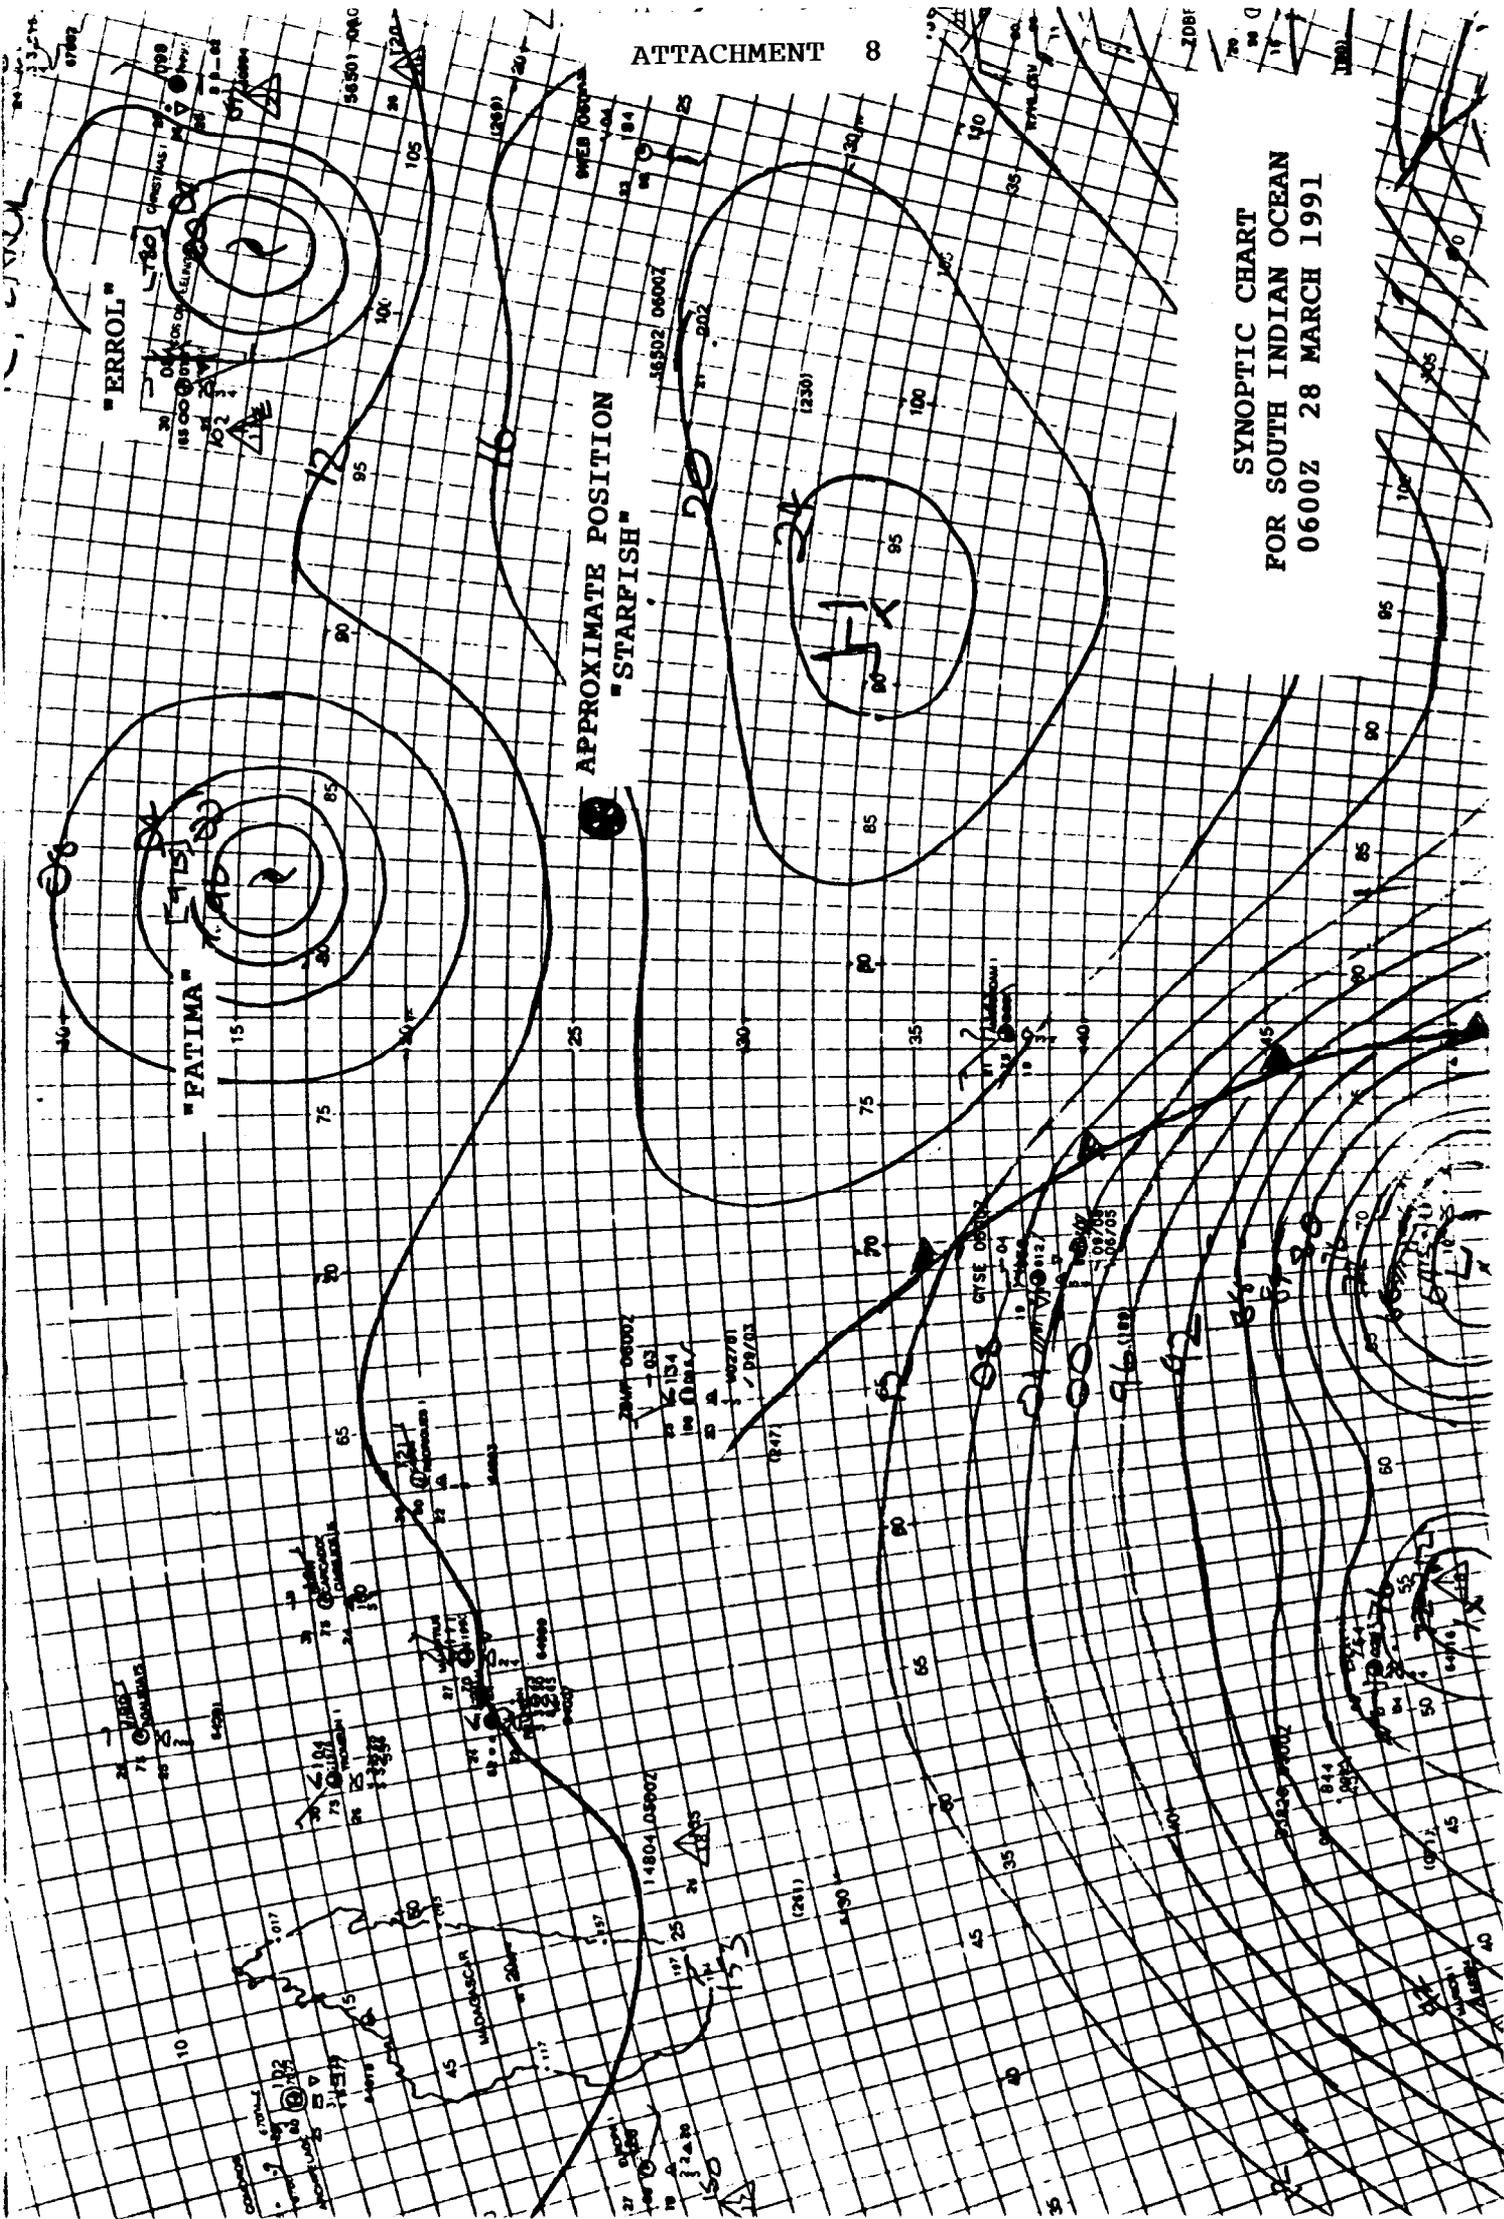
SYNOPTIC CHART
 FOR SOUTH INDIAN OCEAN
 0600Z 28 MARCH 1991

| Attachment 8: Synoptic Chart 28 March 1991 | |
