## OUTLINE OF INCIDENT

The Panamanian registered bulk carrier ALEXANDRE-P, a ship of 94532 tonnes deadweight and some 250 metres in length, loaded a cargo of iron ore at the Western Australian port of Dampier on 12 March 1990.

ALEXANDRE - P

GENERAL ARRANGEMENT

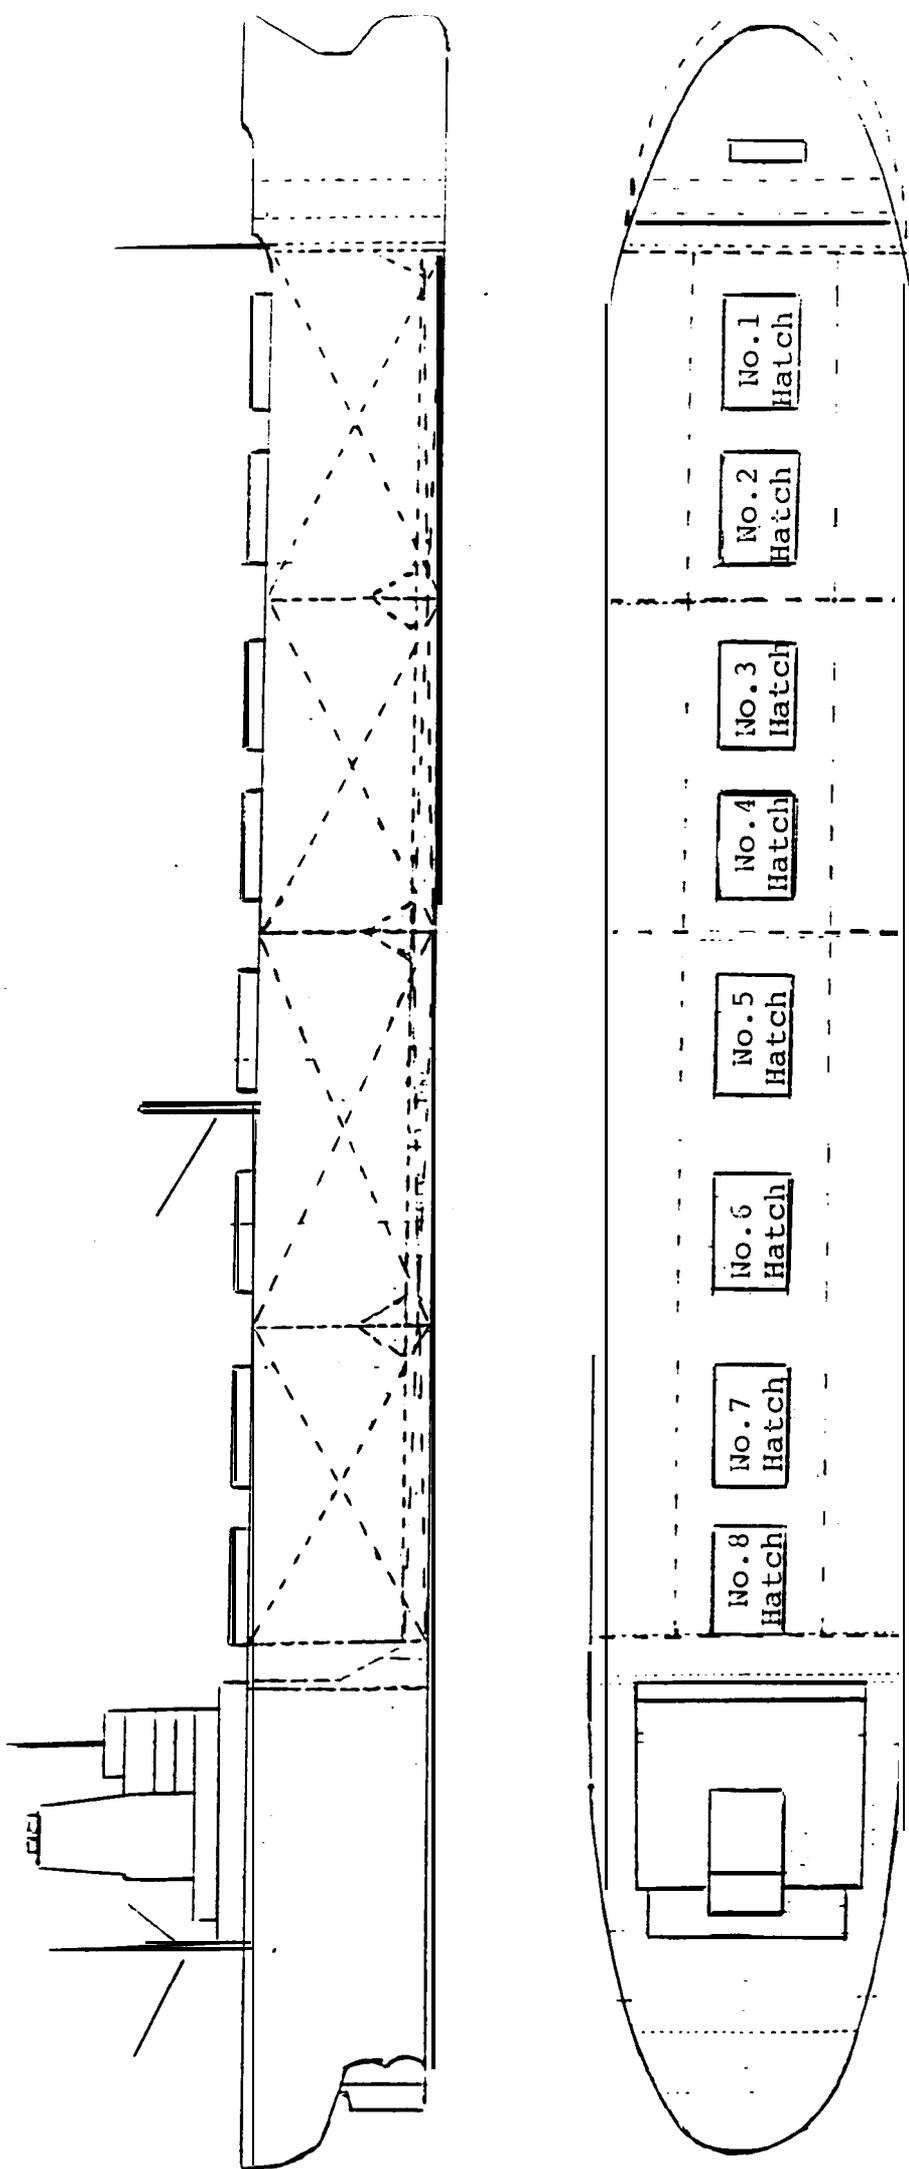
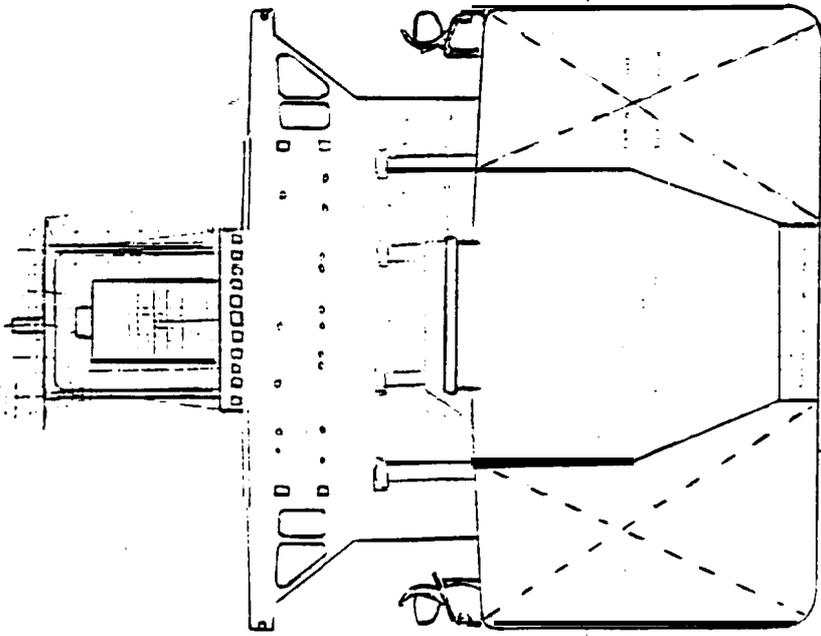
CARGO OIL TANK:- API 607, 38.0825, WITHOUT HATCH & HEAT RES. 100% FULL.

ITEM	POSITION	4 <sup>3</sup>	BBL	TON	KG(M)
NO.1 HOLD OR C.O.T. (C)	83 - 92	117.11.0	73.859	26.027	12.28
NO.3	64 - 74	13039.6	92.010	10.758	7.90
NO.4	55 - 64	11712.9	73.671	9.643	50.66
NO.1 CARGO OIL SIDE (P+S)	83 - 92	18288.0	119.028	15.0894	74.82
NO.2	74 - 83	19199.2	120.758	15.8412	34.84
NO.3	64 - 74	21251.8	134.173	17.6012	7.90
NO.4	55 - 64	16321.8	102.222	13.4672	47.97
SLOP TANK	(P+S) 55 - 58	1.177	4	7.4041	971.4
SUM		112.780	5	709.362	93.055

The normal sea passage ballast condition, in addition to the Fore Peak, Aft Peak and Nos. 1 and 2 Bottom Ballast tanks, allows for 12,200 tonnes of salt water ballast in No.2 Hold (hatches 3 and 4). The 10,635 tonnes of ore distributed between the after end of No.2 Hold and the forward end of No.3 Hold does not therefore appear to be unreasonable with respect to hull longitudinal stress factors.

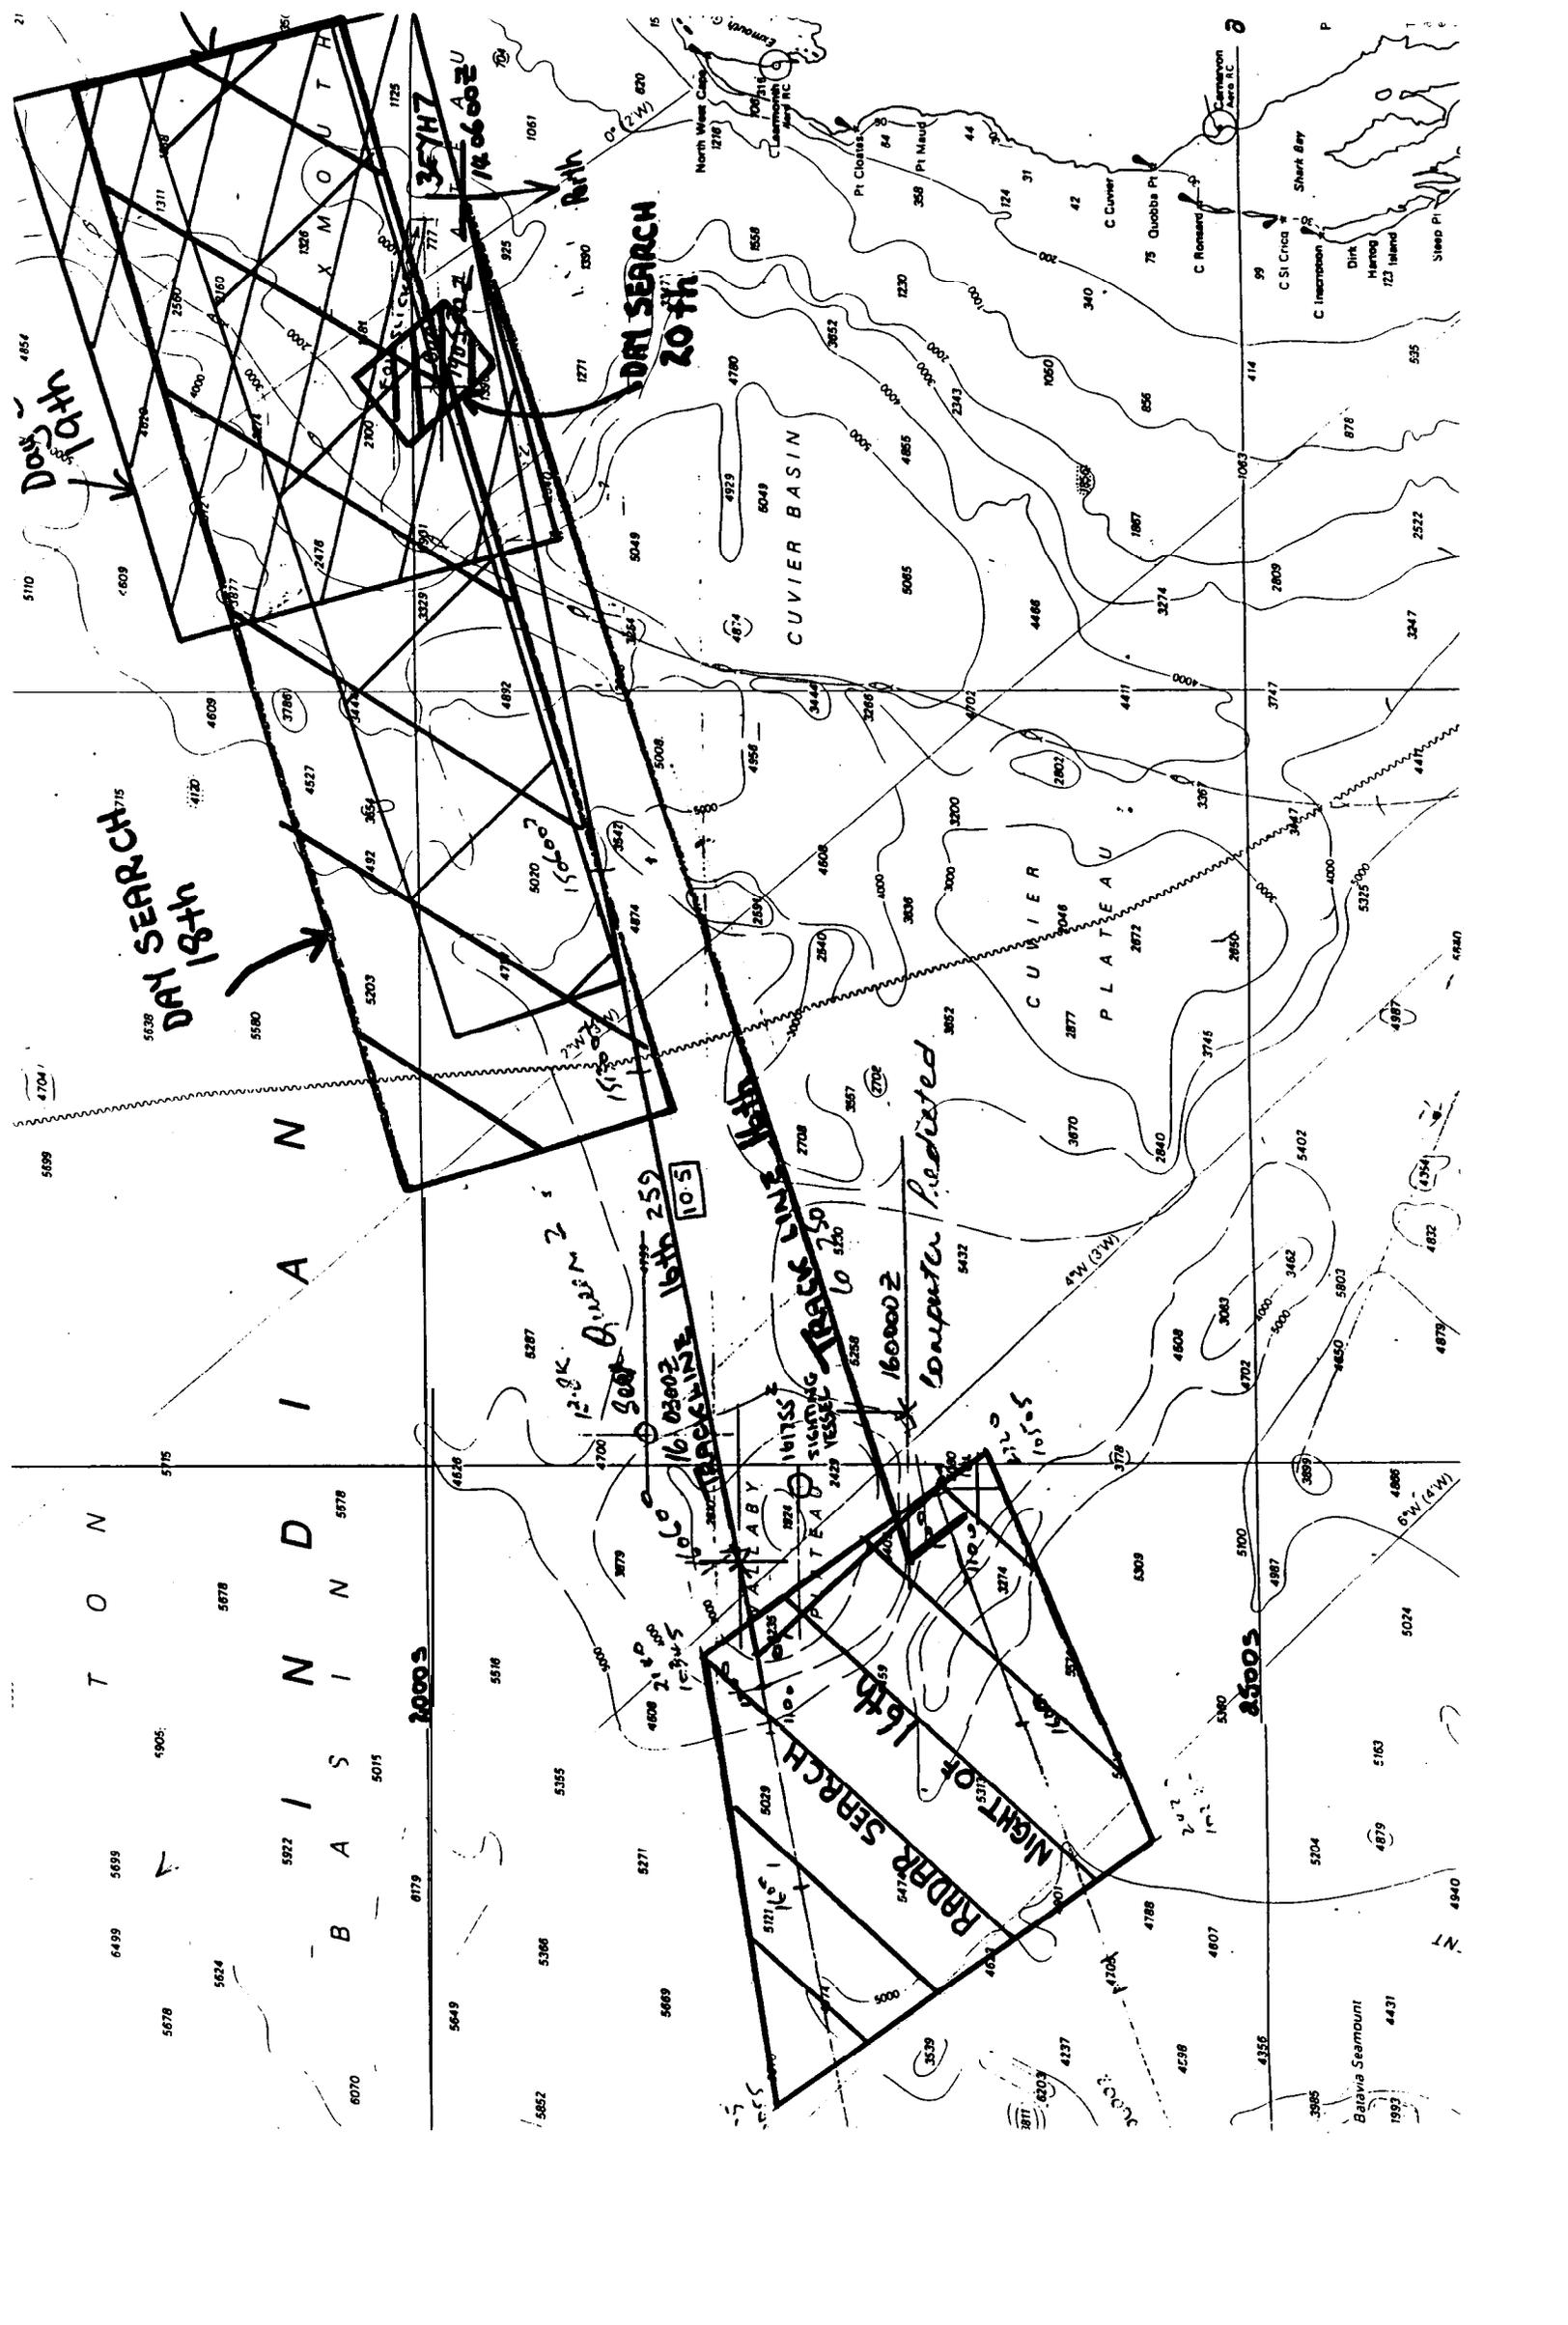
Days to the  
DAY SEARCH  
18th

12.8K  
16000Z  
16th 259  
10.5

16000Z  
Computer Predicted

Attachments: a. AUSREP instructions (Jot included in this Report)  
b. Chartlet showing areas/dates of searches  
c. Chartlet showing sightings/positions/times
