BUREAU OF AIR SAFETY INVESTIGATION

INFORMATION PAPER

SAB/IP/95/02

The Operation of Ground Proximity Warning Systems (GPWS)

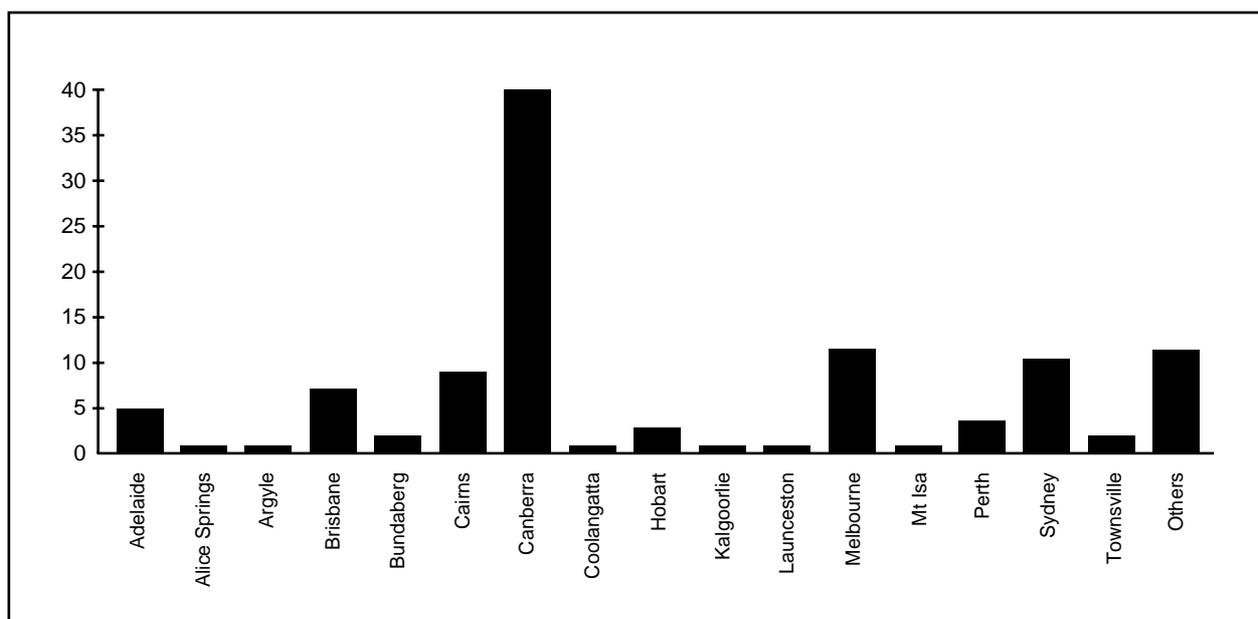
Between April and December 1994, a total of 113 reports were received concerning GPWS warnings. Forty of the reports concerned Canberra (see fig.1) with 27 of these being associated with runway 35, mostly during the approach phase from the west and south-west. This approach path takes the aircraft over, or in the vicinity of, several peaks on the eastern edge of the Brindabella Ranges.

Melbourne was a distant second with ten reports. Again, the majority (six) were concerned with the approach from, or departure to, the west and north-west, while two of the reports were specific to the radio 3LO transmission mast.

Figure 1 GPWS alerts by location

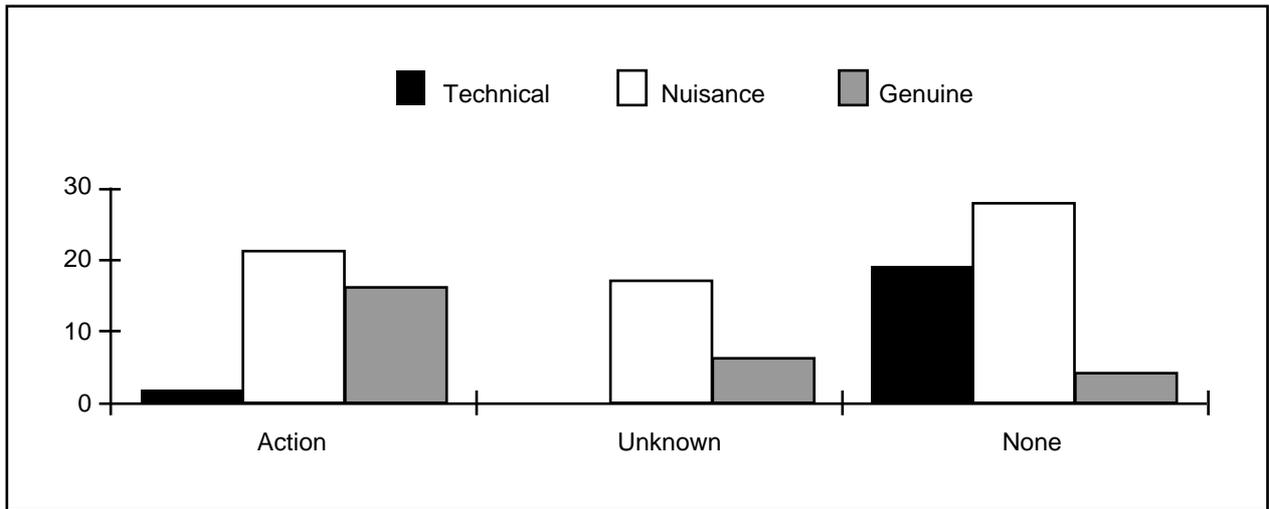
While most of the reported GPWS warnings (69) occurred in conditions that were day VMC, the crew reaction to the warning varied quite considerably. Overall, the crew reaction to the warning was that 39 took action immediately, 51 took no action (mainly due to being visual with terrain), and in 23 reports the crew reaction was not given. In two instances the crew took action even though they classified the alert as a technical malfunction. In 23 of the nuisance warnings the crew took immediate action and in 16 of the genuine warnings the crew responded appropriately (see fig. 2). Flight crew response to seven genuine warnings was not reported.

Figure 2 Flight crew action by classification of warning

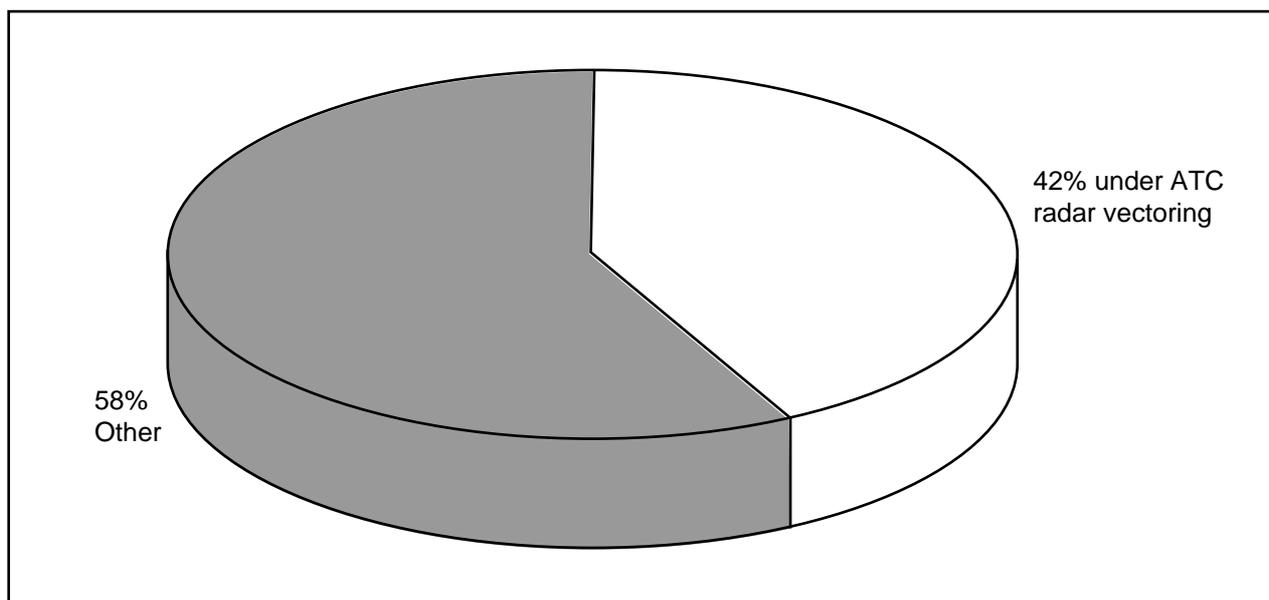
Forty-eight (42%) of the aircraft were under radar vectoring by ATC at the time of the warning (see fig.3). Of these, 16 (14%) were classified by the crew as genuine and 28 were classified as nuisance; however, some of the 28 warnings could have been more correctly classified as genuine. This would tend to indicate that ATS procedures at times take aircraft over areas and terrain where GPWS warnings are likely. Empirical evidence indicated that Cairns would be likely to have a high number of nuisance warnings. The fact that only nine warnings were recorded at that location could be the result of recently revised standard arrival routes and approach procedures that avoid such terrain. The phase of flight was significant in that 57 warnings were reported to have occurred during the approach phase and 29 during descent (BASI has been unable to clarify the significance of reports differentiating between the terms 'approach' and 'descent').

Figure 3 GPWS warnings – radar vectored
