ATSB TRANSPORT SAFETY INVESTIGATION REPORT
Aviation Research and Analysis Report – B20070107
Final

**Trends in immediately reportable matters
involving regular public transport operations**

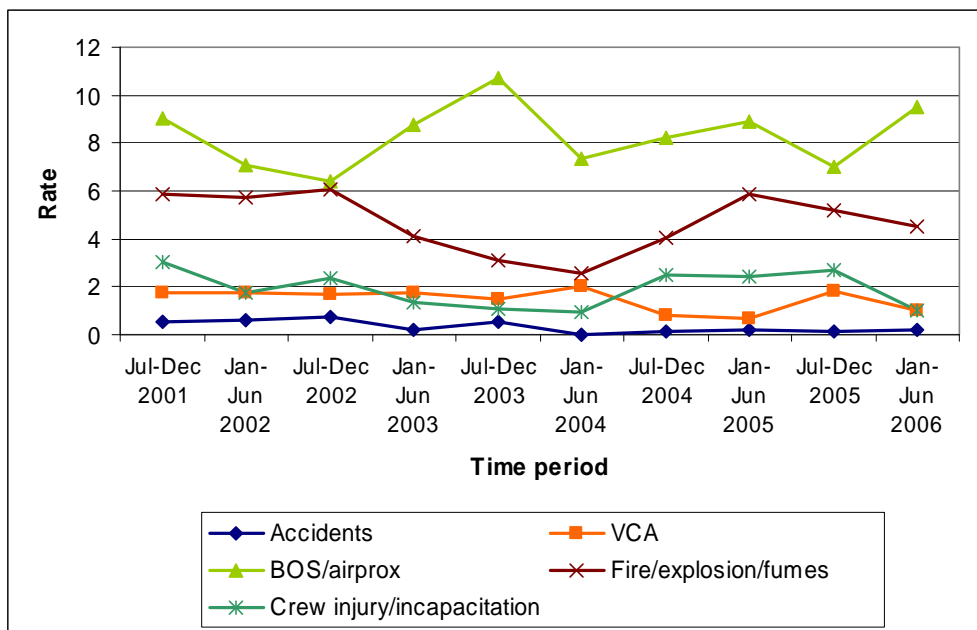
Figure 1: Summary of rates per 100,000 aircraft movements for each IRM group, 1 July 2001 to 30 June 2006

The primary findings, also summarised in Figure 1, are presented below.

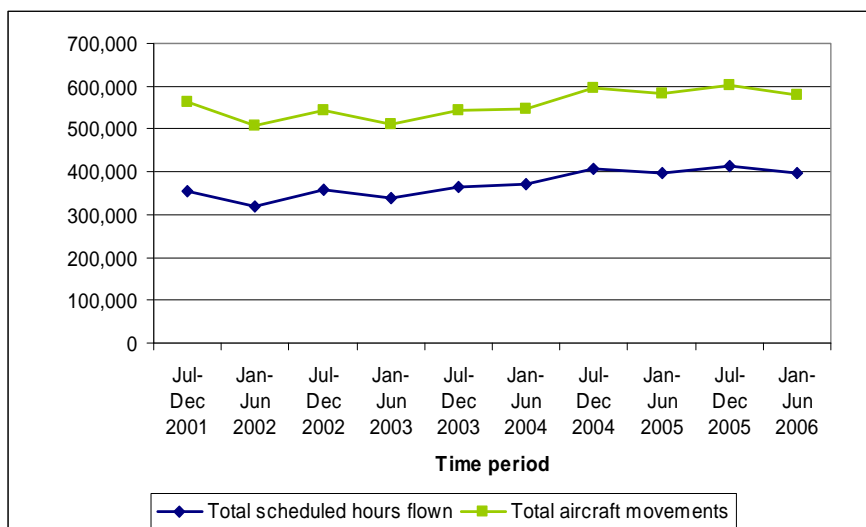
Figure 2 below indicates that there was a generally steady increase in flying hours for each 6-month period over the 5 years studied. The second half of 2005 showed the highest number of flying hours for RPT in Australia with 413,000 hours flown domestically.

Figure 2: Domestic flying hours and domestic and international aircraft movements, 1 July 2001 to 30 June 2006

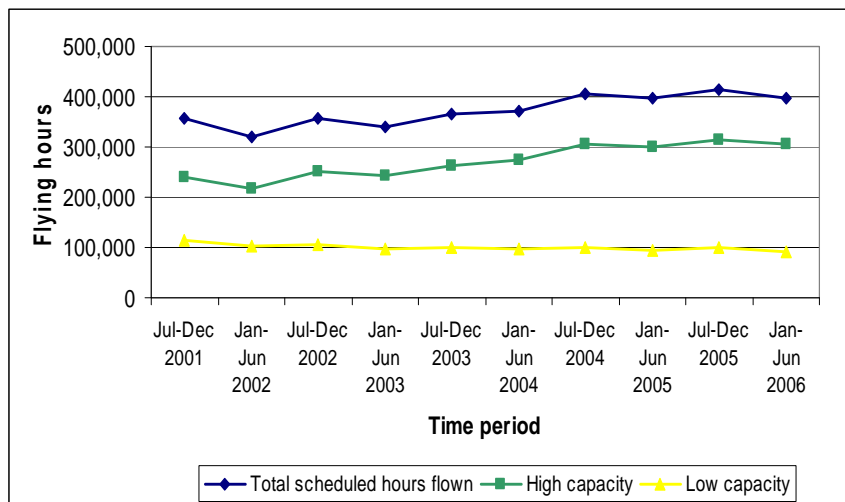
Figure 3 demonstrates that domestic activity is largely determined by the hours flown by high capacity RPT aircraft. Low capacity operations contribute around 27 per cent of the hours flown.

Figure 3: Domestic flying hours by type of air transport operation

There was a 27.5 per cent increase in flying hours for high capacity operations, but a 21.5 per cent decrease in low capacity domestic flying hours over the period studied. The increase in high capacity activity was driven by expansion within existing airlines, the introduction of new airlines and acquisition of high capacity aircraft by regional airlines.

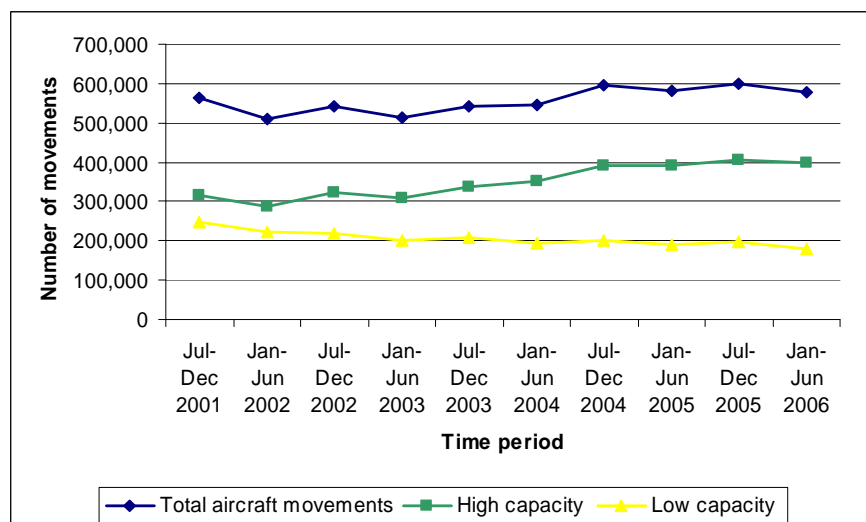
Figure 4: Domestic and international aircraft movements by type of air transport operation

There was a 27 per cent increase in movements from the July-December 2001 period to the January-June 2006 period for high capacity aircraft, matching the change in the number of flying hours. There was a 28 per cent decrease in low capacity aircraft movements for the same period. It is possible that the larger decrease in movements compared with the decrease in flying hours for low capacity RPT aircraft is the result of change in their route structure (more longer segments

and fewer shorter ones) and reduced frequency of flights on routes where higher capacity aircraft were introduced (Figure 4).

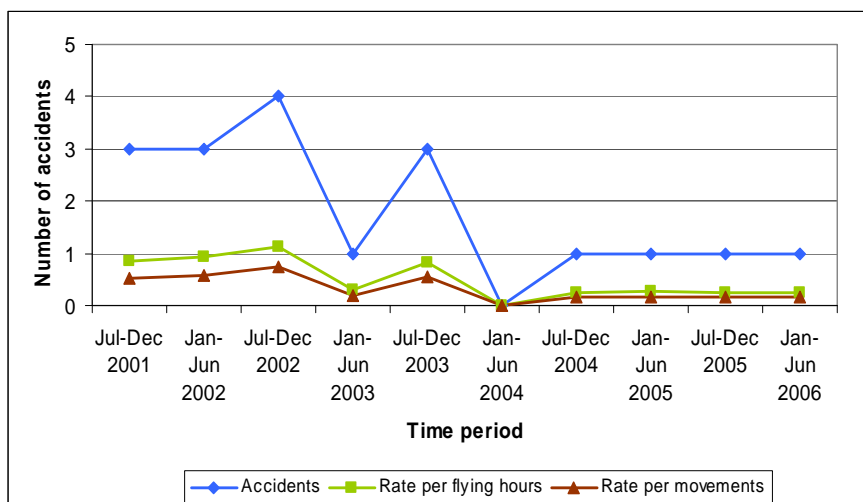
Figure 5: Accidents and accident rate per 100,000 flying hours and 100,000 movements, 1 July 2001 to 30 June 2006

The above graph demonstrates that very few accidents occurred during public transport operations and the numbers have remained low over the 5-year period.⁷ The rate of accidents per flying hours and per aircraft movements reflect the same pattern observed in the actual numbers. Only one fatal accident involving an RPT aircraft occurred during the period.

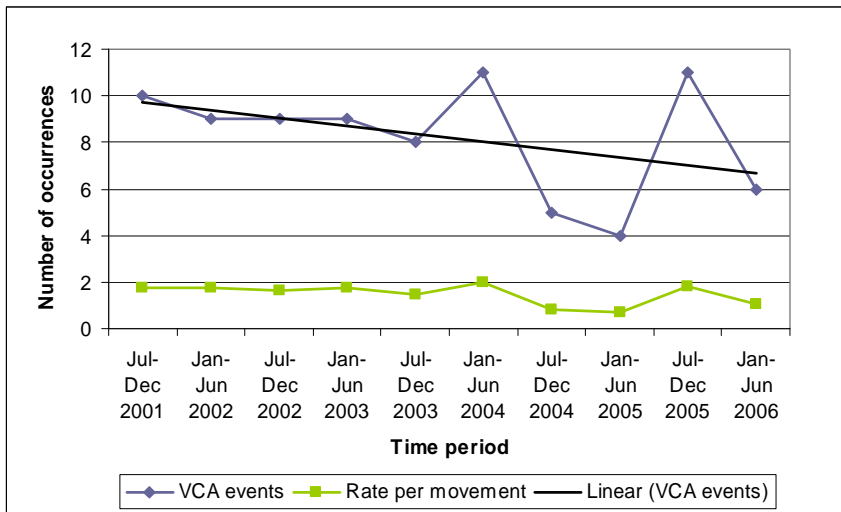
There were 82 violations of controlled airspace by RPT aircraft in the 5-year period studied. Figure 6 presents the number of VCAs for each 6-month period between July 2001 and June 2006. The graph indicates that there was a downward trend in VCA occurrences reported to the ATSB since July 2001. The rate of VCAs per 100,000 aircraft movements also shows a downward trend.

Figure 6: Violation of controlled airspace, 1 July 2001 to 30 June 2006

Note: Two occurrences refer to two aircraft violating the same airspace, at the same location, with the second aircraft entering the airspace directly after the first. These occurred in December 2001 and November 2005. The second aircraft is not counted as a separate occurrence.

A small peak in VCAs was observed for the 6-month period following the introduction of the TSI Act in July 2003. The graph also shows increased variability in VCA reports since the July-December 2003 period, which also coincides with the introduction of new airspace architecture, NAS stage 2b, in November 2003. To better understand the nature of the apparent volatility of VCA notifications in the period between January 2004 and June 2006, and to examine whether the TSI Act or NAS stage 2b changes may have influenced the number of VCA notifications monthly data was examined (Figure 7).

Figure 7 shows that the apparent variability shown in the later period of Figure 6 is an artefact of combining data into 6-month blocks, and as a consequence of normal variation between months where the number of VCA events is relatively low. Figure 7 also indicates that there was a greater change in the number of VCA events

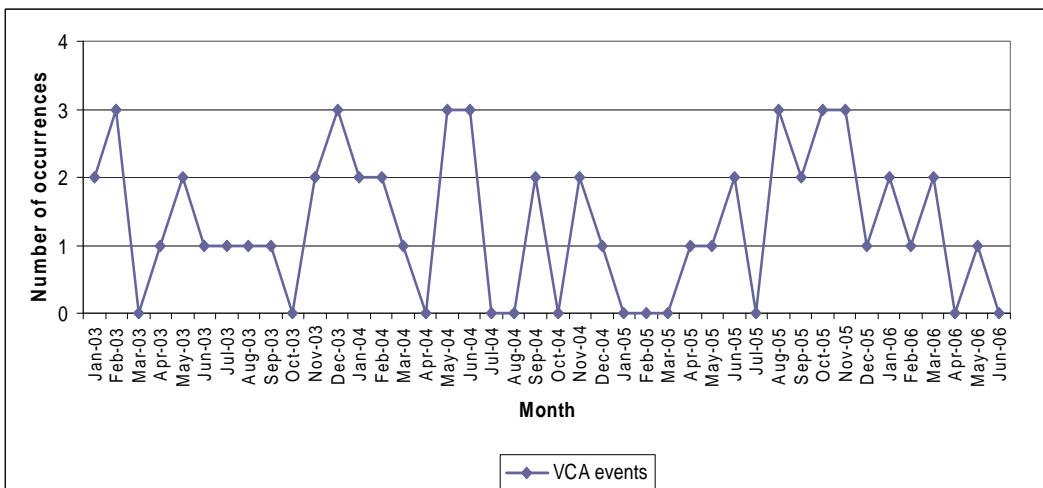
Figure 7: Violation of controlled airspace by month, January 2003 to end June 2006

following the introduction of NAS stage 2b at the end of November 2003 compared with the period immediately following the introduction of the TSI Act in July 2003.

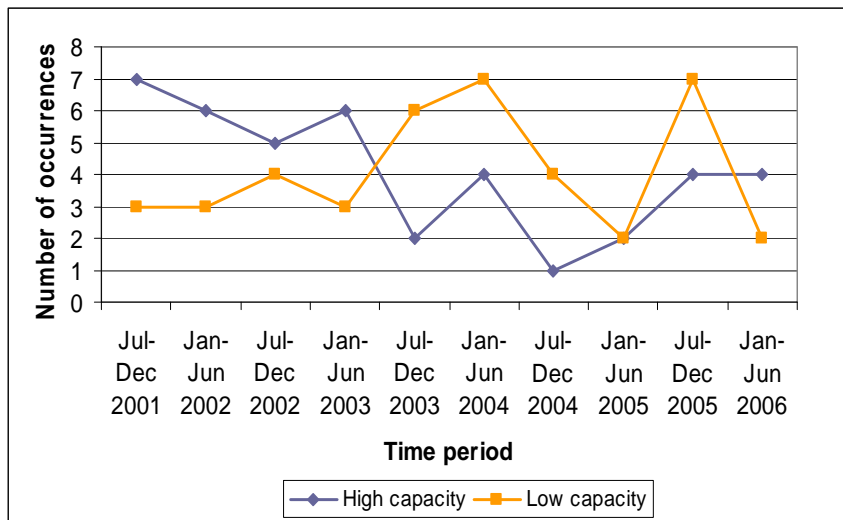
The downward trend in VCA events is clearer for high capacity RPT operations (Figure 8).

Figure 8: Violation of controlled airspace by air transport type, July 2001 to June 2006

The 82 VCA occurrences occurred in equal number for high capacity and low capacity aircraft operations. Violation of controlled airspace involving low capacity aircraft ranged from two to seven for each 6-month period, while the number that involved a high capacity aircraft ranged from one to seven each period. There was considerable variability in the number of VCA events between periods, but VCA events for high capacity aircraft operations appeared to generally decline over the period studied, while no particular trend for low capacity aircraft operations could be observed.

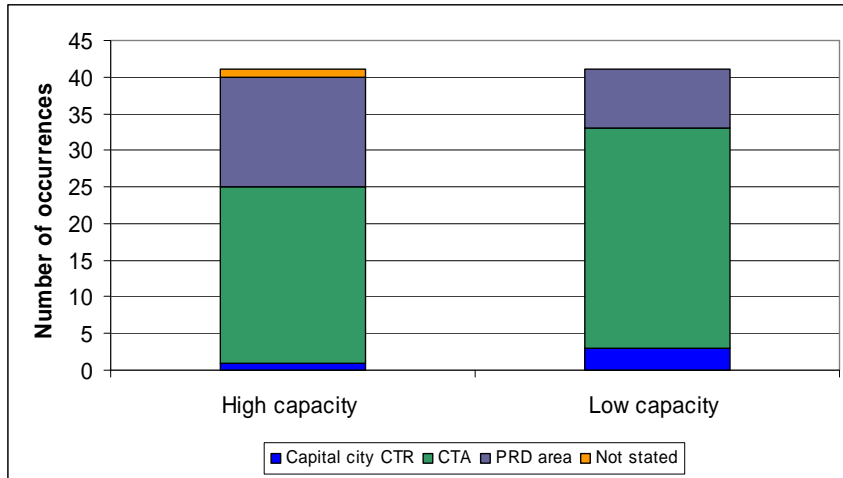
The data for VCA events was also analysed by the type of airspace involved for each occurrence. Figure 9 shows which type of airspace was most commonly involved in VCA occurrences for low and high capacity RPT operations. Entry without a clearance into controlled airspace, other than the control zone around an airport, was the most frequent event. The next most common reason for a VCA was entry into restricted airspace without a clearance, although this is less frequently the case for low capacity RPT compared with high capacity RPT operations.

Figure 9: Type of airspace violated by air transport operation type, July 2001 to June 2006

Note: CTR refers to a control zone and is defined as the controlled airspace around an aerodrome

CTA is an abbreviation for controlled airspace and refers to controlled airspace that is not a control zone (CTR) (Aviation Theory Centre, 2004; National Airspace System Implementation Group, 2003).

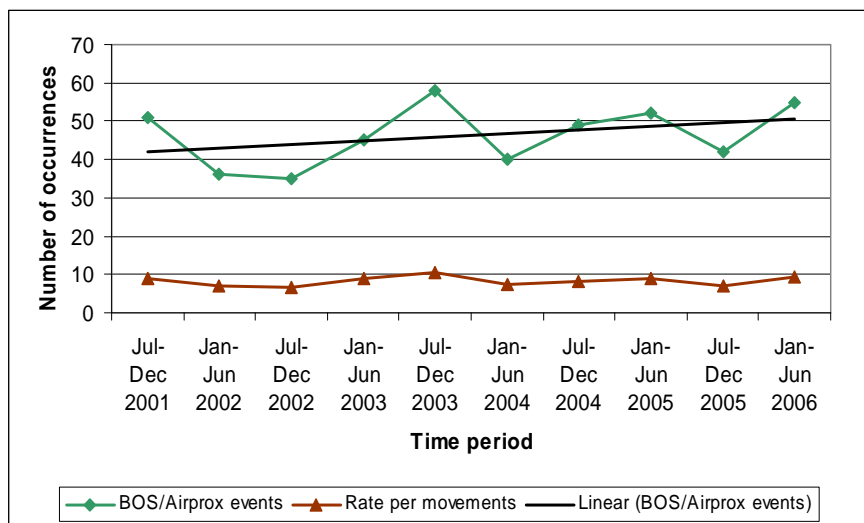
Figure 10: Breakdown of separation and airprox events and rate per 100,000 movements, 1 July 2001 to 30 June 2006

The rate of BOS and airprox events did not exceed 10.6 per 100,000 movements in any 6-month period, and averaged 8.3 per 100,000 movements over the 5 years studied.

Combining the BOS and airprox data in Figure 10 allows for a trend analysis of BOS and airprox events even though the NAS stage 2b airspace classification changes potentially affected the categorisation of some occurrences. For example, the change from Class C to Class E airspace, where there is no separation service between IFR aircraft and VFR aircraft, meant that occurrences that previously would have been classified as BOS events between an IFR and a VFR aircraft became classified as airprox events.

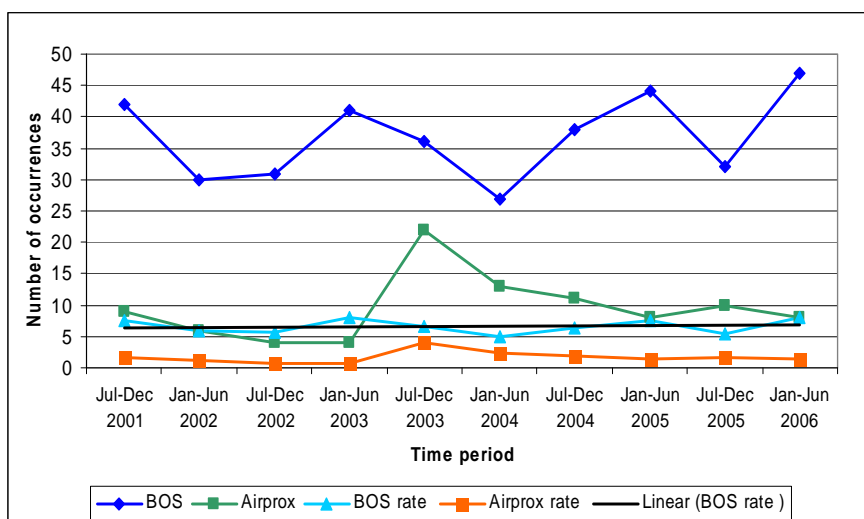
Figure 11: Breakdown of separation and airprox events and rates per 100,000 movements, 1 July 2001 to 30 June 2006

Figure 11 displays the trend in BOS and airprox events separately along with the associated rate per aircraft movement. The number of BOS increased over the period as did airprox events, albeit to a smaller degree. While the actual number of BOS and airproxes increased, the respective rates between the end of 2001 and mid 2006 did not.⁸ However, the previously mentioned peaks in airproxes in the July to December 2003 period and in BOS in the January to June 2005 period were significantly higher than the periods that immediately preceded them.

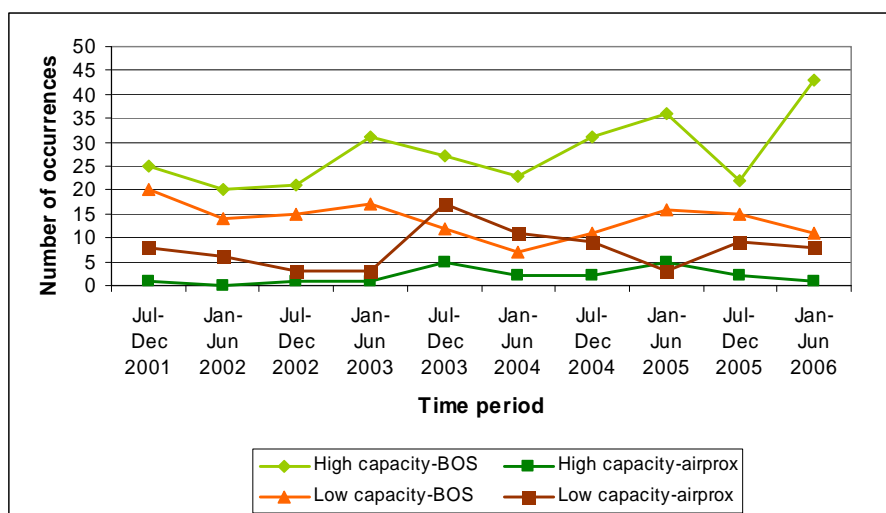
The trend in BOS/airprox events differed between high capacity operations and low capacity operations. There was an observable increase in the number of BOS events over the period for high capacity operations, but a decrease in events involving low capacity aircraft. Airproxes involving high capacity aircraft were uncommon and remained unchanged over the time period, while airproxes involving low capacity aircraft increased slightly (Figure 12). Like the overall rate of BOS, the rate for high capacity BOS did not increase between the end of 2001 and mid 2006.¹⁰

Figure 12: Breakdown of separation and airprox events by type of air transport operation, 1 July 2001 to 30 June 2006¹¹

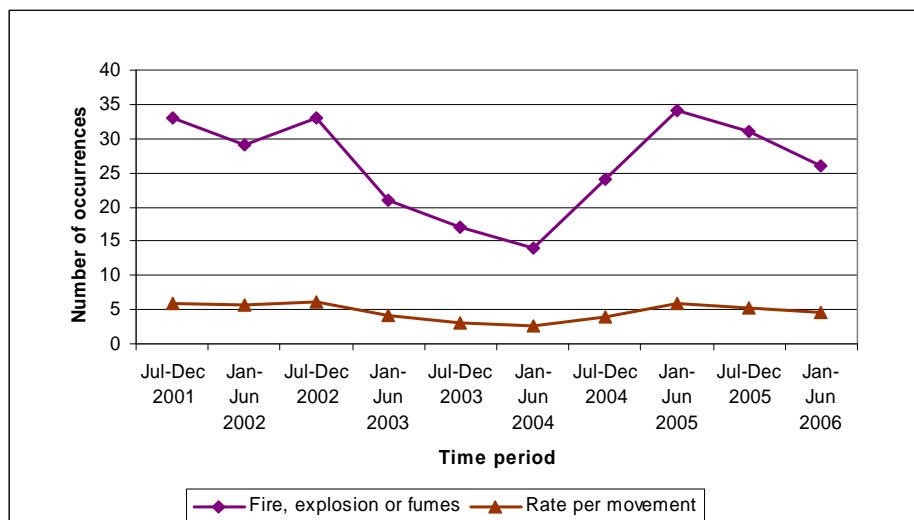
Table 4 and Figure 13 show that there were between 14 and 34 reported occurrences of either fire, smoke, or fumes for each 6-month period. The number of occurrences trended downwards, before increasing in the second half of 2004. While the TSI Regulations refer to this category of IRM as ‘fire, smoke, fumes or explosions’, there were no explosions reported in this time period.

Figure 13: Reported fire, smoke, explosions or fumes occurrences and rate per 100,000 aircraft movements, 1 July 2001 to 30 June 2006

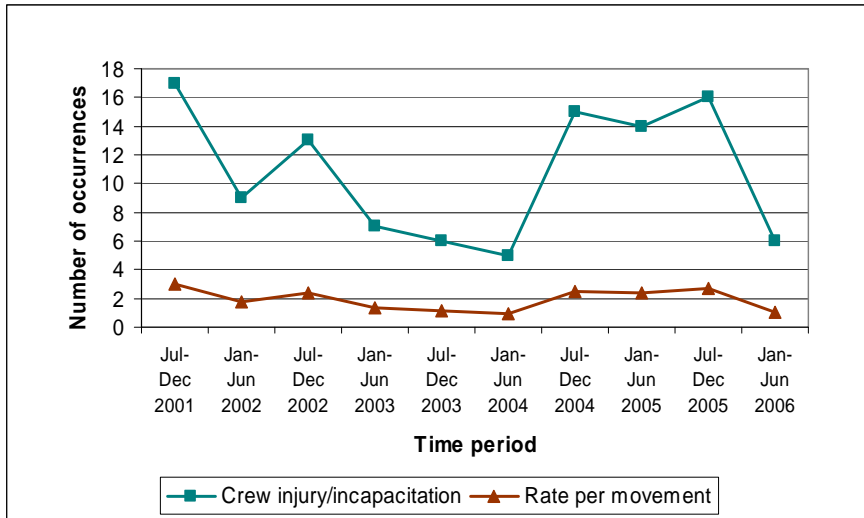
Figure 15 indicates that the overall number of crew incapacitation or injuries was low and variable. The rate of crew injury or incapacitation trended downward.

Figure 15: Crew injury or incapacitation and rate per 100,000 aircraft movements, 1 July 2001 to 30 June 2006

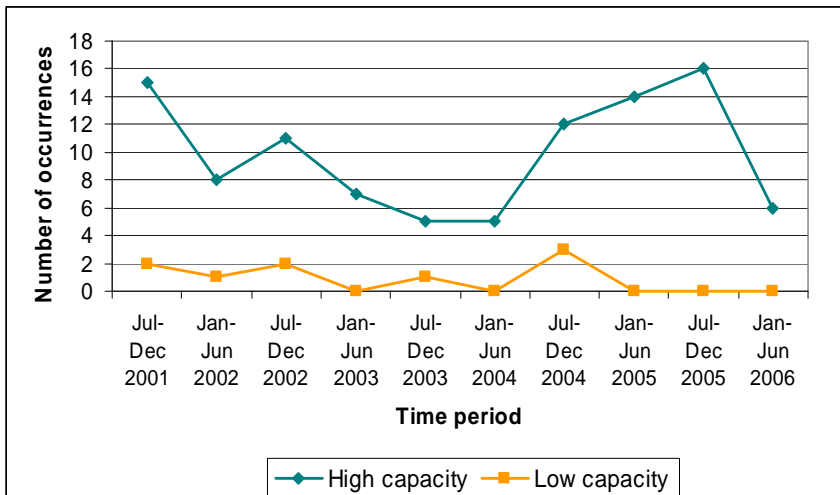
Given the relative flying hours of high capacity and low capacity operations, it is not surprising that more crew injuries and incapacitation were observed in high capacity operations (Figure 16). Also, the number of cabin crew required on passenger transport operations is determined, in part, by the number of passengers carried. It is based on a ratio of one attendant per 36 passengers (see Civil Aviation Order (CAO) 20.16.3). Hence, high capacity aircraft require many more cabin crew than low capacity aircraft.

Figure 16: Crew injury or incapacitation by type of air transport operation
