# Aviation Occurrence Statistics 2003 to 2012

## **ATSB Transport Safety Report**

Aviation Research Report

AR-2013-067

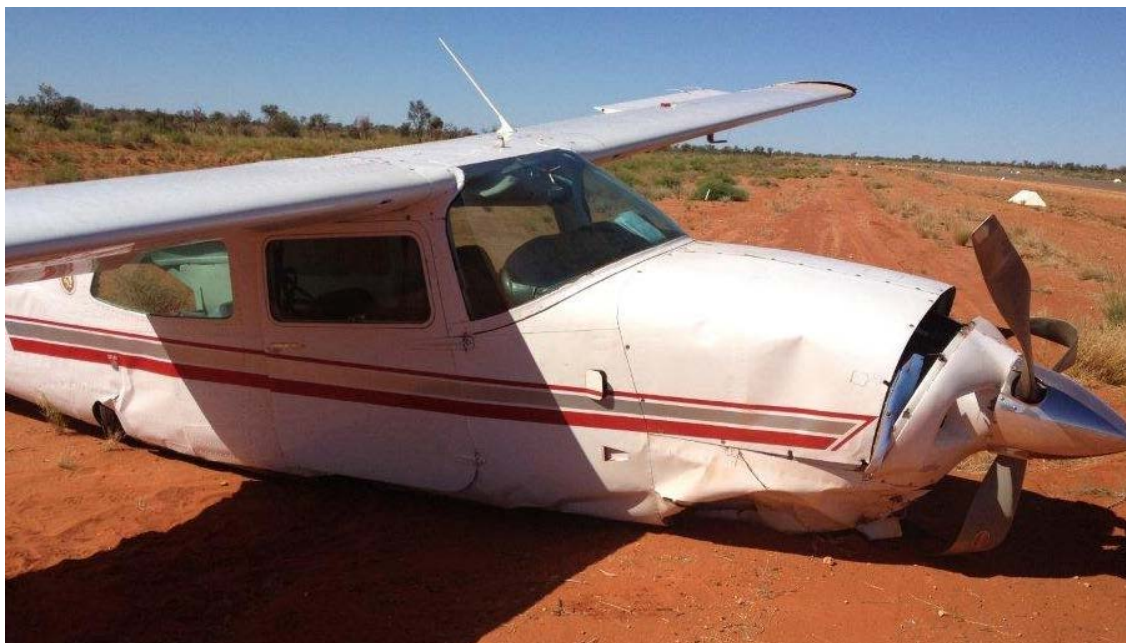
Collision with terrain, Cessna 210 Centurion (VH-TWP), Nyirripi aircraft landing area, Northern Territory (ATSB investigation AO-2012-056)

- On landing at Nyirripi airstrip, NT, the Cessna 210 Centurion being flown by a pilot in command under supervision (ICUS) on a line training flight ballooned twice. The supervisory pilot took control of the aircraft with the intent of recovering from the balloon to a normal landing. A dust devil caused the aircraft to yaw significantly to the left, and the supervisory pilot applied full

power to go-around but the aircraft did not climb. The supervisory pilot rolled the aircraft into a 30° right bank to remain over clear ground, closer to the runway. Realising that the aircraft was going to impact the ground, the supervisory pilot rolled the wings level. The aircraft impacted fairly hard and skidded about 100 m before coming to rest north of the runway and about 600 m from the threshold. The supervisory pilot was seriously injured with possible spinal injuries, and the pilot ICUS had minor injuries. This accident was investigated by the ATSB, and following the accident, the aircraft operator issued guidance notes on windshear recognition and recovery to all flight crew. This accident demonstrated that if an approach becomes unstable, conducting a go-around early is usually the safest course of action. A Bureau of Meteorology Research Centre report has noted that not all dust devils are visible and that they pose a major hazard to light aircraft during landing (ATSB investigation AO-2012-056).

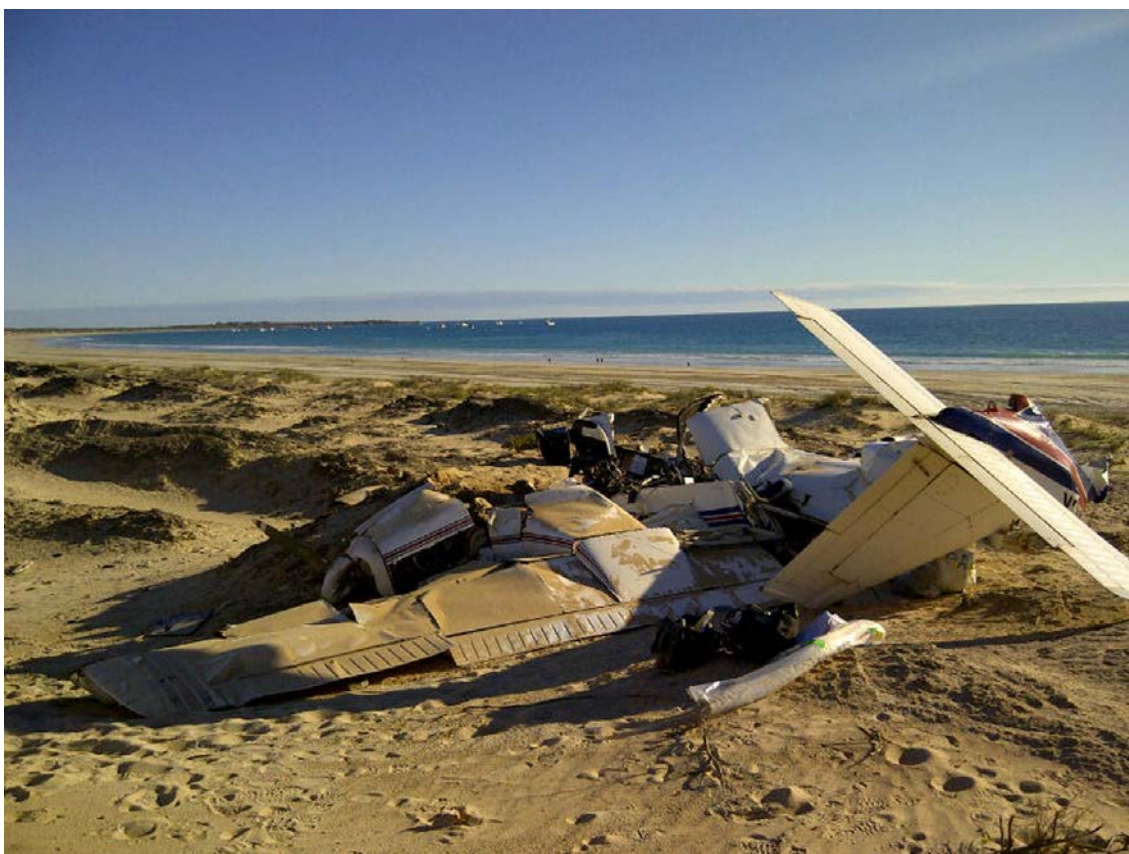
Collision with terrain, Piper PA-34-200 Seneca (VH-LCK), near Broome, Western Australia (ATSB investigation AO-2012-093)

- Shortly after takeoff from runway 28 at Broome Airport, WA, a Piper Seneca collided with terrain. The aircraft was on the outbound leg of a regular freight-carrying flight between Broome and Port Hedland, WA. A company employee, who was familiar with the aircraft and near the airport at the time of the accident, heard the engines during the initial takeoff roll and thought they sounded normal. Several witnesses reported that, during the period after the

takeoff, they heard unusual noises from the engines. Other witnesses that were closer to the accident site reported hearing the engines cut out and that they watched as the aircraft descended steeply towards the ground. Emergency services commenced a search for the missing aircraft and pilot and the wreckage was found during the latter part of the evening in sand dunes, about 880 m beyond the upwind end of the runway and close to the extended runway centreline. The pilot sustained fatal injuries and the aircraft, although substantially intact, was destroyed by impact forces. There was no post-impact fire. Damage to the wreckage was consistent with the aircraft descending steeply into terrain at relatively low forward speed and a high rate of descent. There was no evidence of in-flight structural failure. The fuel tanks ruptured on impact, the cockpit and cabin were severely disrupted and the landing gear was retracted. This accident was investigated by the ATSB (ATSB investigation AO-2012-093).

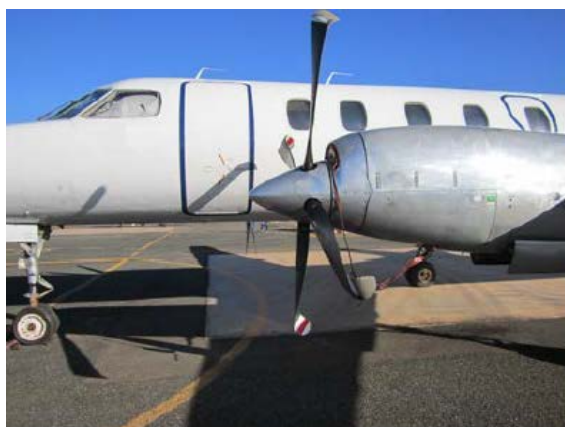
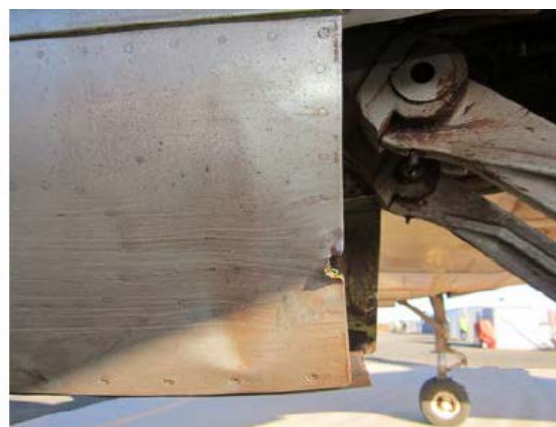
Propeller (left) and landing gear door (right) strike, Fairchild SA227-DC Metroliner (VH-WBQ), Granny Smith Aerodrome, Western Australia (ATSB investigation AO-2012-106)

- On arrival at Granny Smith Aerodrome, WA on a flight from Perth, the flight crew of a Fairchild Metro joined the circuit and extended the landing gear. In the circuit and again on approach to land, the flight crew confirmed that the three green down-locked lights ('three greens') were illuminated. During the landing flare, the left wing suddenly dropped. The first officer immediately applied right aileron in an attempt to counteract the wing drop and the aircraft touched down. After shutdown, the crew inspected the aircraft and determined that the left propeller had contacted the ground. The aircraft operator examined the aircraft and believed that there was uncommanded retraction of the left landing gear on, or just after touchdown, which resulted in the left wing dropping. Right aileron was applied, which raised the left wing, and with the forward momentum of the aircraft, the left landing gear extended. The flight crew could not recall hearing the landing gear warning horn activate during the landing. The left landing gear was later examined and ground tested and found to be working correctly. This occurrence was investigated by the ATSB, but the reason for the uncommanded retraction could not be determined (ATSB investigation AO-2012-106).

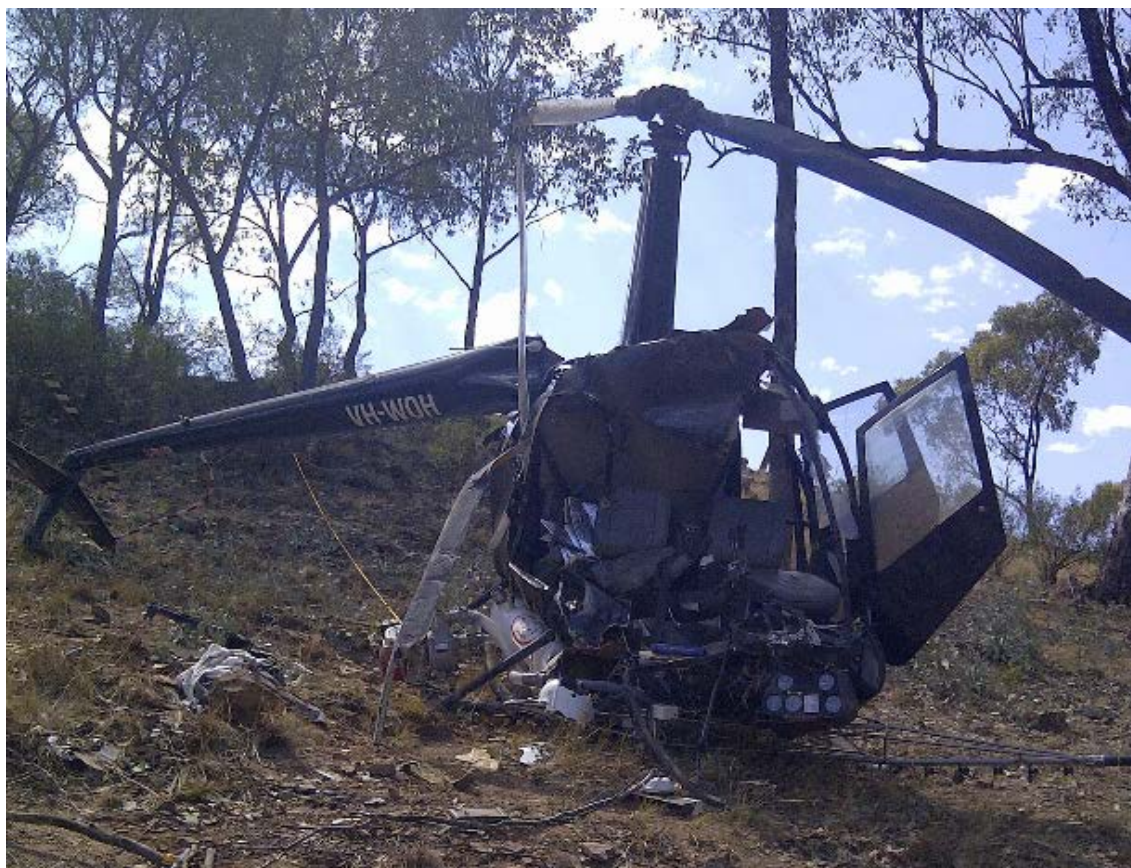
Loss of control, Robinson R44 helicopter (VH-WOH), 20 km SW of Mudgee, New South Wales (ATSB investigation AO-2012-165)

the engine. This resulted in a probable reduction in main rotor RPM (an overpitch condition) and a descent. The time between this point and the first contact with a tree was insufficient for the pilot to complete a recovery action (ATSB investigation AO-2012-165).

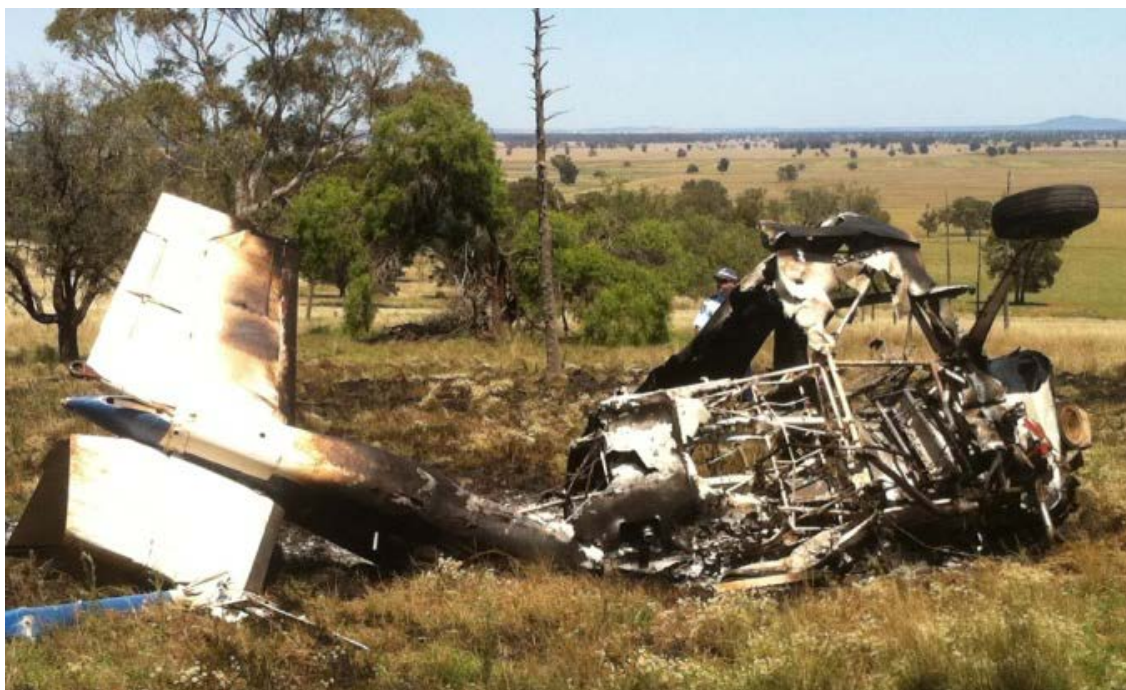
Collision with terrain, Cessna A118B/A1 (VH-ZAP), 40 km S of Forbes, New South Wales (ATSB investigation AO-2012-003)

- While applying chemicals in a field, a Cessna A188B developed a high sink rate as a result of a downdraught and the left wing impacted trees. The subsequent post-impact fire seriously damaged the aircraft and the pilot was injured. The ATSB investigated this accident, and the pilot reported that he had difficulties activating the emergency dump control system to lighten the aircraft. This accident highlights the risks associated with executing a turn when in close proximity to the ground. Such manoeuvres require heightened pilot vigilance regarding controlling the aircraft. In addition, pilots must be prepared to immediately identify the situation and act to control the aircraft, in order to compensate for a change in wind direction or downdraughts (ATSB investigation AO-2012-003).

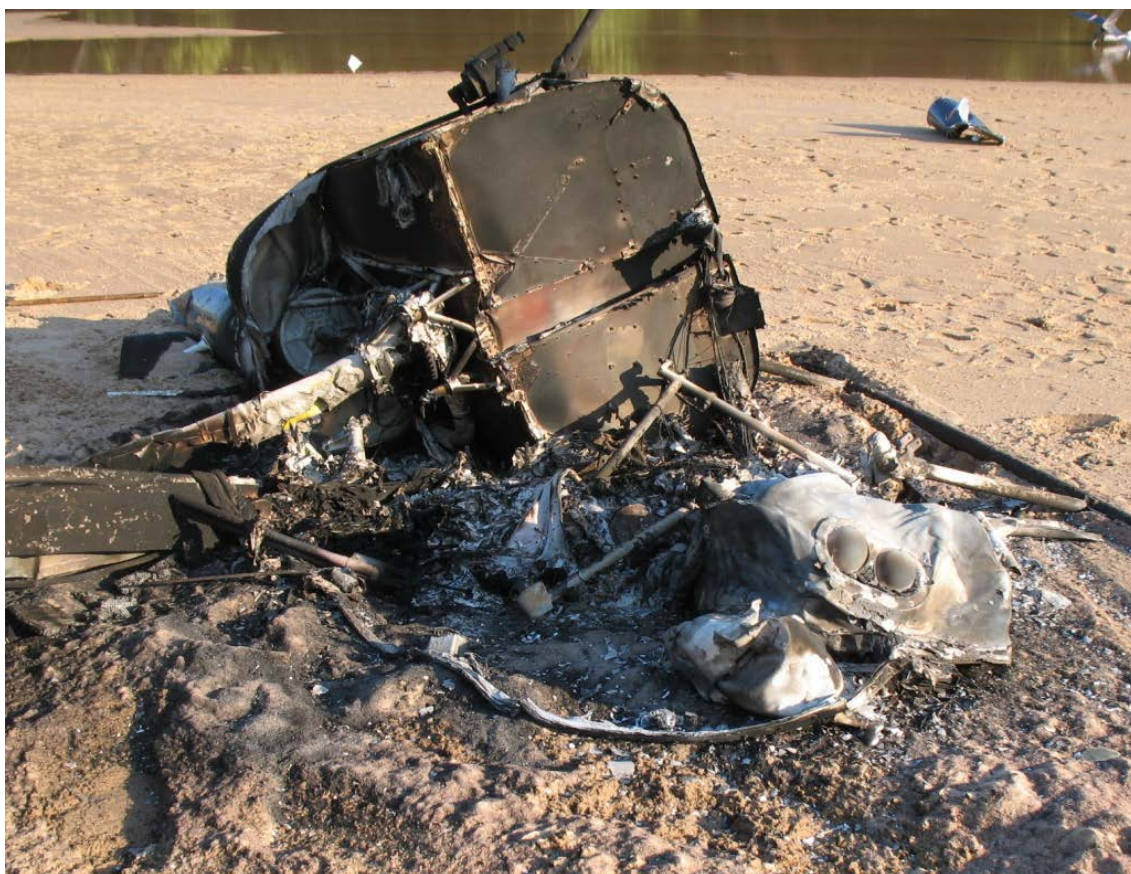
Collision with terrain, Robinson R22 helicopter (VH-FHR), 45 km ENE of Richmond Airport, Queensland (ATSB investigation AO-2012-006)

- While conducting low-level aerial work along the Dutton River near Richmond, Qld at low speed and low altitude, the pilot felt a 'kick' to the Robinson R22 helicopter and the machine suddenly yawed to the left. Shortly after, a second 'kick' and yaw occurred, followed by the sounding of the low rotor RPM warning horn. The pilot entered autorotation, and attempted to recover forward airspeed with the little height he had available (less than 250 ft). The pilot was unable to arrest the R22's descent, and it impacted the sandy river bed heavily and rolled onto its right side. A fire commenced immediately after impact, but the pilot was able to escape with minor burns. The ATSB investigation suggested that the 'kicks' and yaw experienced may have been due to environmental effects at low altitude, such as the effect of the gusting and swirling winds and mechanical turbulence. This accident highlights the need for helicopter pilots to be mindful of conducting operations with a combination of forward airspeed and altitude which may place the machine in the 'avoid' area of their helicopter's height-velocity diagram. The pilot in this accident was not wearing a helicopter safety helmet. The investigation determined that the post-impact fire initiated at the head height of the pilot, and that a helmet and visor may have reduced the severity and extent of the burns sustained (ATSB investigation AO-2012-006).

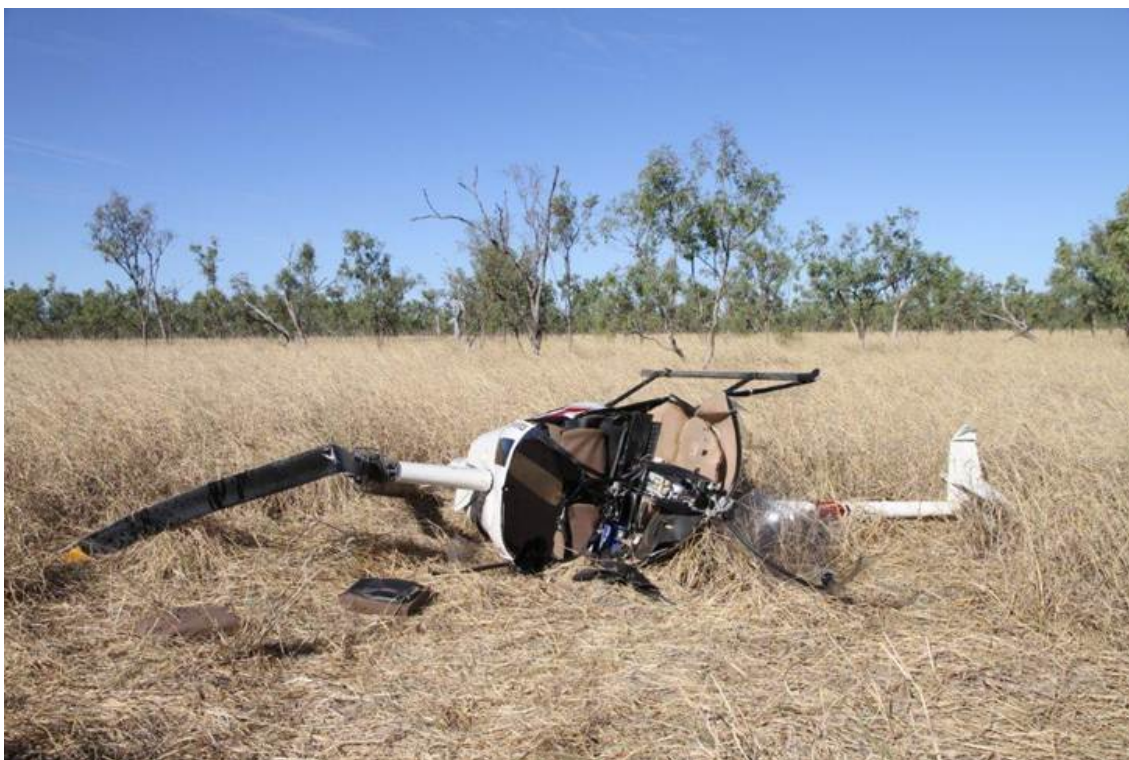
Collision with terrain, Robinson R22 helicopter (VH-STK), 23 km NE of Miranda Downs authorised landing area, Queensland (ATSB investigation AO-2012-091)

The first of these accidents involved a Robinson R22 helicopter conducting aerial mustering near Miranda Downs, Qld. During the mustering, the right skid struck a tree and the helicopter crashed. The pilot, the only occupant, was seriously injured and the helicopter sustained substantial damage. Both the ATSB and the helicopter's operator conducted an investigation into the accident and, using Global Positioning System (GPS) data, determined that the R22 had climbed to about 2,500 ft above sea level before commencing a left spiral descent. Bureau of Meteorology data, obtained by the operator, indicated that the temperature was 14.7° C and the dew point 1.3° C. The operator determined that this combination of temperature and dew point would indicate a moderate carburettor icing risk at cruise power and a serious icing risk at descent power. As a result of this occurrence, the aircraft operator advised the ATSB that they reminded their pilots of documentation in relation to carburettor icing and auto-rotations. This accident was a good reminder to all pilots of the importance of maintaining awareness of the weather conditions that are conducive to carburettor ice formation, and to closely monitor aircraft performance during times when the risk exists (ATSB investigation AO-2012-091).

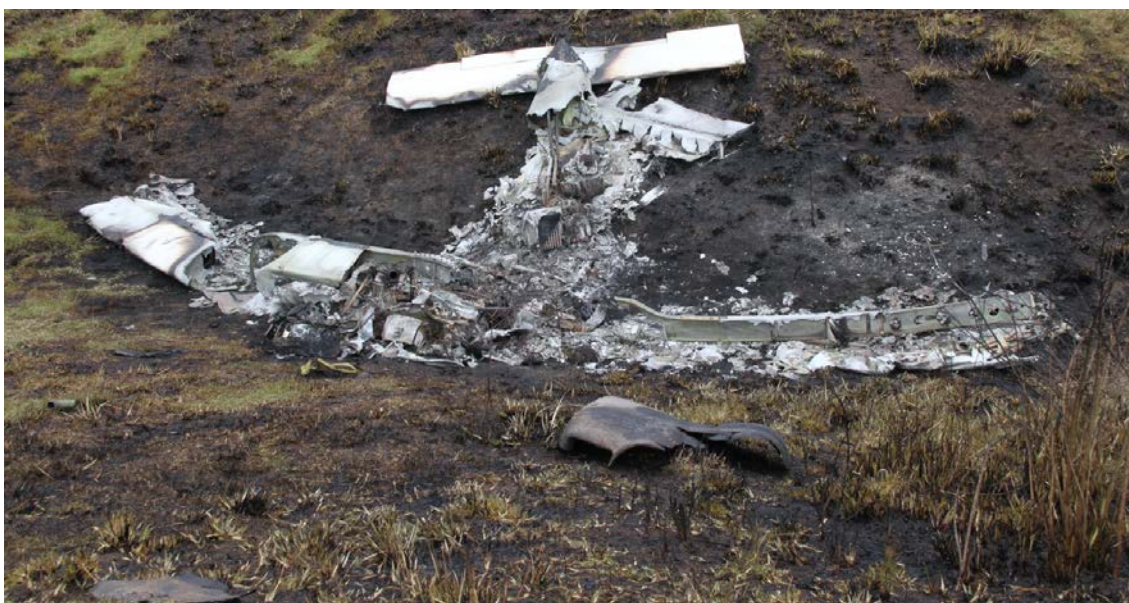
Collision with terrain, SOCATA TB-20 Trinidad (VH-HBB), 3 km S of Lismore, New South Wales (ATSB investigation AO-2012-149)

- On 9 November 2012, a student pilot and instructor departed Gold Coast Airport, Qld, for a training flight in a SOCATA TB-20 Trinidad. The student pilot had recently purchased the

TB-20, and was under the supervision of an instructor while undertaking transition training. The pilots had conducted a number of circuits at Lismore Airport, NSW, when several witnesses travelling along the Bruxner Highway observed the aircraft make an abrupt steep bank to the left, before pitching nose down and rapidly descending. Some of these witnesses then saw the aircraft's nose raise and the descent rate to reduce, before crossing the highway at a very low height and colliding with the ground in a paddock adjacent to the highway. The aircraft skidded along the ground, colliding with a fence, rupturing the fuel tanks before the aircraft flipped over. Both occupants on board the aircraft were fatally injured and a fuel-fed fire destroyed a substantial amount of the aircraft structure. At the time of writing, this accident was under investigation by the ATSB. This investigation is considering whether the operation of the engine and propeller, the aircraft's handling qualities, or the experience of the student or instructor contributed to the accident (ATSB investigation AO-2012-149).

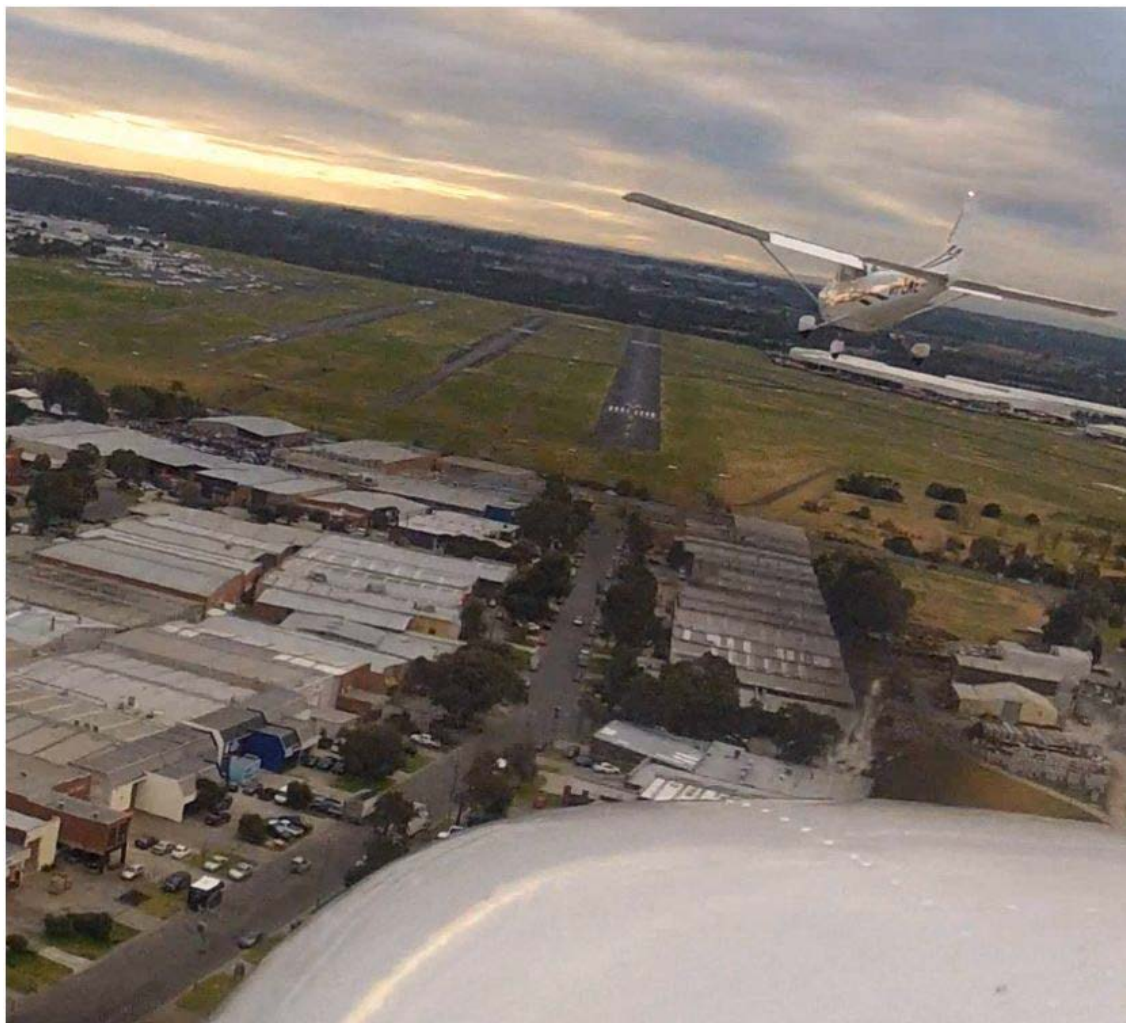
Near collision between two Cessna 172S Skyhawk aircraft (VH-EWE and VH-EOP), Moorabbin Airport, Victoria (ATSB investigation AO-2012-099)

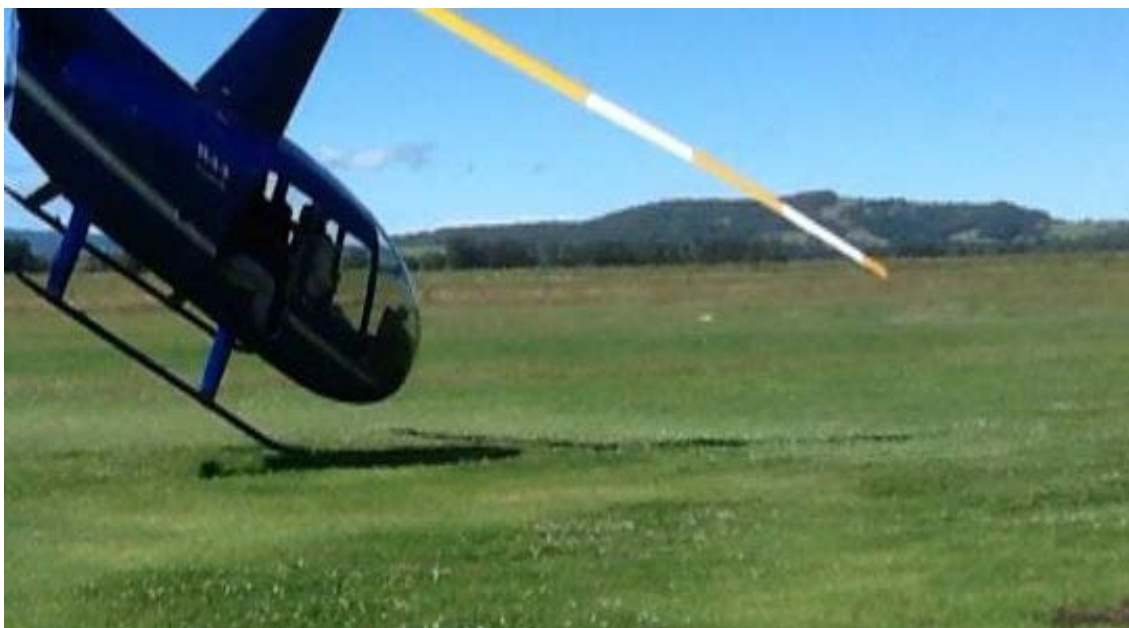
Loss of control, Robinson R44 helicopter (VH-COK), Jaspers Brush Aerodrome, New South Wales (ATSB investigation AO-2012-021)

- On 4 February 2012, a Robinson R44 helicopter lifted off from Jaspers Brush Aerodrome, NSW for aerial photography of the launching of a deep sea submarine in nearby Jervis Bay. On board were the pilot and a camera operator. Soon after lifting off, the pilot's door opened and the pilot reached out to close the door. Simultaneously the helicopter abruptly pitched nose-up then steeply nose-down, rolling to the right before the right landing gear skid and main rotor blades struck the ground. A fuel-fed fire started in the vicinity of the fuel tanks and lower mast area prior to the helicopter coming to a stop. Both occupants were fatally injured, and the helicopter was destroyed. The ATSB investigation into this accident found that the pilot's door was not properly latched prior to lift off and opened during the turn to depart. In attempting to shut the door the pilot probably let go of the cyclic control from the normal (right) control hand, allowing for an unintended, abrupt nose-up pitch and the helicopter tail hitting the ground. The helicopter then nosed over and impacted the ground. A fire began when one of the fuel tanks was breached. An important aspect of this investigation was post-accident survivability, and the ATSB identified that the fatal injuries in this and several other accidents involving R44 helicopters were due to the post-impact fire. In this and the other accidents, the R44's had not (and were not yet required to have been) modified in accordance with a manufacturer service bulletin that specified replacement of aluminium fuel tanks with more impact-resistant bladder-type fuel tanks, which decrease the risk of a post-accident fire. Both the ATSB and CASA have separately highlighted the benefits of the upgraded bladder-type fuel tank and related modifications to operational and maintenance personnel, and as of 30 April 2013, all R44 helicopters operating in Australia are now required by CASA to be fitted with bladder-type fuel tanks. This accident highlighted the importance of ensuring all doors are secured prior to takeoff. That said, the opening of a door in flight will not normally affect the operation of an R44, but the instinctive reaction to immediately deal with such an event can be quite strong. Pilots need to be aware that this reaction may be hard to overcome and in the event of an unexpected situation occurring such as the opening of the door, it is vital that pilots should continue to 'fly the aircraft'. This includes choosing to land to close the door if necessary (ATSB investigation AO-2012-021).

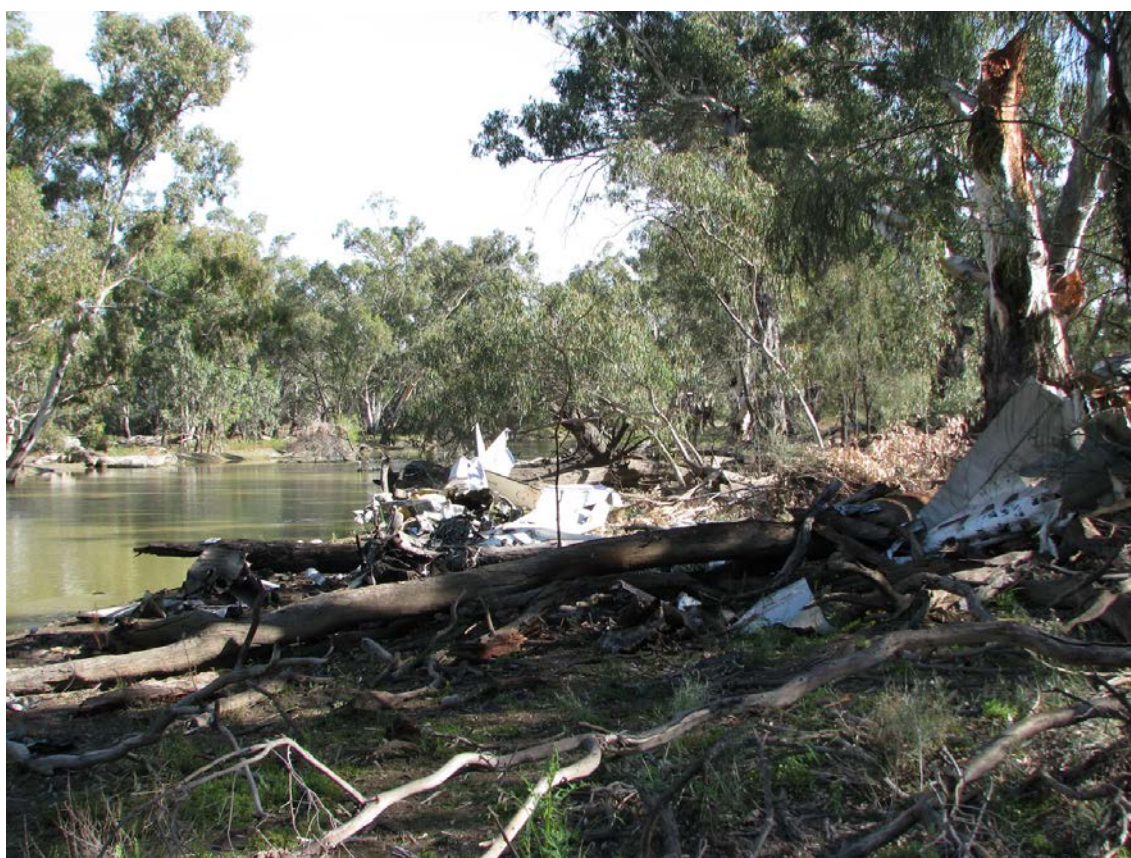
Collision with terrain, Cessna 172 Skyhawk (VH-WLF), 10 km W of Wentworth, New South Wales (ATSB investigation AO-2012-072)

- On 28 May 2012, a Cessna 172 Skyhawk collided with terrain near Wentworth, NSW while on a solo private flight in the local area. No details of the flight were submitted to ATC, or left with any other person. After a two day search and rescue operation, the aircraft wreckage was found 10 km west south west of Wentworth Airport. The pilot had been fatally injured, and the

aircraft destroyed by the impact and a post-impact fire. Examination of the wreckage by the ATSB identified that the aircraft collided steeply with the terrain at high speed. All of the major aircraft components were accounted for in the vicinity of the accident site, with the exception of the left cabin door. There was no evidence of any pre-impact damage or fire. Continuity of the flight control system to the cockpit area was established. A number of cockpit instruments were retained for further technical examination. On-site examination of the aircraft's propeller and engine revealed no pre-impact abnormalities, and damage to the propeller and engine crankshaft was consistent with their failure while under power. Fuel and other aircraft records indicated that the aircraft was fully refuelled at the aerodrome on 10 May 2012 and had likely not flown since that date. Weather at the time of the accident was calm, with no significant low cloud and good visibility. At the time of writing, this accident was still under investigation by the ATSB, with a focus on the pilot's flying experience, licence, endorsements and medical history, the recovered cockpit instruments, and the aircraft's weight, balance, performance, and maintenance records (ATSB investigation AO-2012-072).

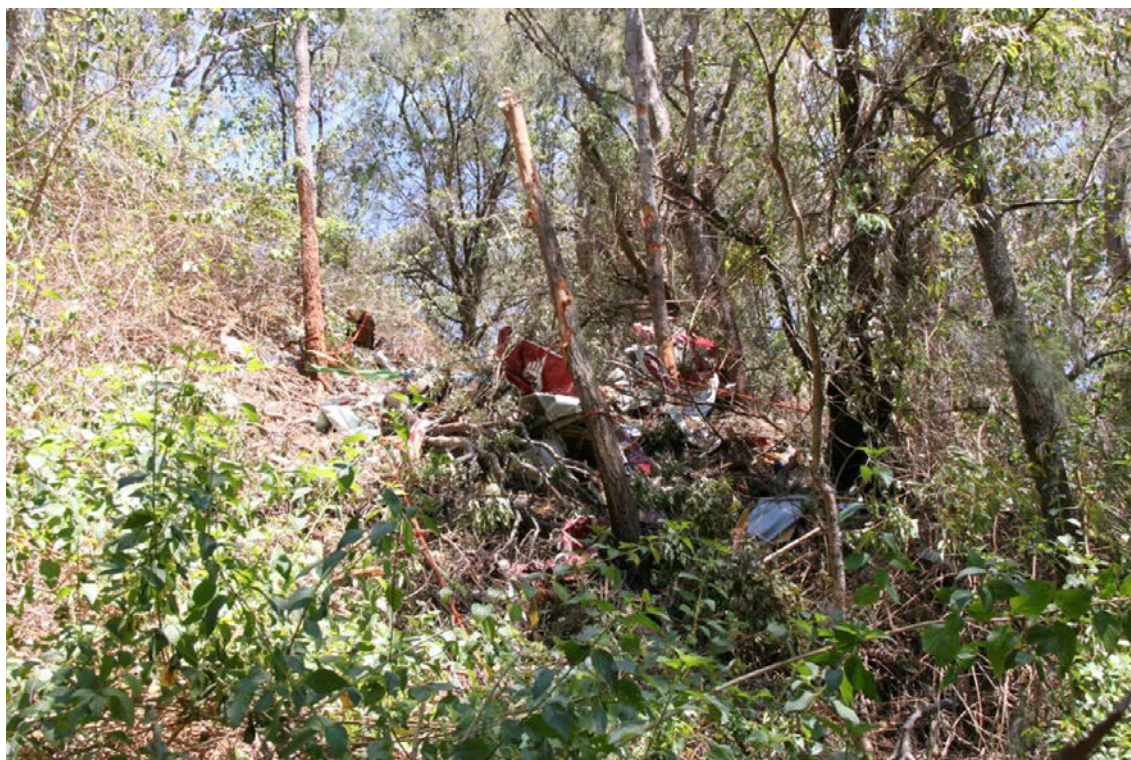
Collision with terrain, de Havilland DH.84 Dragon (VH-UXG), 36 km SW of Gympie, Queensland (ATSB investigation AO-2012-130)

- On 1 October 2012, a de Havilland DH-84 Dragon took off from Monto, Qld on a private VFR flight to Caboolture with the pilot and five passengers on board. About two hours into the flight, the pilot requested air traffic control assistance and reported that the aircraft was in 'full cloud'. For most of the remainder of the flight, the pilot and ATC exchanged communications, at times relayed through a commercial flight and a rescue flight in the area due to the limited ATC radio coverage in the area at low altitude. Air traffic control was unable to direct the pilot to an area of known visual conditions because of the extent of the cloud cover and uncertainty over the aircraft's position. Communication with the aircraft was subsequently lost. A two day search and rescue effort found the wreckage of the aircraft in a remote area to the south-west of Gympie. The accident was not survivable, and the six occupants were fatally injured. At the time of writing, this accident was still under active investigation by the ATSB. Several items and components that were retrieved from the accident site have already been examined, including a GPS unit and some aircraft instruments, and no indications of an aircraft malfunction have been found. The investigation will continue to examine air traffic radar and radio recordings, the aircraft wreckage, instruments and maintenance records, the emergency response, weather information, and witness reports (ATSB investigation AO-2012-130).

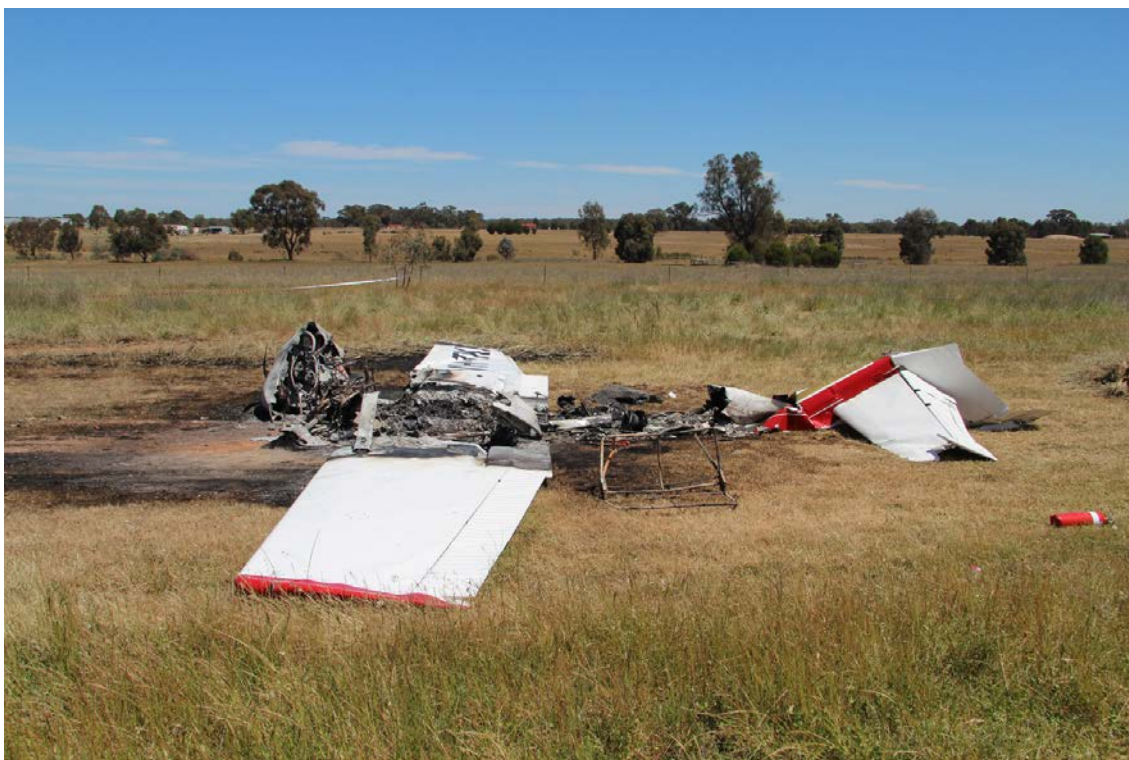
Wirestrike, Cessna 172N Skyhawk (VH-TKI), 9 km NE of Bendigo, Victoria (ATSB investigation AO-2012-142)

- On 29 October 2012, a Cessna 172N was being operated on a maintenance positioning flight from Coldstream, Vic. to a private airstrip at Bagshot, Vic. with a pilot and two passengers on board. The aircraft arrived in the circuit at Bagshot as another aircraft was on final approach to land from the south. A passenger in the aircraft reported that both the pilot and passengers were focussing on the aircraft that had just landed as they completed their circuit and commenced final approach. A witness at the airfield saw the Cessna contact a powerline while on short final approach, rotated over the powerline, and impacted the runway in an almost inverted attitude. A post-impact, fuel-fed fire destroyed the aircraft, and all occupants of the aircraft were injured, one fatally. The ATSB investigation into this accident was still underway at the time of writing, but found that the nose landing gear contacted the powerline. The powerline had no markers fitted, and was not required to under the current Australian Standards for private landing strips. The owner of the landing strip advised he routinely advised pilots using the airstrip of the location of the powerlines, and that there was a need to land a significant distance down the airstrip if approaching from the south to avoid the powerlines (ATSB investigation AO-2012-142).

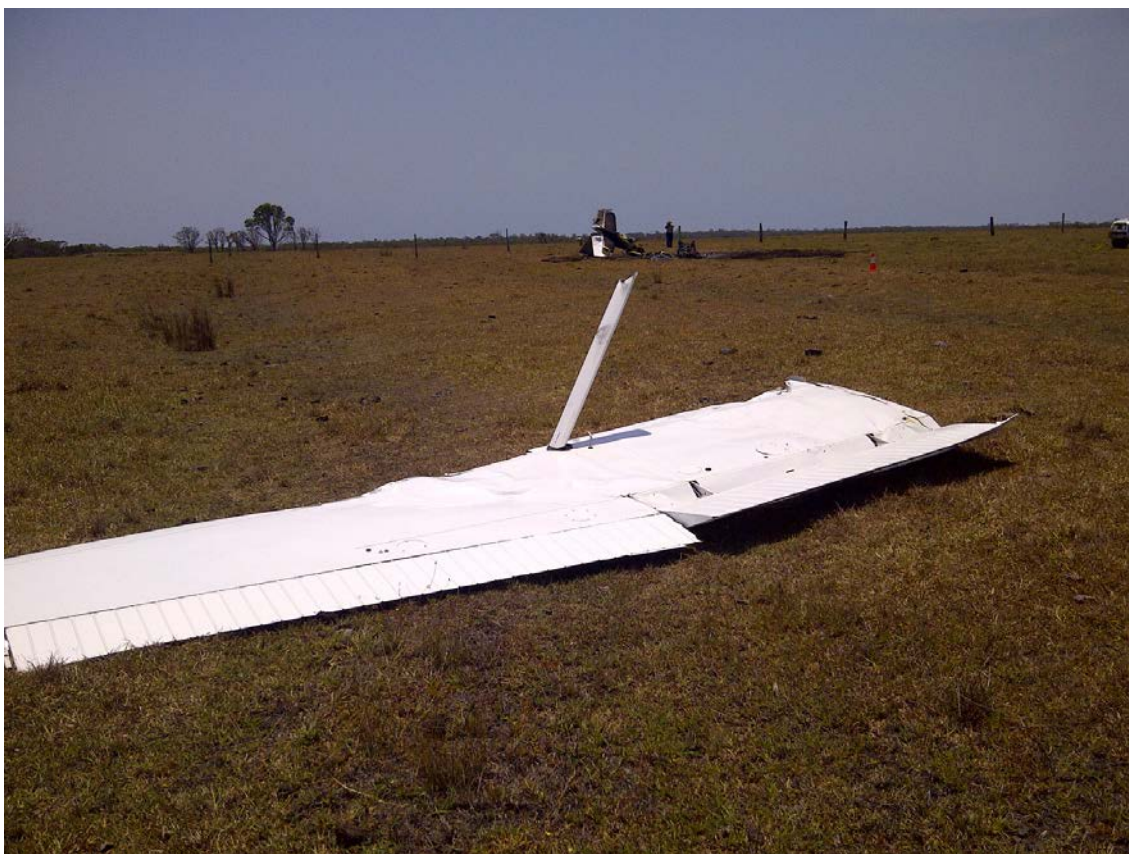
Collision with terrain, Cessna 182A Skylane (VH-SGB), Burrum Heads, Queensland (ATSB investigation AO-2012-170)

- On 17 December 2012, a Cessna 182A took off on a private flight from the pilot's own airstrip near Gympie, Qld. The pilot was flying in to a Christmas function at a parachute drop zone at Burrum Heads, about 100 km away, and was intending to land in a paddock about 1,500 m to the north of the drop zone. Several witnesses gathered at the drop zone saw the Cessna fly almost overhead at low altitude, and sever two powerlines at a height of about 9 m above the ground. The aircraft was then seen to climb, still trailing the cables, before turning slightly right and disappearing from sight behind trees. The ATSB investigation, which was still underway at the time of writing, found that the aircraft impacted the ground in a nose down attitude of almost 90° with little forward airspeed, and that the right wing had separated from the aircraft prior to impact. A post-impact, fuel-fed fire had consumed most of the wreckage and the pilot was fatally injured (ATSB investigation AO-2012-170).

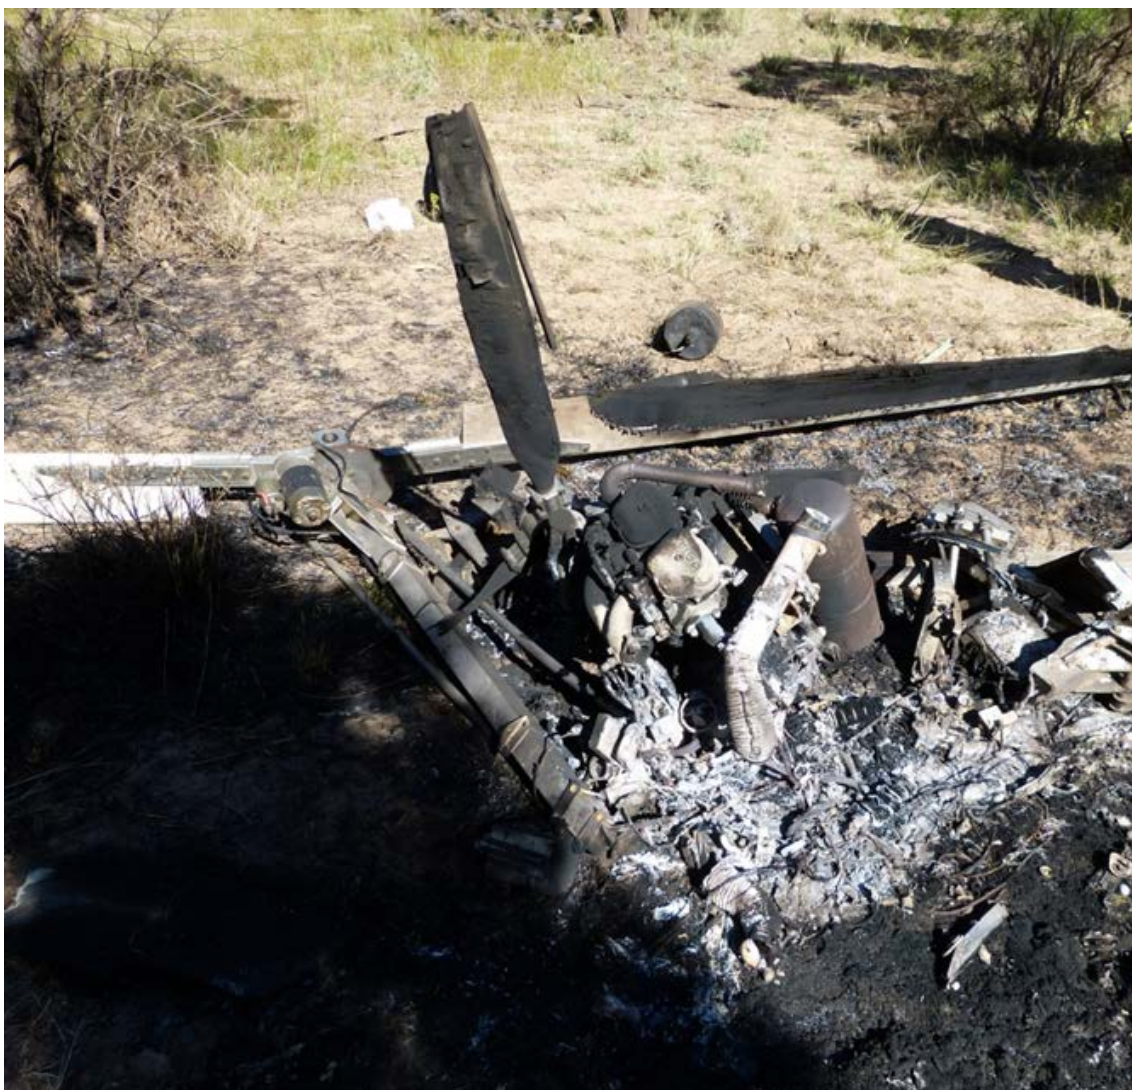
Collision with terrain, Gyroscopic Rotorcraft gyrocopter, near Bollon, Queensland (ATSB occurrence 201203961). Photo source: Australian Sports Rotorcraft Association

- On 6 May 2012, a Gyroscopic Rotorcraft gyrocopter collided with terrain at a cattle station near Bollon, Qld while conducting aerial mustering. The pilot, who was the sole occupant, was fatally injured, and the gyrocopter was destroyed by the impact and a post-impact fire. An investigation was conducted by ASRA into this accident. The ground party involved in the muster observed the gyrocopter 'swooping' down to attempt to move stubborn cattle, a manoeuvre that was considered as normal practice when using a gyrocopter for aerial mustering. The ground parties were generally able to keep the gyrocopter in sight, except during the swooping manoeuvres when they lost sight of it below the tree line. One witness observed the gyrocopter swoop down until obscured from view by the tree line, and then heard a 'crack' and observed smoke from where he had last seen the gyrocopter. The ASRA investigation identified that the pilot did not hold a current ASRA pilot licence, and that the gyrocopter's logbook was not up to date. An ELT was identified at the accident site, however, it was an older model of ELT that required manual activation, and was not activated in the accident. Investigators from ASRA determined from damage to the pilot's helmet and the propeller that during flight at or below tree top level, the helmet became dislodged due to a worn press stud used to fasten the helmet's chin strap, and passed through the arc of the propeller. The helmet was destroyed, and the propeller blade dislodged from its hub. It is likely that the pilot lost control of the gyrocopter at this point, and at low altitude, the gyrocopter rolled to the right and struck trees and terrain. The ATSB assisted ASRA by providing an assessment of a GPS unit that was located at the accident site, however, the unit was badly fire damaged and was unlikely to still contain useful data (ATSB occurrence 201203961).

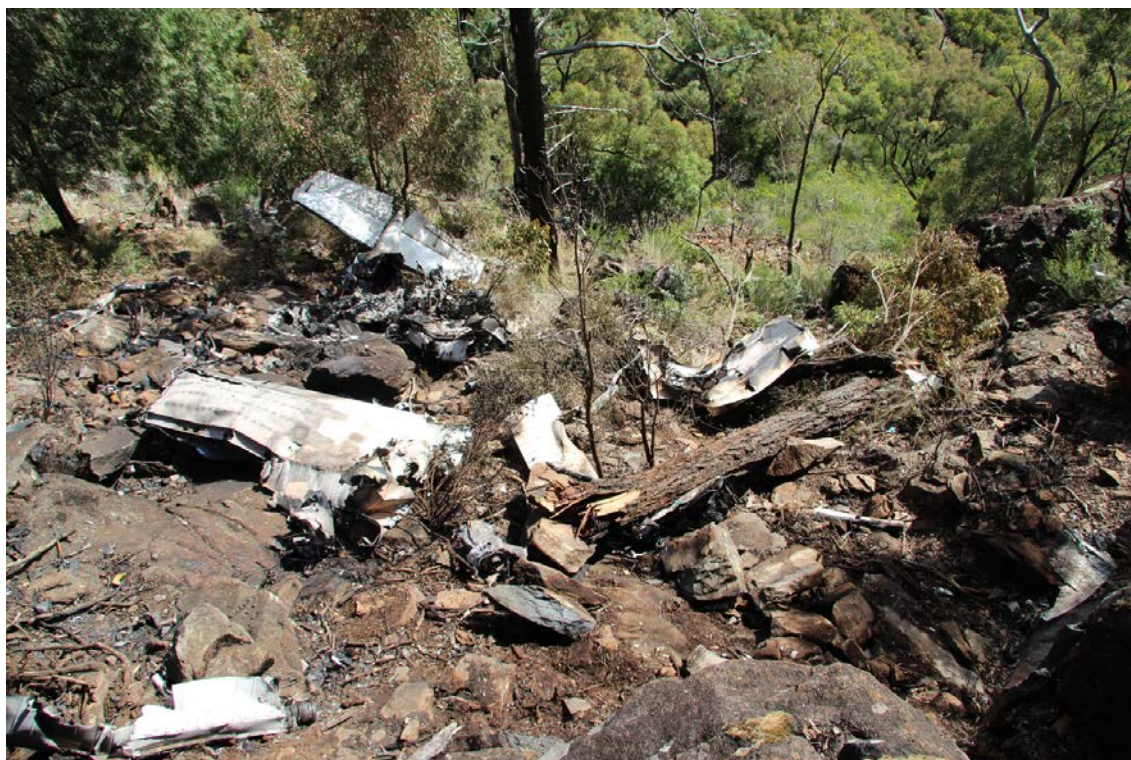
Visual flight rules in instrument meteorological conditions and controlled flight into terrain, Cessna 182Q Skylane (VH-CWQ), 15 km N of Tooraweenah, New South Wales (ATSB investigation AO-2012-076)

- On 4 June 2012, the pilot of a Cessna 182Q took off from Walgett, NSW in good weather conditions for a flight to Mudgee, initially climbing to 5,500 ft. During the flight, the cloud base lowered. About 25 minutes after the pilot departed, he rang a friend who lived near Mudgee, and asked for an appraisal of the weather there. The friend reported weather conditions suggesting that it might not be suitable to fly to Mudgee in VFR conditions. The friend recalled that the pilot said that if the weather conditions deteriorated too much, he would turn around and return to Walgett. For the next 10 minutes, the pilot continued to descend until the aircraft was flying about 1,000 ft above flat terrain, either close to or in the base of the cloud. The terrain ahead and to the left of this track continued to rise to an altitude significantly above that at which the aircraft was flying. About 13 minutes later, the aircraft impacted a rock face in the Warrumbungles near Tooraweenah, NSW, destroying the aircraft and fatally injuring the pilot. The ATSB investigation into this accident found that the risk to flight was increased by

deteriorating weather conditions, and the pilot was probably flying with forward visibility sufficiently obscured by cloud to not be able to see and avoid the rising terrain. In addition, the pilot did not select a flight track to avoid the rising terrain, or conduct a diversion to a suitable aerodrome, which would have been an effective measure to manage the deteriorating weather. The ATSB *Avoidable Accidents* publication *Accidents involving Visual Flight Rules (VFR) pilots in Instrument Meteorological Conditions* is a good reminder to pilots of the insidious risks associated with reduced forward visibility when flying in or near the cloud base (ATSB investigation AO-2012-076).

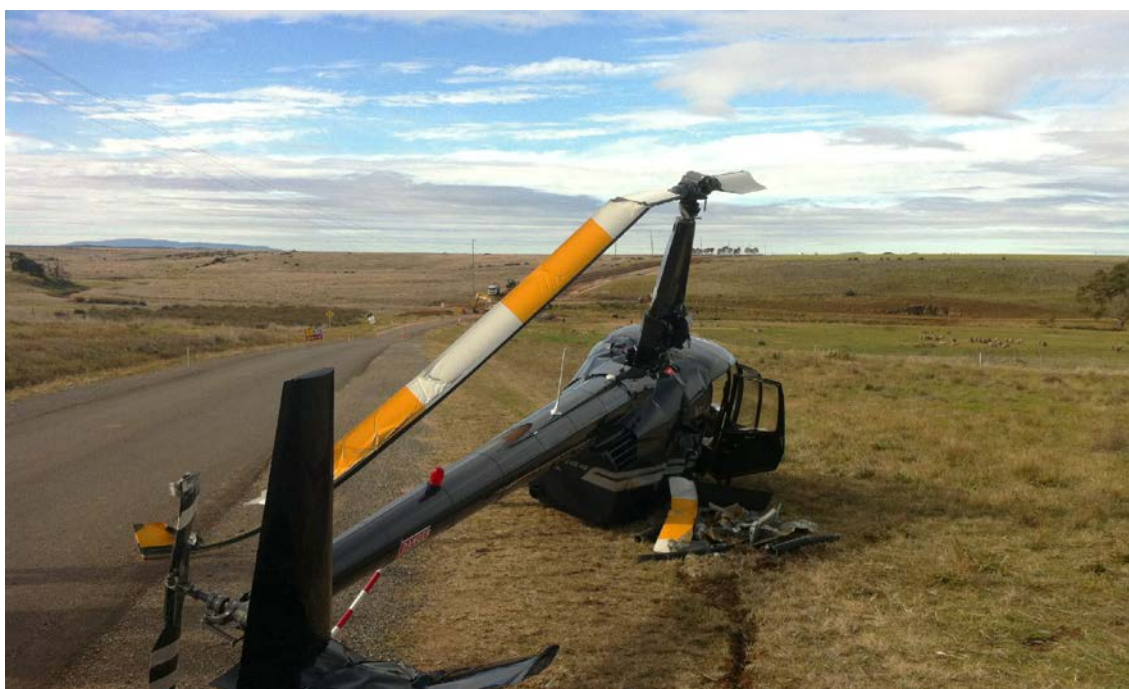
Wirestrike, Robinson R44 Raven I helicopter (VH-HIE), 21 km E of Maryborough Airport, Victoria (ATSB investigation AO-2012-079)

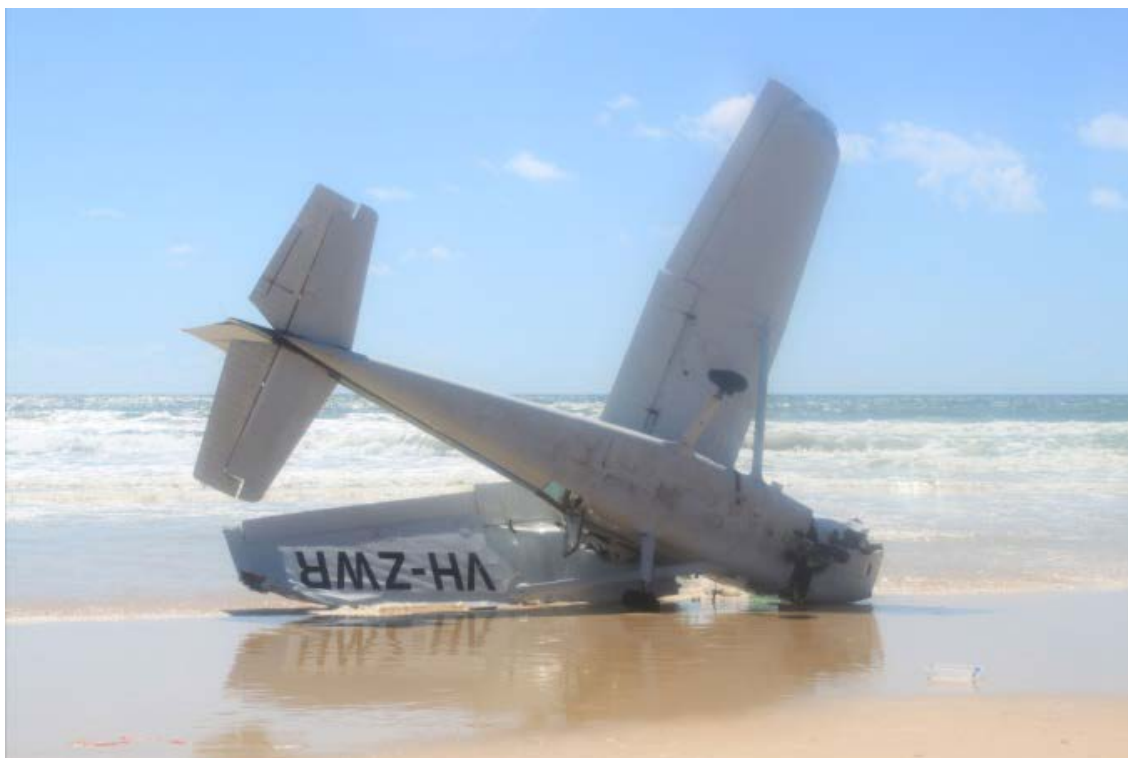
Collision with terrain, Cessna 172N Skyhawk (VH-ZWR), The Oaks, 6 km S of Happy Valley, Fraser Island, Queensland (ATSB investigation AO-2012-007)

- A Cessna 172N aircraft was taking off from Happy Valley airstrip, Qld to conduct a visual flight rules charter flight with the pilot and three passengers on board. After takeoff at about 25 to 30 ft above ground level, the aircraft descended and impacted the ground. The ATSB investigated

this accident, and found that the circumstances of the aircraft's descent were consistent with an aerodynamic stall as it climbed out of ground effect while flying at an airspeed and configuration where the airspeed would not normally remain constant (ATSB investigation AO-2012-007).
