# Aviation Occurrence Statistics 2003 to 2012

## **ATSB Transport Safety Report**

Aviation Research Report

AR-2013-067

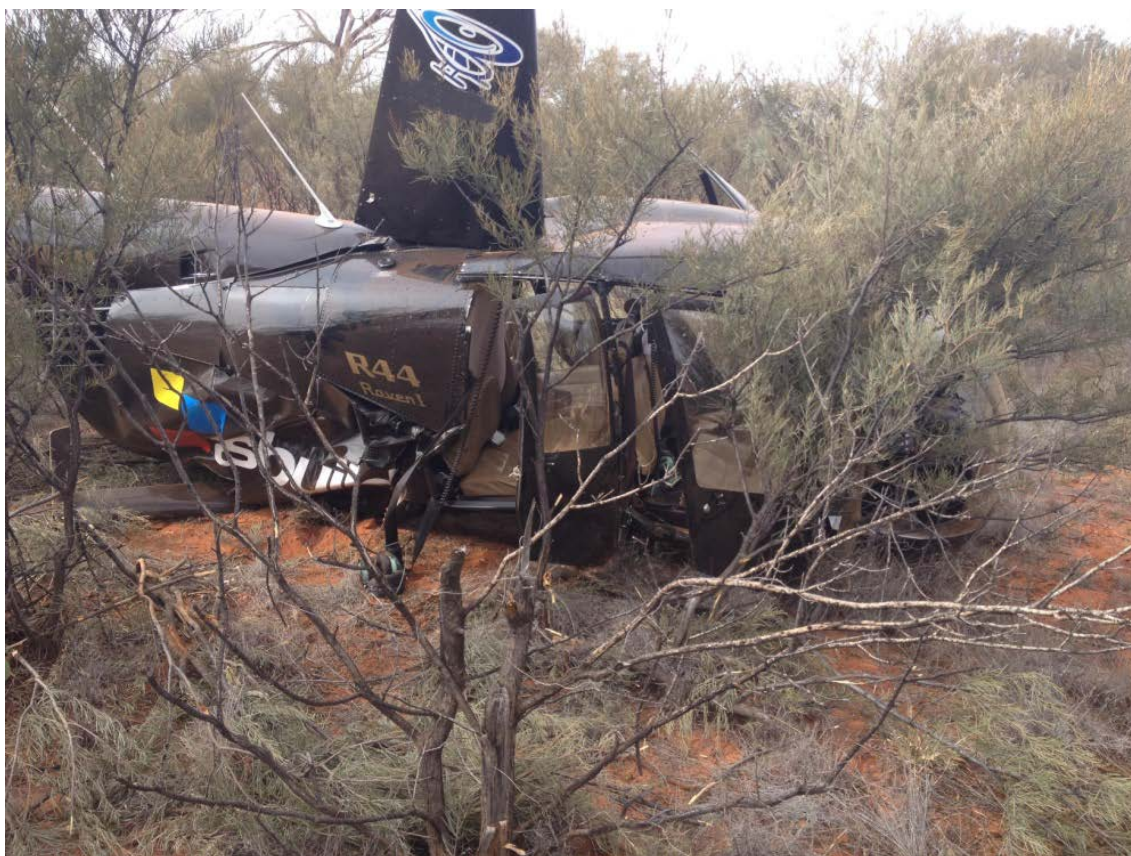
Collision with terrain, Robinson R44 Raven I helicopter (VH-HOU), near Maryvale, Northern Territory (ATSB investigation AO-2012-078)

- During a manoeuvre to slow down the helicopter by initiating a descent and flare, the Robinson R44 was seriously damaged when it lost power and collided with terrain near Maryvale, NT. On board the helicopter were a pilot and three passengers, one of whom was seriously injured as a result of the accident. The ATSB investigated this accident, and while a definitive cause for the engine power loss could not be identified, a review of the carburettor icing chart for the R44 revealed that the temperature / dew point spread at the time of the accident put the flight in the 'Serious Icing – Descent Power' operating realm (ATSB investigation AO-2012-078).

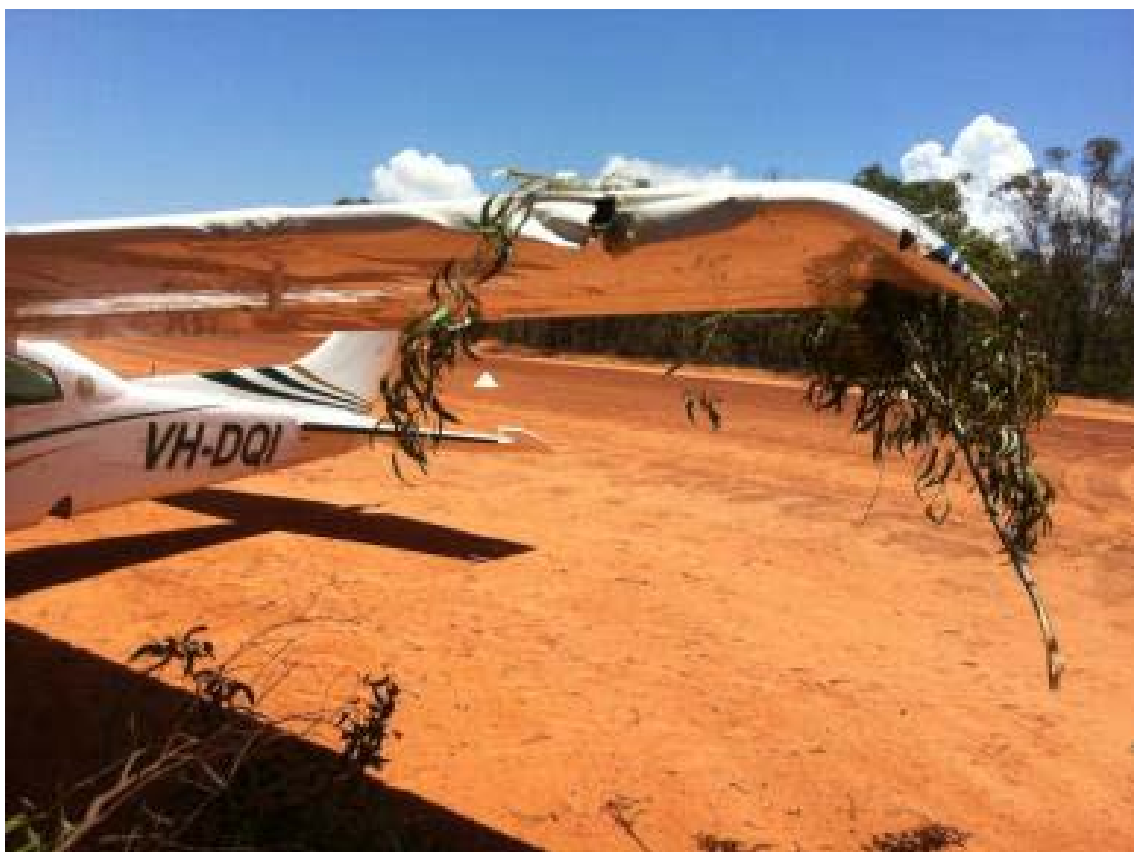
Runway excursion, Cessna T210 Centurion (VH-DQI), Cape Leveque, Western Australia (ATSB investigation AO-2013-001)

- Another Cessna 210 was departing from Cape Leveque, WA on the return leg of a scenic charter. On board were the pilot and five passengers. Early in the take-off run, the aircraft veered to the left, and the pilot applied right rudder. The pilot elected to continue the takeoff. At about 45 kts, the aircraft again veered to the left. With the aircraft about one metre off the centreline of the runway, the pilot attempted to re-align the aircraft, but it did not respond. The aircraft main wheels were now in contact with washed-out areas of ground on the edge of the runway. The aircraft's left wing clipped trees and the Cessna swung almost 90°, striking the right wing on the ground. The ATSB conducted an investigation into this accident, and the airport operator closed the airstrip the day after the accident to grade the runway surface and repair the washouts (ATSB investigation AO-2013-001).

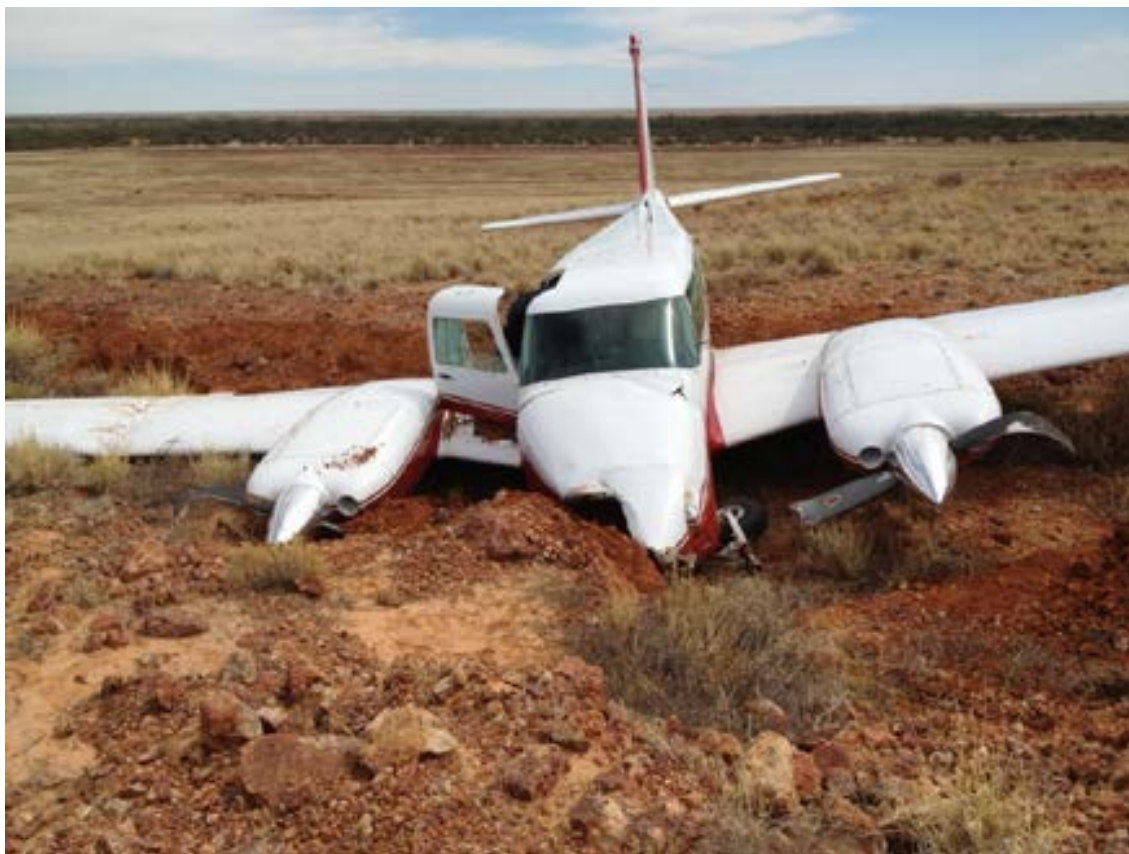
Runway excursion, Piper PA-39 Twin Comanche (VH-MMN), Innamincka Township authorised landing area, South Australia (ATSB investigation AO-2012-146)

The remainder of runway excursions were overruns (where the aircraft continued beyond the end of the runway), and were split evenly between aircraft on the landing roll and the takeoff roll. All were the result of a rejected take-off or, in the case of overruns on landing, braking performance; rather than a long or fast landing.
