Engine failure involving Airbus A320, VH-VFY

40 km NNW of Narrabri Airport, New South Wales, 22 September 2016

ATSB Transport Safety Report
Aviation Occurrence Investigation
AO-2016-123
Final – 27 April 2017

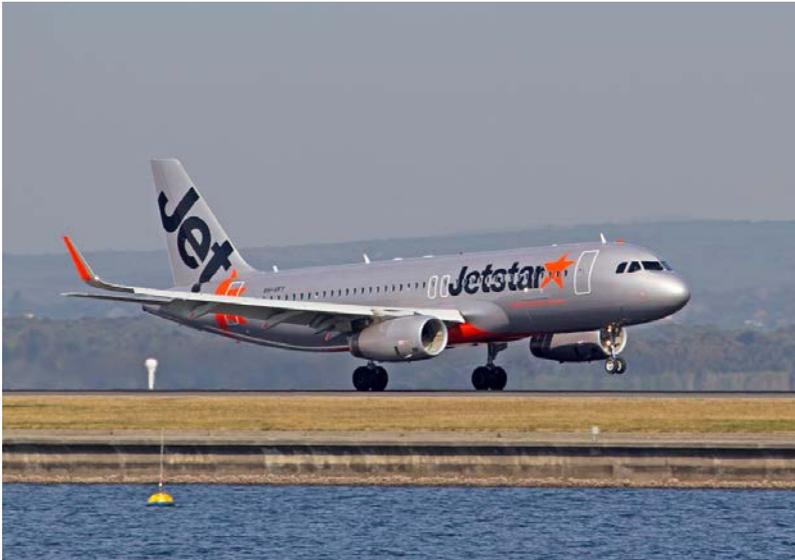
Figure 1: Airbus A320 VFY

On 22 September 2016, at 1608 Eastern Standard Time (EST), a Jetstar Airways Airbus A320-232 aircraft, registered VH-VFY (VFY) (Figure 1), operated a scheduled passenger flight, JQ956, from Sydney, New South Wales, to Cairns, Queensland (Qld).
