AVIATION RESEARCH INVESTIGATION REPORT
B2005/0085

Power loss related accidents involving twin-engine aircraft

June 2005

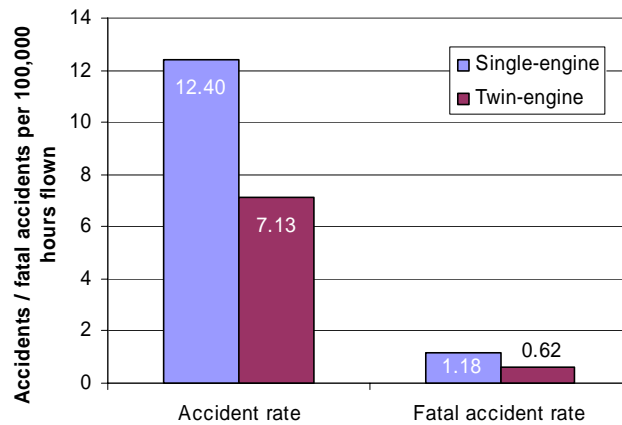
Figure 1: Accidents and fatal accidents per 100,000 hours flown, 1993 to 2002

The twin-engine accident rate is approximately 60 per cent of the single-engine accident rate and the twin-engine fatal accident rate is approximately 55 per cent of the single-engine fatal accident rate (Figure 1). Hence, twin-engine aircraft were just over half as likely to be involved in an accident or fatal accident compared with single-engine aircraft per hour flown. The rate is probably better per distance flown because twin-engine aircraft generally fly faster than single-engine aircraft.

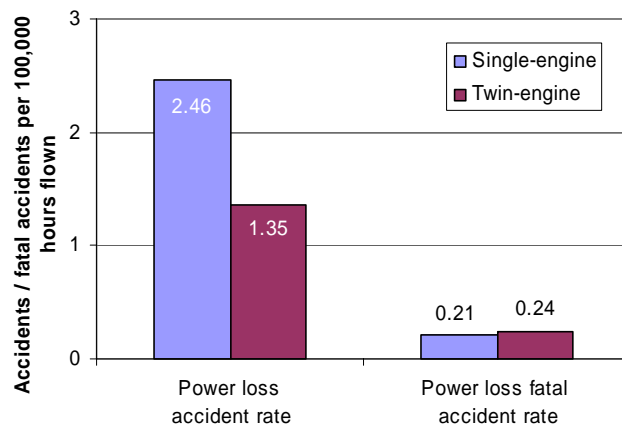
Figure 2: Power loss accidents and fatal accidents per 100,000 hours flown, 1993 to 2002

The rate at which power loss accidents involving twin-engine aircraft occurred was about 60 per cent of the single-engine rate: this is similar to the ratio for all accidents. However, when considering only fatal accidents subsequent to a power loss, the accident rate for twin-engine aircraft was approximately the same as that for single-engine aircraft (0.24 and 0.21 respectively). Hence, while a twin-engine aircraft was just over half as likely to be involved in an accident when a loss of power has occurred compared with a single-engine aircraft per hour flown, both twin- and single-engine aircraft were about equally likely to be involved in a fatal accident after a power loss per hour flown.

In addition, eighteen per cent of single-engine fatal accidents involved a power loss, while the proportion more than doubled to 38 per cent for twin-engine aircraft.

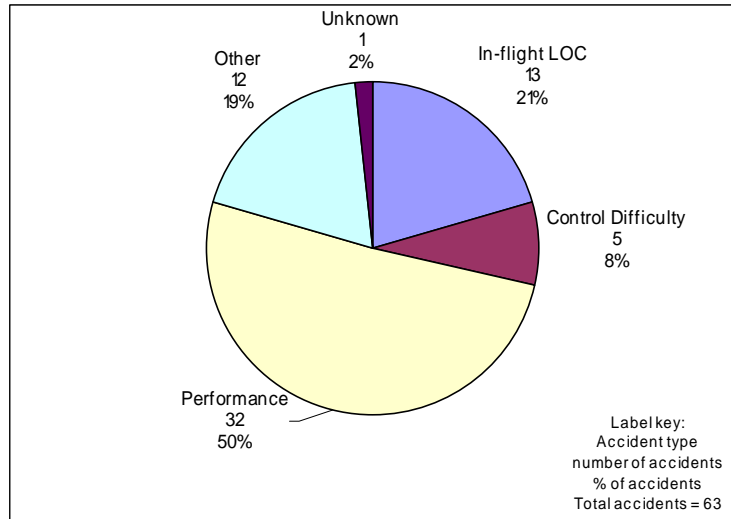
Figure 3: Types of accidents involving power loss (all accidents)

Classification of all the twin-engine power loss accidents, using the categories defined in section 6.1, is shown in Figure 3.

Twin-engine aircraft power loss accidents are most likely to happen due to the reduced performance of the aircraft (50 per cent). Accidents in this group include those where the aircraft's performance was degraded by the loss of power itself and cases where the aircraft was not configured for optimal performance for the power available (including complete loss of power). As a result, the aircraft's capacity to climb or maintain altitude was the principal factor contributing to the development of the accident.

In-flight loss of control was the next biggest category. Twenty-one per cent of twin-engine aircraft accidents involving a power loss resulted in a loss of control in-flight.

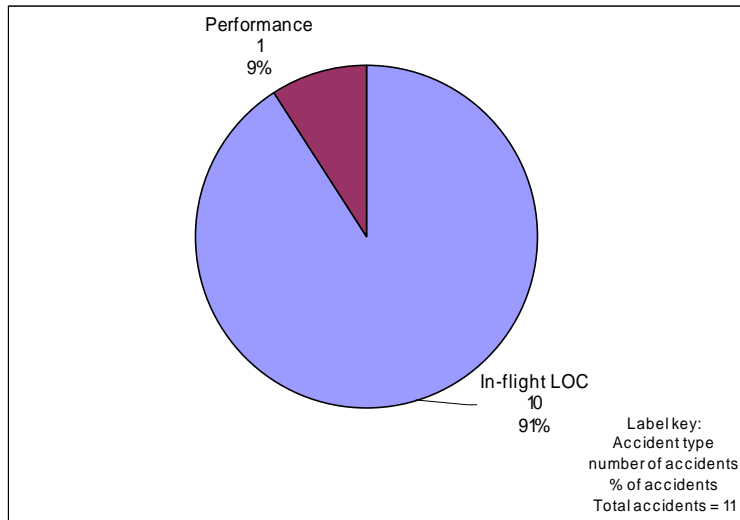
Figure 4: Types of fatal powerloss accidents

Ten of the 11 twin-engine aircraft fatal powerloss accidents involved an in-flight loss of control. The other fatal accident occurred when an aircraft was ditched at sea at night following a dependent double engine failure (the failure of the first engine and the subsequent aircraft management affected the probability of the second engine's failure). There were no fatal accidents in the other accident classification groups.

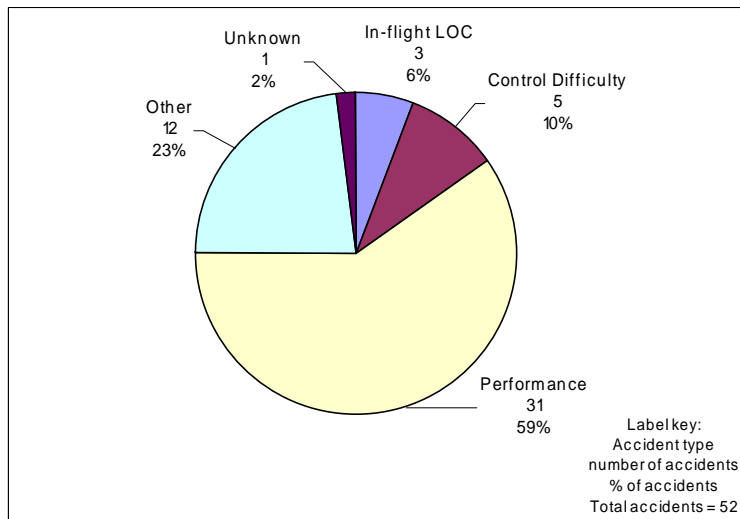
Figure 5: Types of non-fatal power loss accidents

In contrast to the fatal accidents, the majority of the non-fatal accidents (59 per cent) were primarily the result of degraded aircraft performance. In-flight loss of control and those accidents where control was a significant problem (*Control Difficulty*) accounted for six per cent and 10 per cent of non-fatal accidents respectively. Accidents not related to control or performance issues (i.e. those categorised as *Other*) accounted for 23 per cent of non-fatal accidents. One accident could not be classified.

This categorisation shows a disproportionately high risk of a twin-engine aircraft power loss accident associated with in-flight loss of control being fatal.
