Emerging trends in Australian aviation safety

January – June 2014

ATSB Transport Safety Report

AR-2014-127

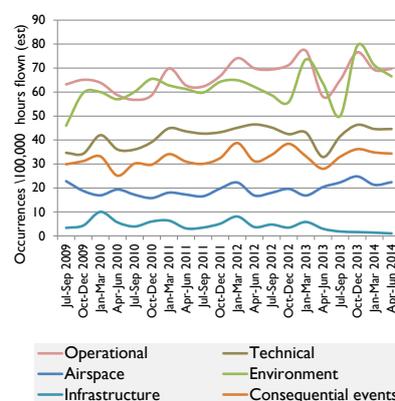
Safety occurrence reporting across all types of Australian aviation – last 5 years

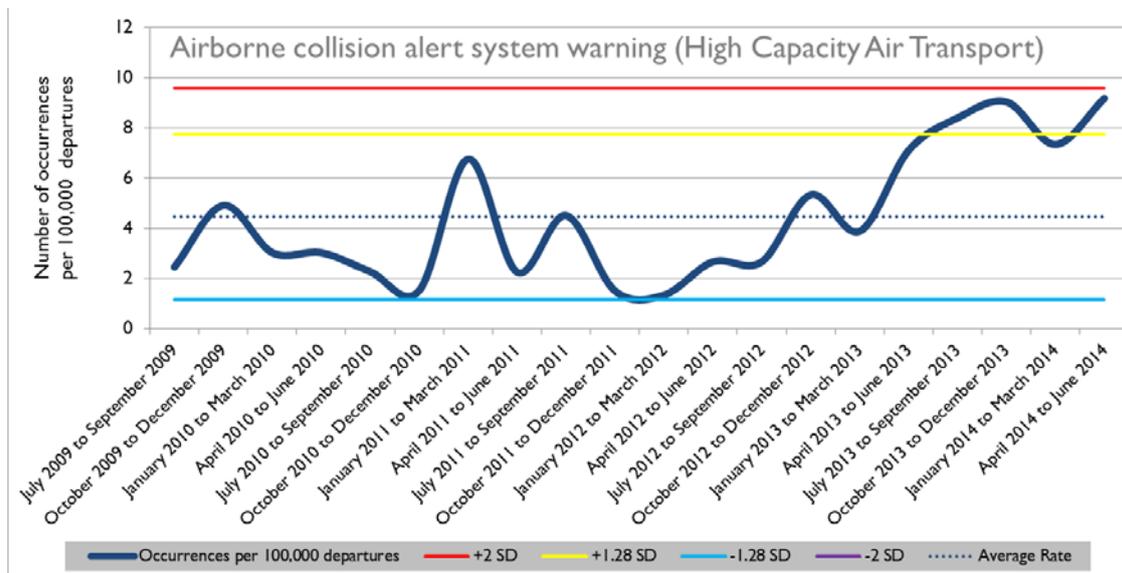
Airborne collision alert warnings – High capacity air transport

The rate of *Airborne collision alert system warnings* reported in high capacity air transport operations has been significantly above average in the last few quarters, and showed a slight increase in Apr-Jun 2014.

The most common location for these occurrences was Sydney, with TCAS-RA alerts on approach to that airport making up 12 of the 28 occurrences in the last 6 months. All of those occurrences happened during independent visual approaches (IVAs). The majority of occurrences involving an IVA involved runway 34L/R approaches (only two occurred on runway 16L/R approaches). Further investigation by the ATSB has found that IVAs at Sydney Airport have contributed to most of the rise seen in this type of occurrence over the last 2 years.

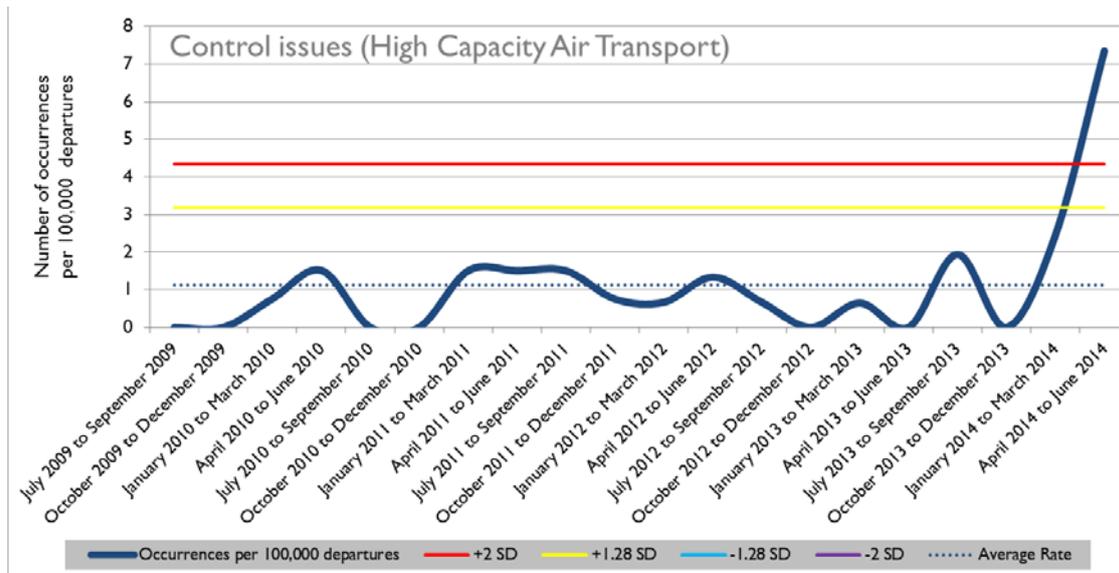
Control issues – High capacity air transport

Control issues involving high capacity air transport aircraft are a low frequency occurrence type, but there was a significant increase in occurrences in January to June 2014.

A large proportion of these occurrences were reported by one airline (10 of 16 occurrences), and the Fokker 100 was overrepresented when considering the fleet size and activity (5 occurrences).

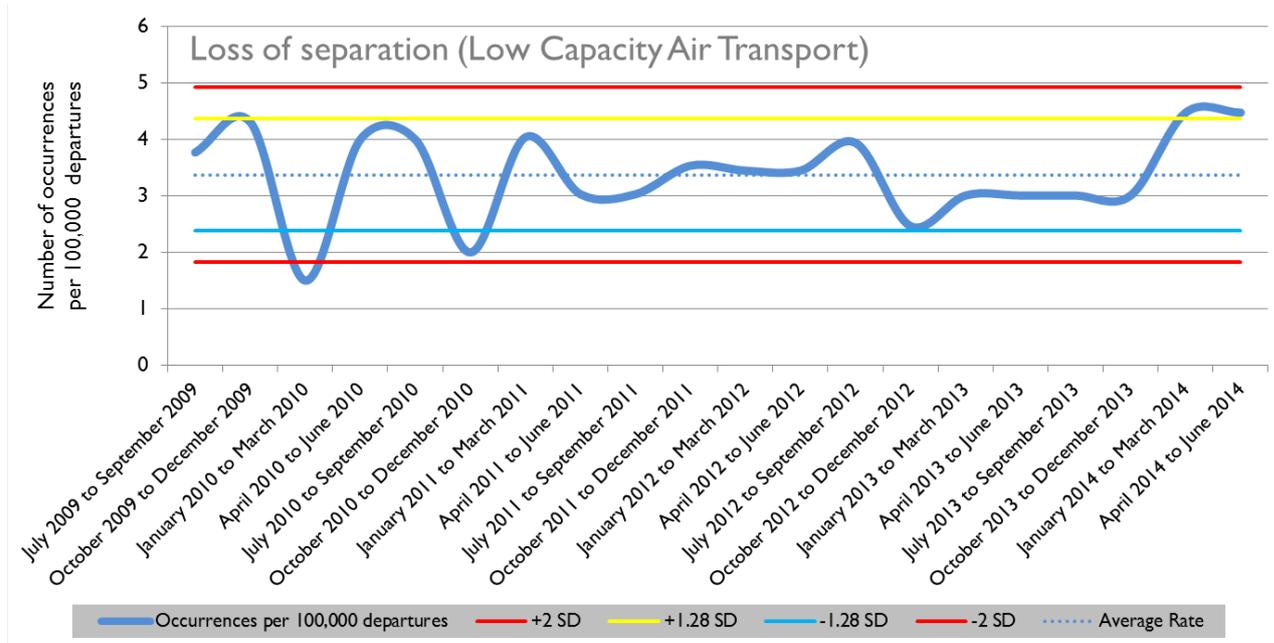
Loss of separation – Low capacity air transport

The rate of Loss of separation (LOS) occurrences involving low capacity RPT and charter aircraft was above average across the January to June 2014 period. Most of the 18 occurrences over the last 6 months were low risk occurrences, although there was one high risk LOS which involved a Cessna 206 and a military Boeing 737 in close proximity near Darwin Airport. Air traffic control was most often alerted to the LOS by a Short Term Conflict Alert (STCA), or there was no alert. Occurrences while aircraft were under radar control (10 of 18 occurrences) were most common.

No particular operators or aircraft types stood out. Darwin/Northern Territory (NT) were the most common locations for occurrences in the 6 months (three occurrences close to Darwin, four occurrences elsewhere in northern NT).

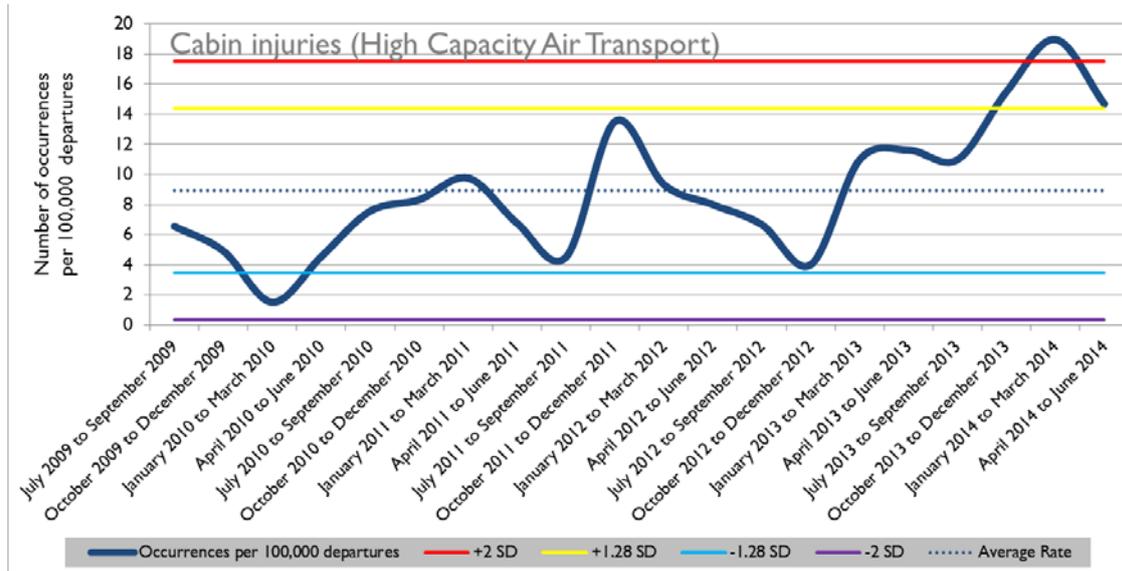
The rate of *Cabin injury* occurrences in high capacity air transport spiked in the January to April 2014 quarter, but has since been decreasing.

Almost all reported *Cabin injuries* (95 per cent) involved injuries to cabin crew, particularly on domestically-operated aircraft types. Minor bruises and sprains were the most common types of injury. Most involved some sort of turbulence or aircraft disturbance, with 22 per cent occurring in severe turbulence.
