# Loading related event involving Airbus A320, VH-VGI

Melbourne Airport, Victoria, 21 December 2016

**ATSB Transport Safety Report**  
Aviation Occurrence Investigation  
AO-2016-177  
Final – 27 April 2017

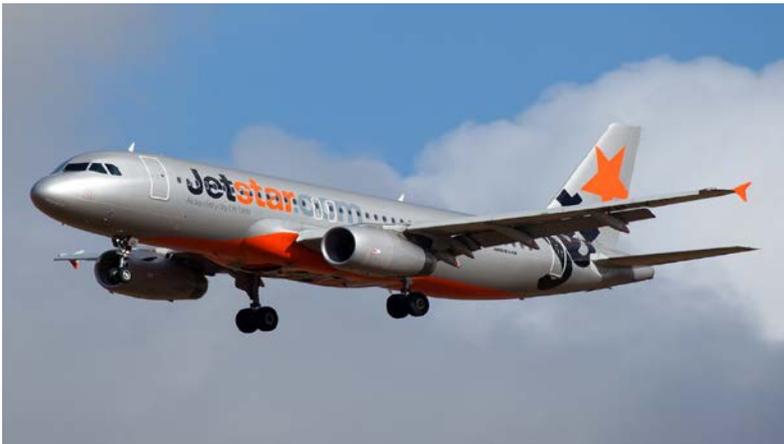
**Figure 1: Image of VH-VGI**

On 21 December 2016, an Airbus A320 aircraft, registered VH-VGI (VGI), and operated by Jetstar Airways, was being loaded at Melbourne Airport, Victoria, prior to operating flight JQ792 to Sunshine Coast, Queensland (Figure 1).
