# Collision with terrain involving Robinson Helicopter R22 Beta, VH-PSC

29 km south-east of Limbunya Station, Northern Territory, on 27 June 2023

**ATSB Transport Safety Report**  
Aviation Occurrence Investigation  
AO-2023-031  
Preliminary 31 August 2023

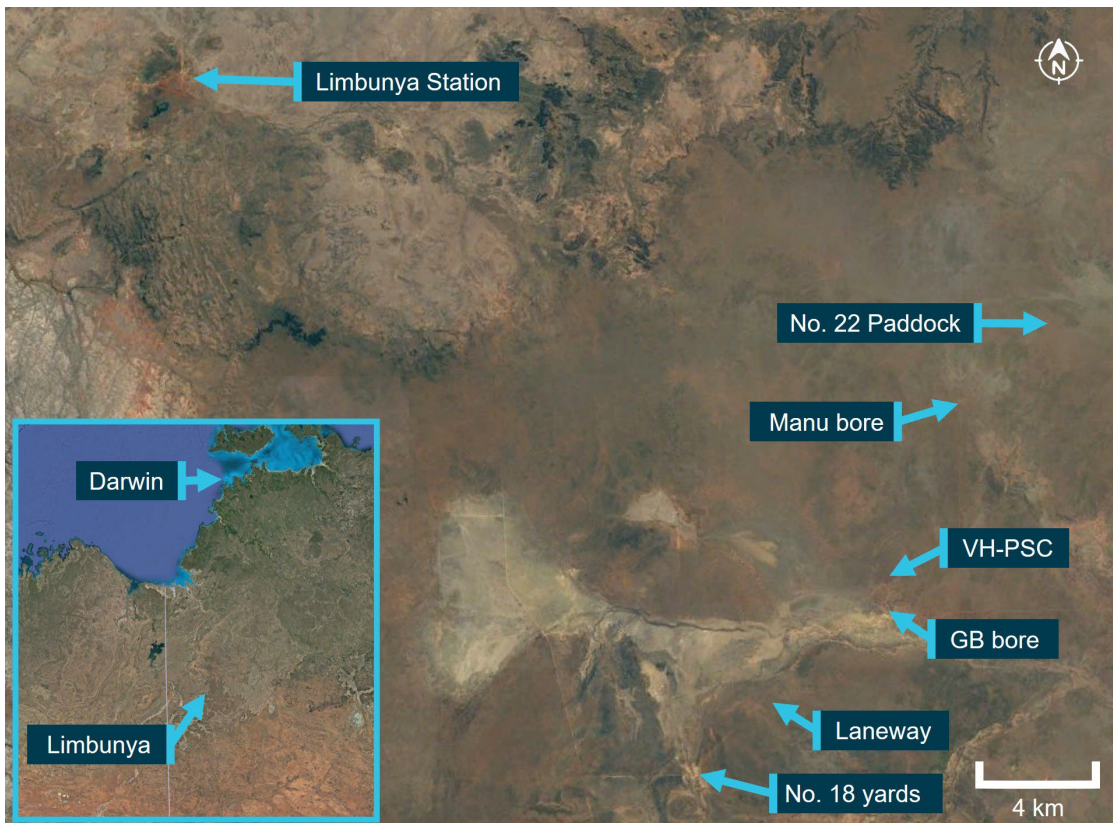
**Figure 1: Limbunya Station and operational area**

Source: Google Earth, annotated by the ATSB

On 27 June 2023, at about 0700 local time, the pilot of a Robinson Helicopter R22 Beta, registered VH-PSC (PSC), departed Limbunya Station, Northern Territory, in company with a second R22 registered VH-RCS (RCS). Their task was to muster stock in a small paddock to the north of GB bore, about 29 km to the south-east of the station homestead. In addition, they were to assist the ground mustering party to move stock that had been mustered from ‘No. 22’ paddock into the GB bore holding yards the previous day, to the ‘No. 18’ yards (Figure 1).

The helicopters arrived at the northern end of the paddock at about 0730 and began pushing cattle south towards the GB bore holding yards. The pilot of PSC then supported the ground mustering party in moving stock from the yards into a fenced laneway. The laneway would guide the stock to the No. 18 holding yards, that were located about 8 km to the south-west.
