# *FlightSafety*

January–February 2014

**The floating world** | Ballooning and safety

**Blind faith** | EFBs and plan Bs

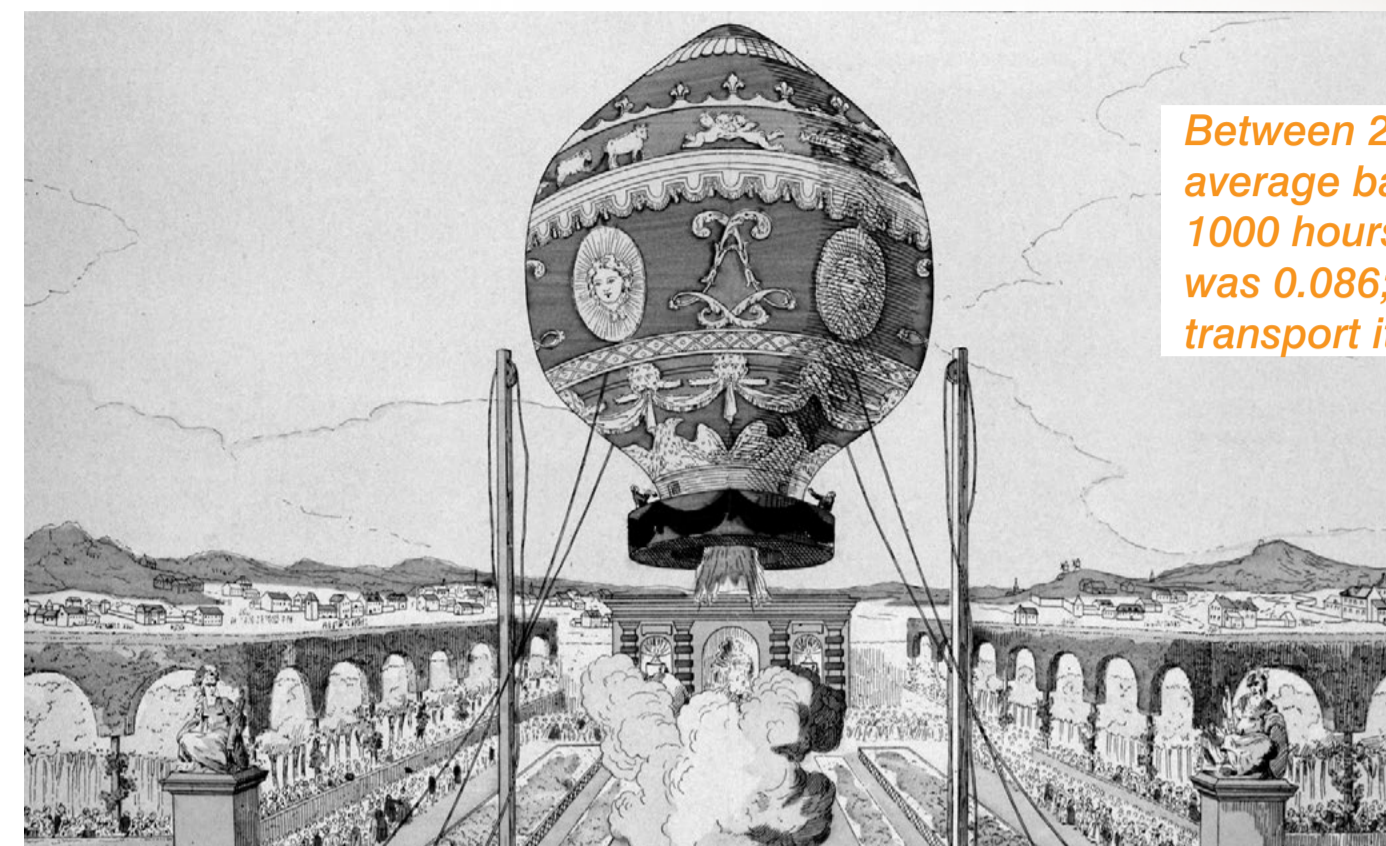
A Montgolfier balloon makes a tethered ascent circa 1783

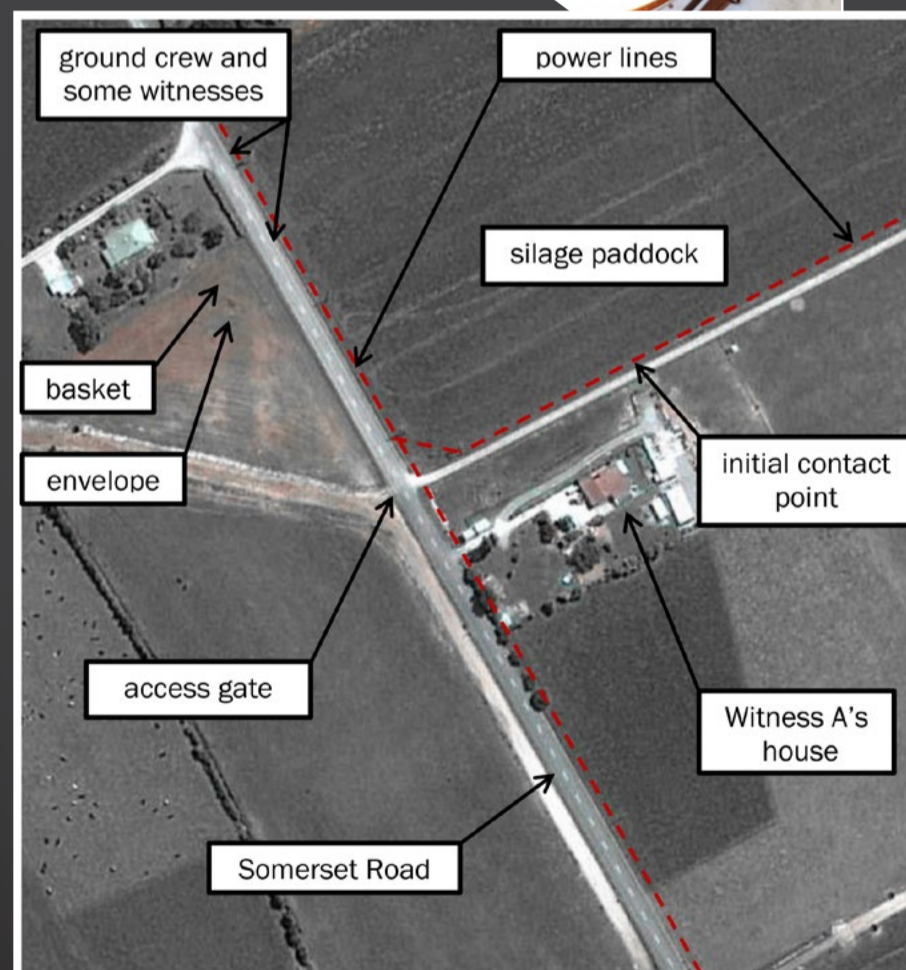
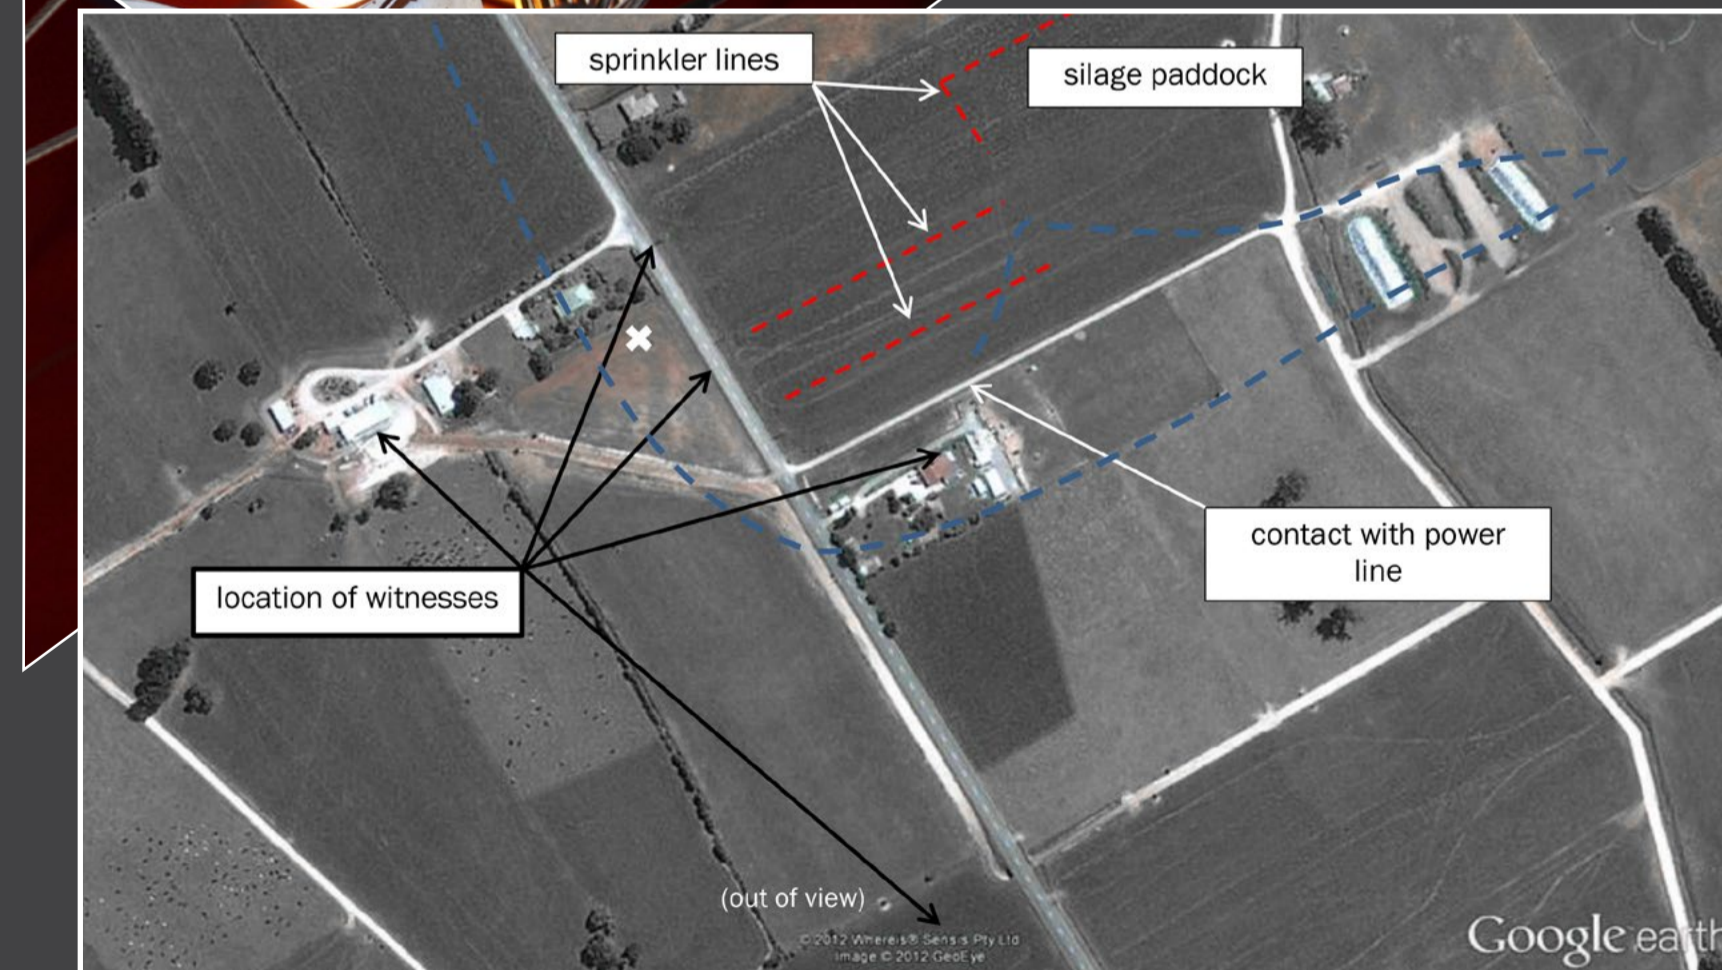
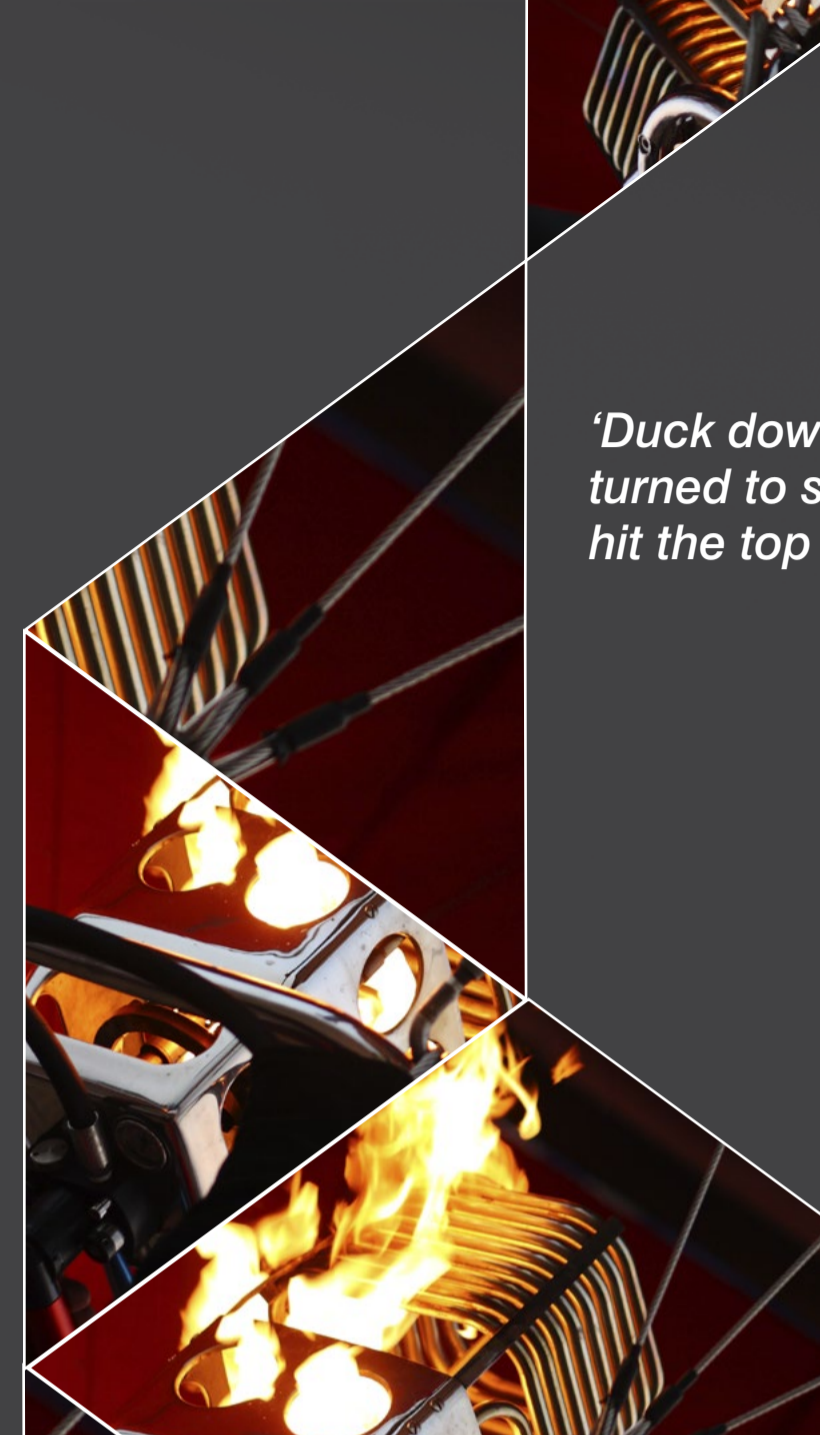
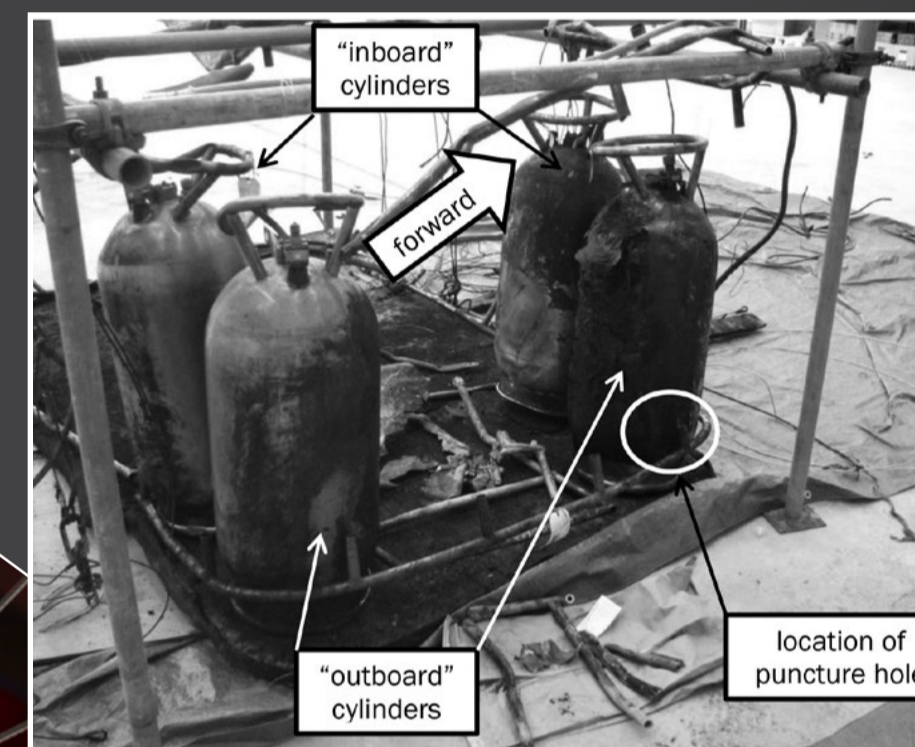
Photos: Transport Accident Commission final report – inquiry 12-001, 7 January 2012

The balloon was drifting west towards the power lines on the western boundary of the paddock when the wind changed, taking it towards power lines closer to the southern boundary. The pilot applied the burners to climb the balloon over the power lines.

As the balloon's ground crew chief was walking to his vehicle, he heard the pilot yell out, 'Duck down'. The crew chief turned to see the balloon basket hit the top power line.

*'Duck down'. The crew chief turned to see the balloon basket hit the top power line.*

A woman in a nearby house saw the balloon approaching the power lines and heard the burners roaring. She ran outside in time to see the basket caught under one of the wires, with people on board trying to push the top wire off the lip of the basket.

Between 15 and 30 seconds later, according to the time stamp on the camera, there was an intense electrical arc and fire broke out in the lower part of the basket. One of the power lines then snapped. The official investigation concluded the arcing had ruptured one of the balloon's liquid petroleum gas (LPG) fuel cylinders, and fuel, escaping at about 100psi, intensified the fire.

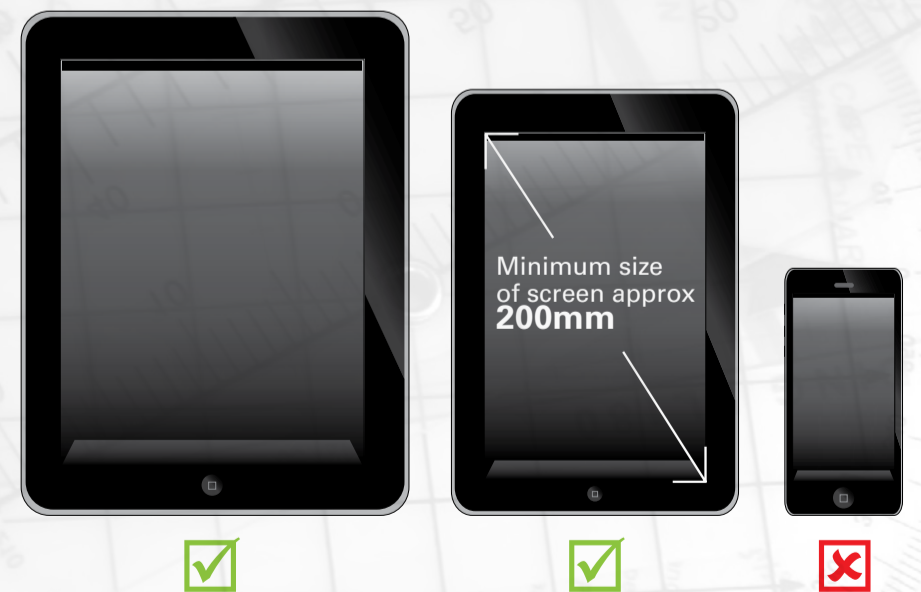
7.2.1 The screen size and resolution will need to demonstrate the ability to display information in a manner comparable to the paper aeronautical charts and data it is intended to replace. The recommended minimum size of the screen is 200mm measured diagonally across the active viewing area. If the intent of the installation is to display charts and maps, the device should be suitably sized to display the image without excessive scrolling.

Note: Some manufacturers’ screen sizes may vary marginally from this minimum but may still be acceptable

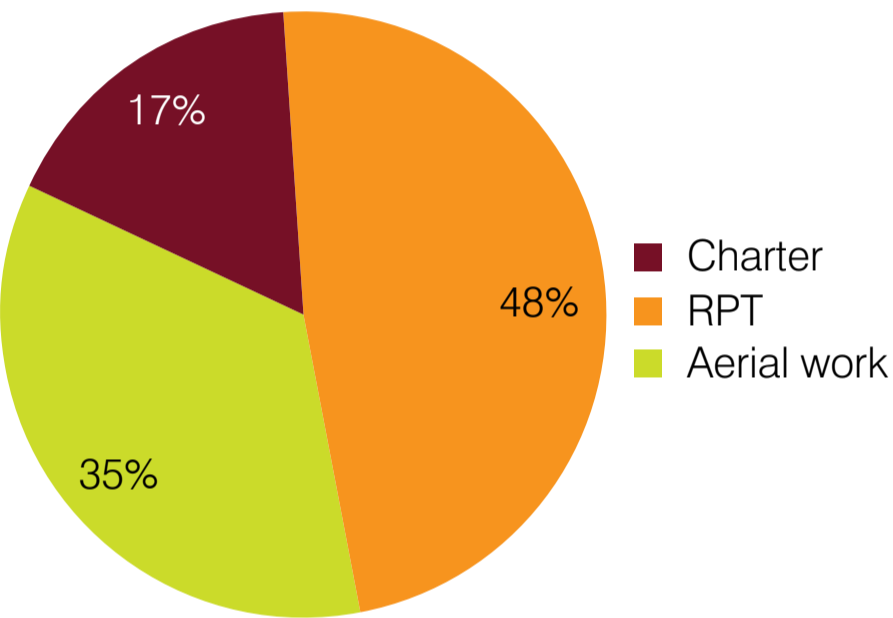
### Hours flown by sector

There RPT sector accounted for nearly half of the flying hours conducted across all industry sectors in 2012. This was followed by aerial work and charter. All three sectors reported an increase in flying activity compared to the 2011 calendar year.

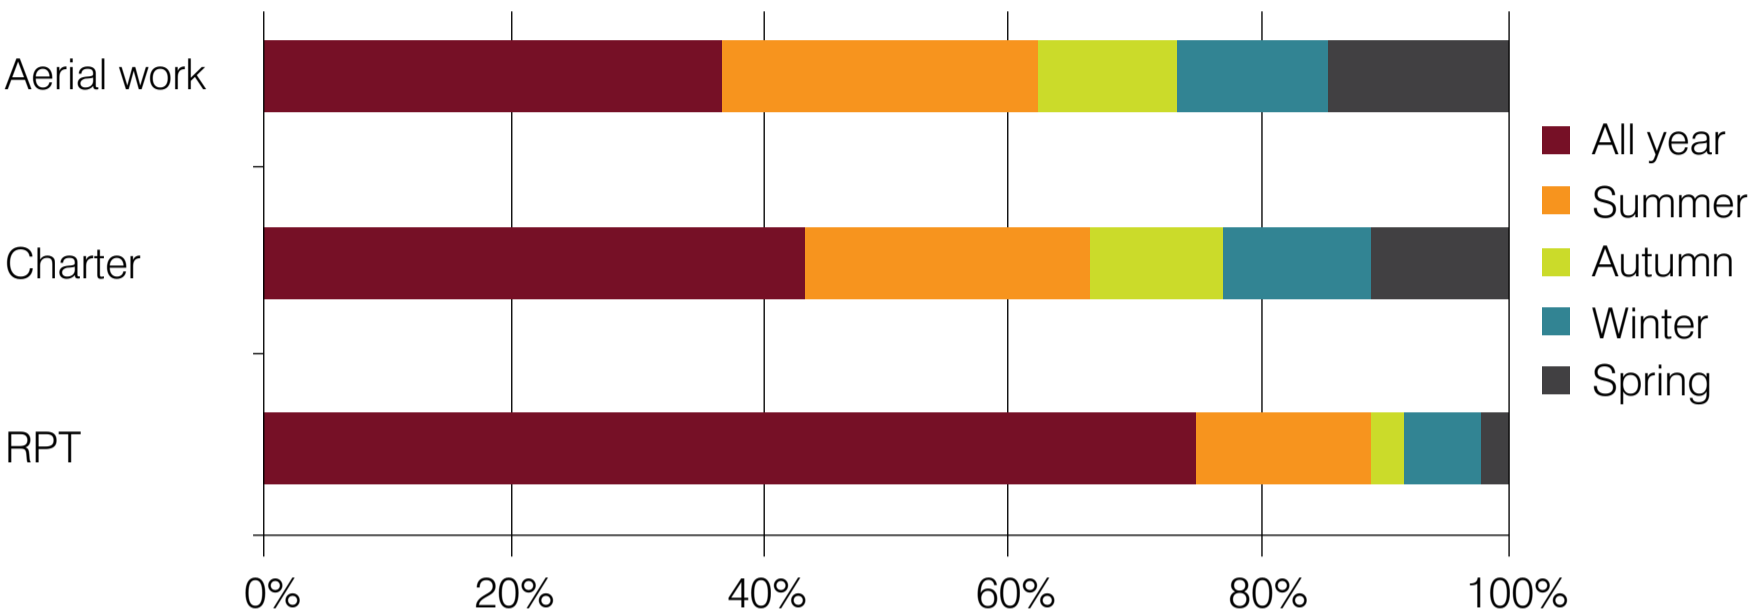
### Peak season for RPT, charter, and aerial work

Three-quarters of RPT operators reported having no peak season with constant operations year round. Summer was the peak season for five operators (14%), with winter being the peak season for two (6%).

Aerial work followed a similar pattern to charter operators with some slight differences. Over one-third (37%) reported year-round operations, followed by summer (26%), spring (15%), winter (12%) and autumn (11%).

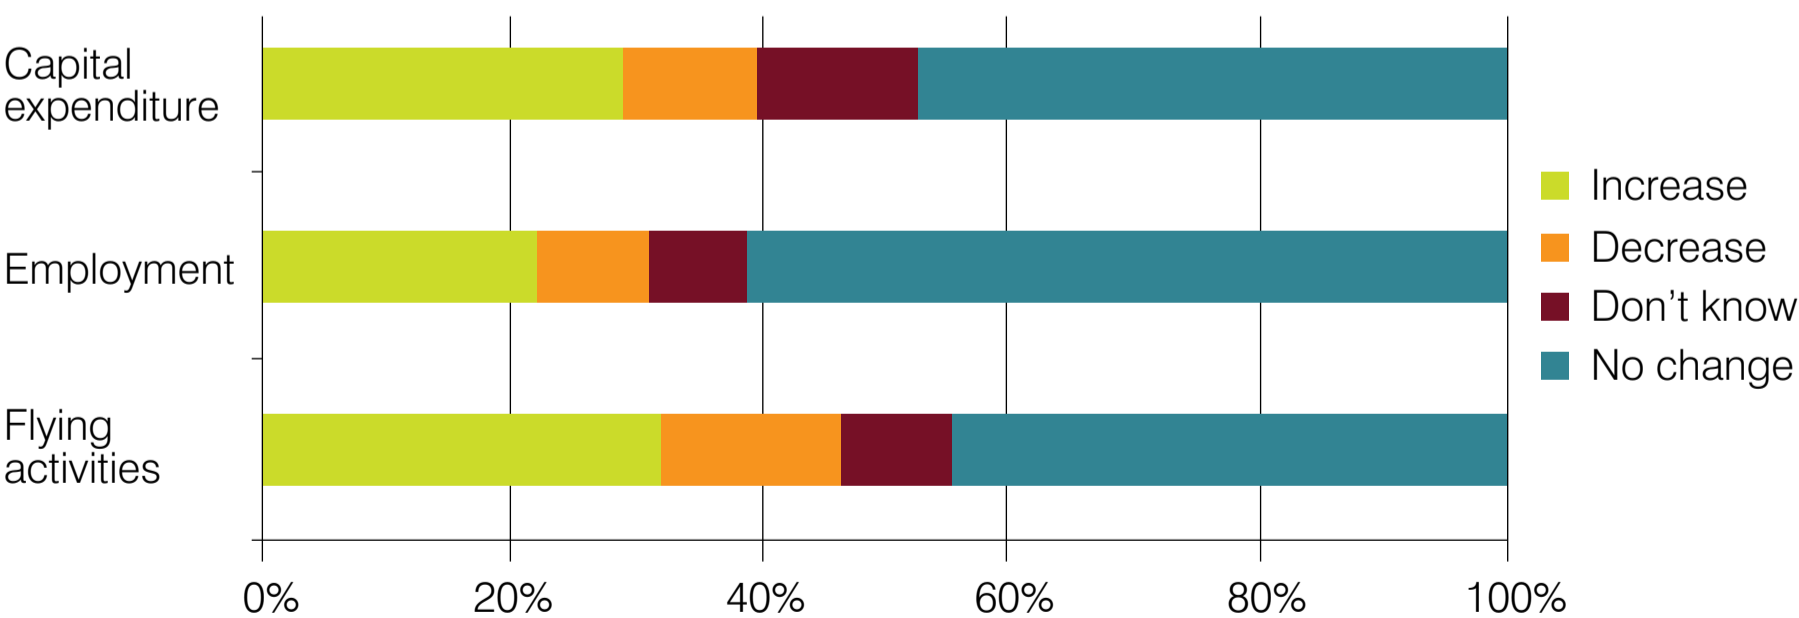
### Organisational expectations for the 2013 calendar year

Operators reported having a stable or optimistic attitude towards capital expenditure, employment and flying activities in 2013. The majority of AOC holders indicated that they expected no change to their employment level. From the three categories, flying activities contained the most operators expecting an increase in activity. This is consistent with the increase in passenger numbers and hours flown reported over the past two years.

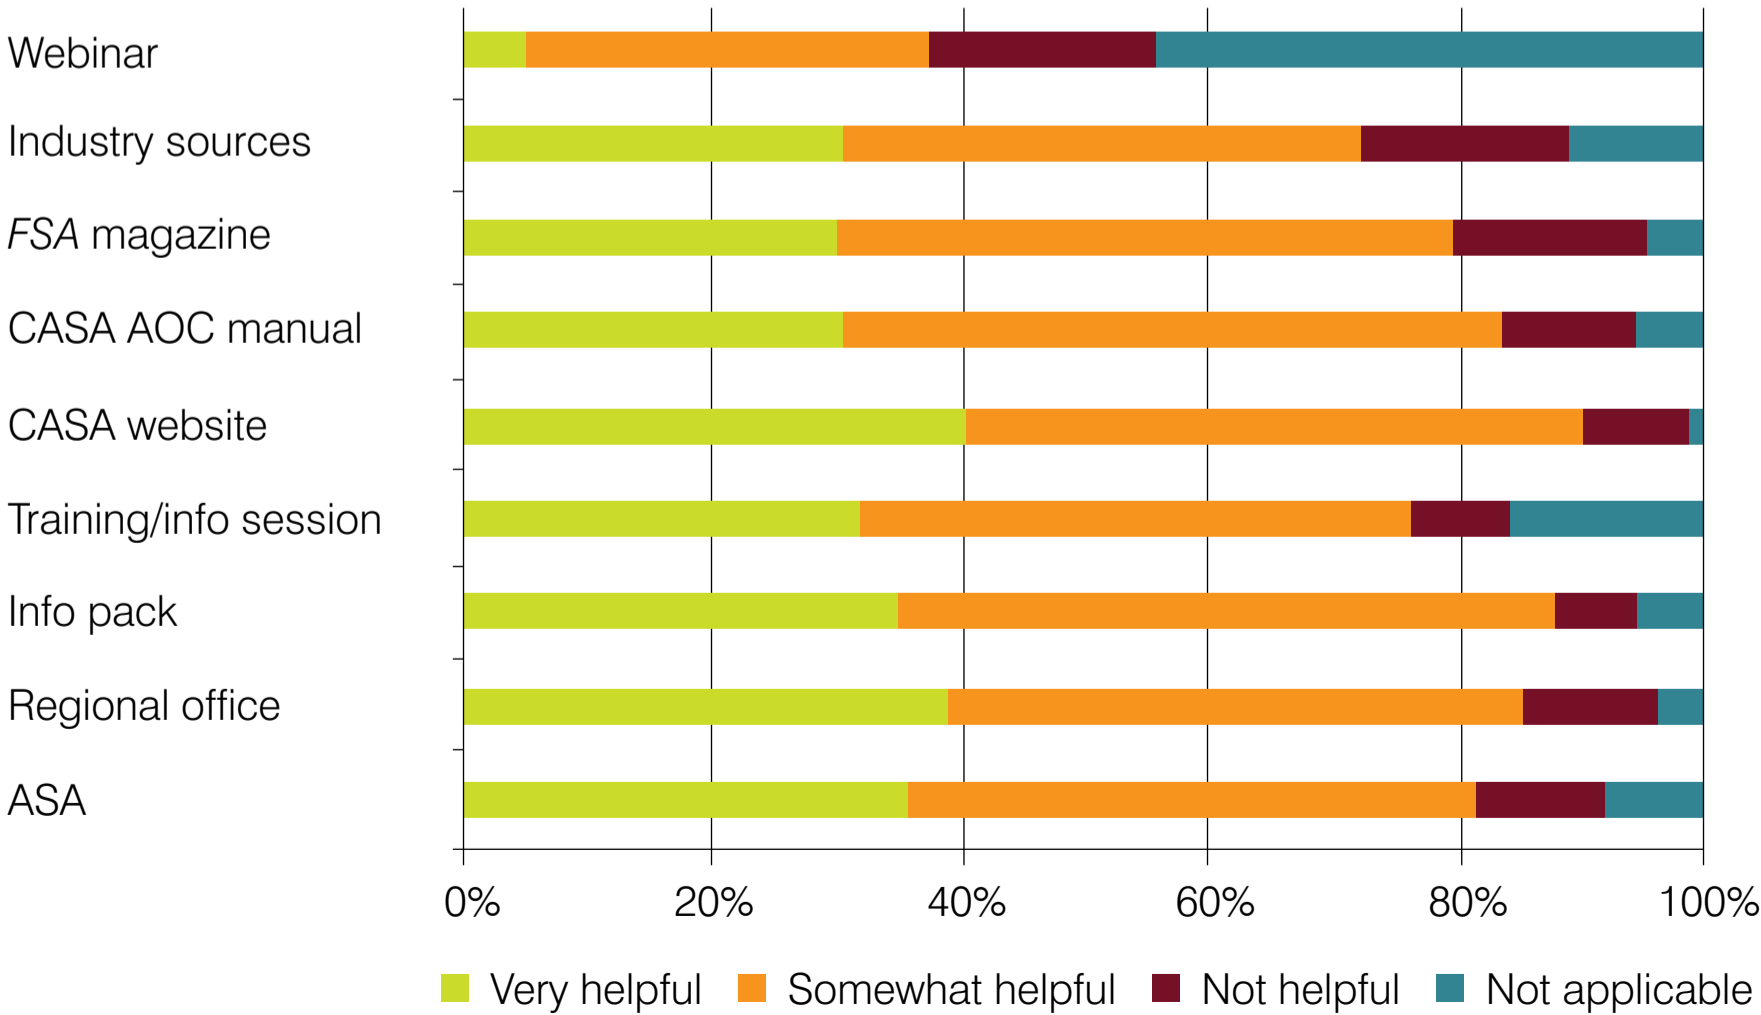
Helpfulness of information from various sources

The CASA website was rated as the most useful place to get information with around 40 per cent rating it as very helpful and a further 50 per cent rating it as somewhat helpful. Only 9 per cent rated the website as not helpful.

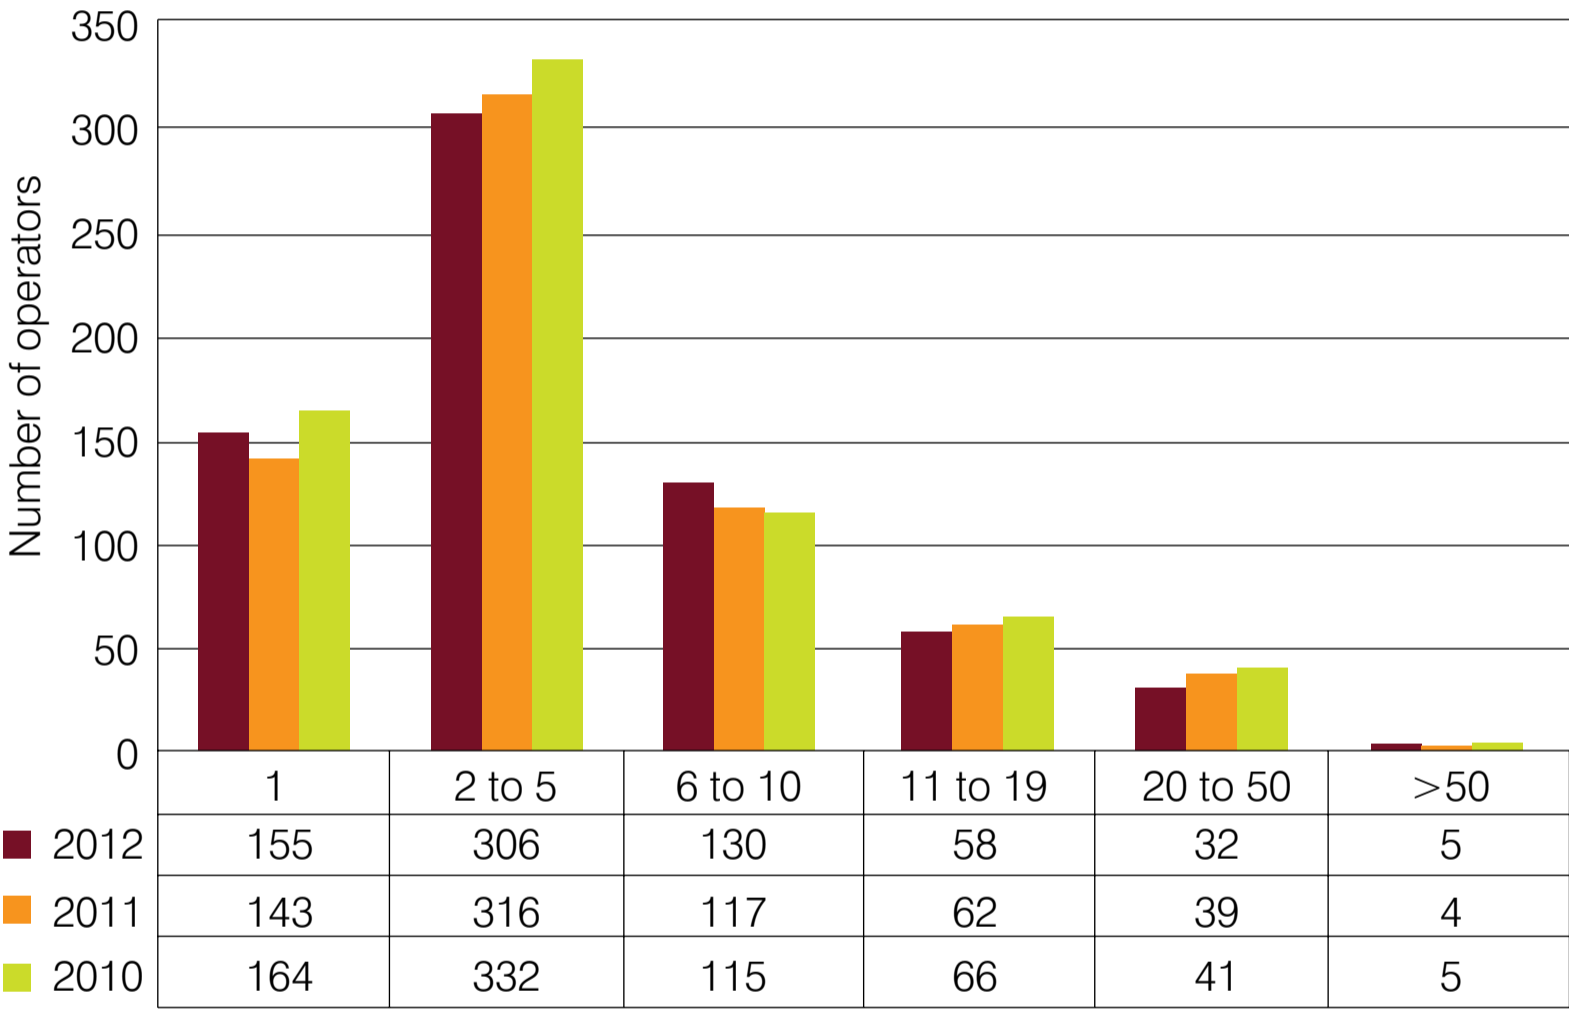
Annual AHSQ comparison of aircraft used by AOC holders

AOC holders reported that they operated 4,376 aircraft during the 2012 calendar year, which accounts for around one-third of the more than 15,000 aircraft on the Australian register. This is consistent with previous surveys. Operators also reported using 46 foreign registered aircraft (1.1% of the total used) during 2012.

The majority of AOC holders operate with two to five aircraft. There is also a large portion of operators using a single aircraft. However, the majority of flying hours come from the operators who manage more than 50 aircraft.

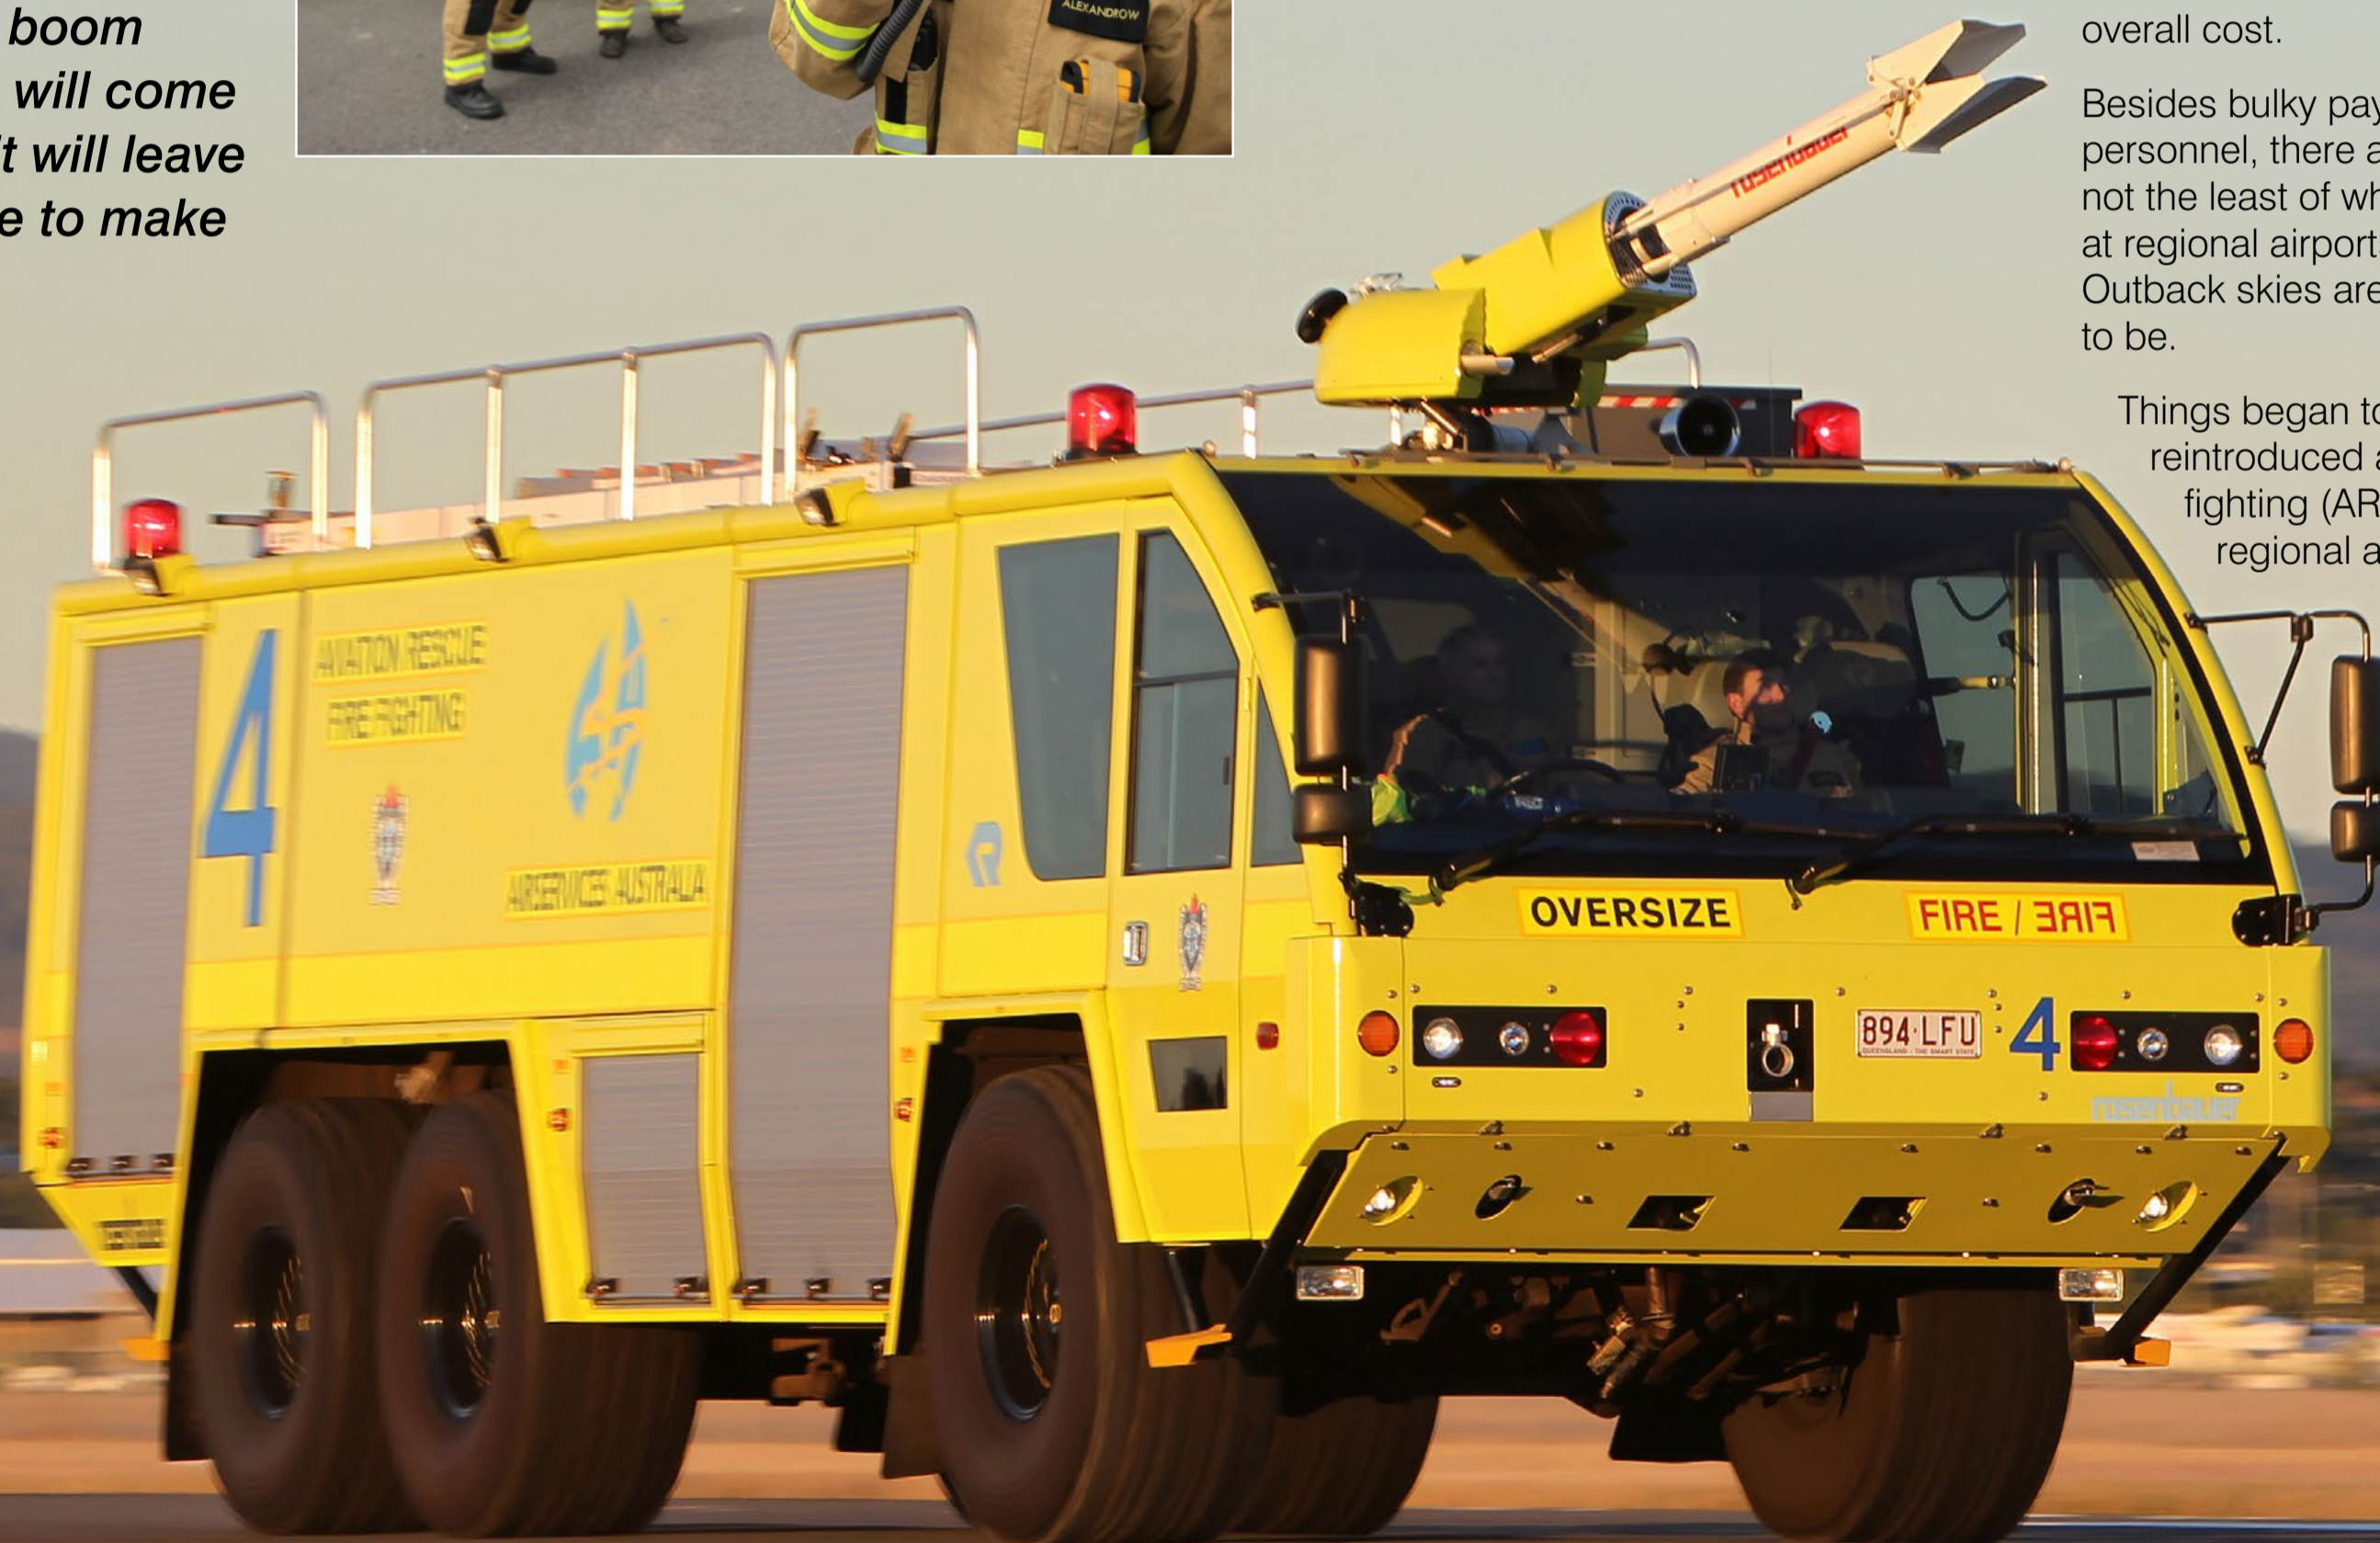
Things began to ramp up back in 2009, when Airservices reintroduced an operational aviation rescue and fire fighting (ARFF) service at Karratha, then the busiest regional airport in WA. Monitoring all regularly scheduled passenger aircraft arrivals and departures seven days a week, the on-duty fire crew staffs a Fire Control Centre and three Rosenbauer

MK 8 ULFVs (ultra-large fire vehicles); Austrian-assembled state-of-the-art tenders over 10 metres long, weighing in at 30 tonnes, but still capable of a top speed of 120km/h thanks to a 14.0 litre Detroit Diesel engine pushing out 495kW of power and 2576Nm of torque, allowing response to incidents within two minutes.

Fully equipped with fire-fighting agent, these behemoths can empty their 9000-litre water and foam-filled tanks in less than two minutes via a roof-mounted monitor capable of throwing the contents a distance of more than 80 metres.

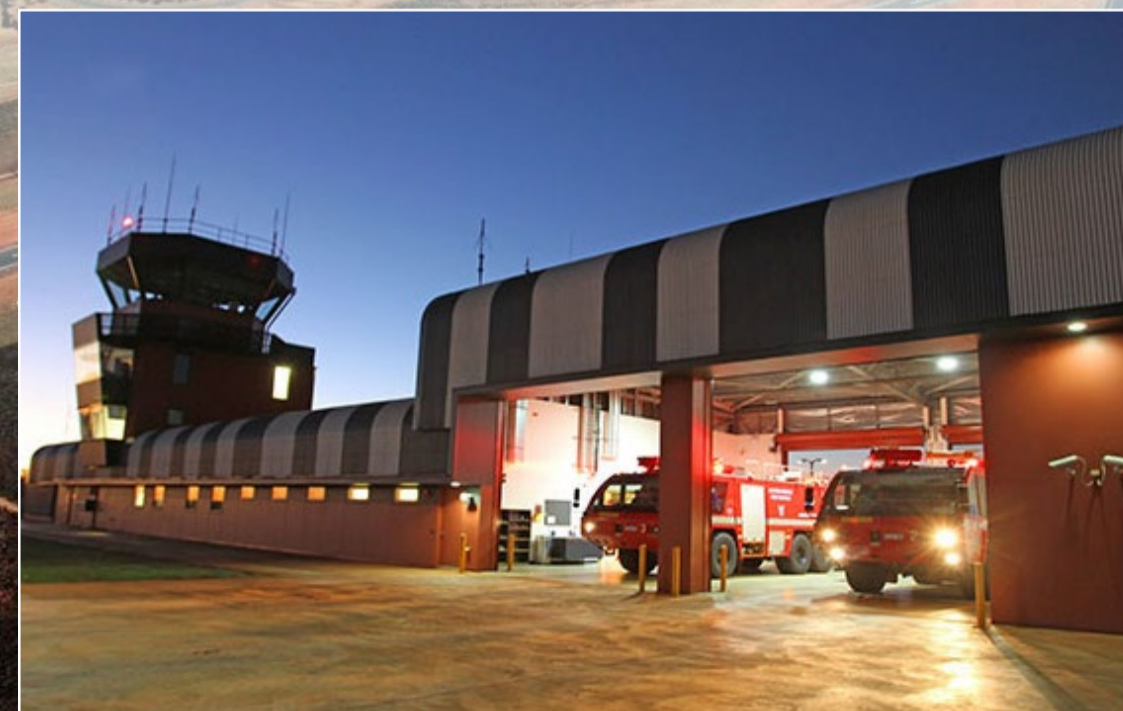
Photo: Broome air traffic control tower and aviation rescue fire station

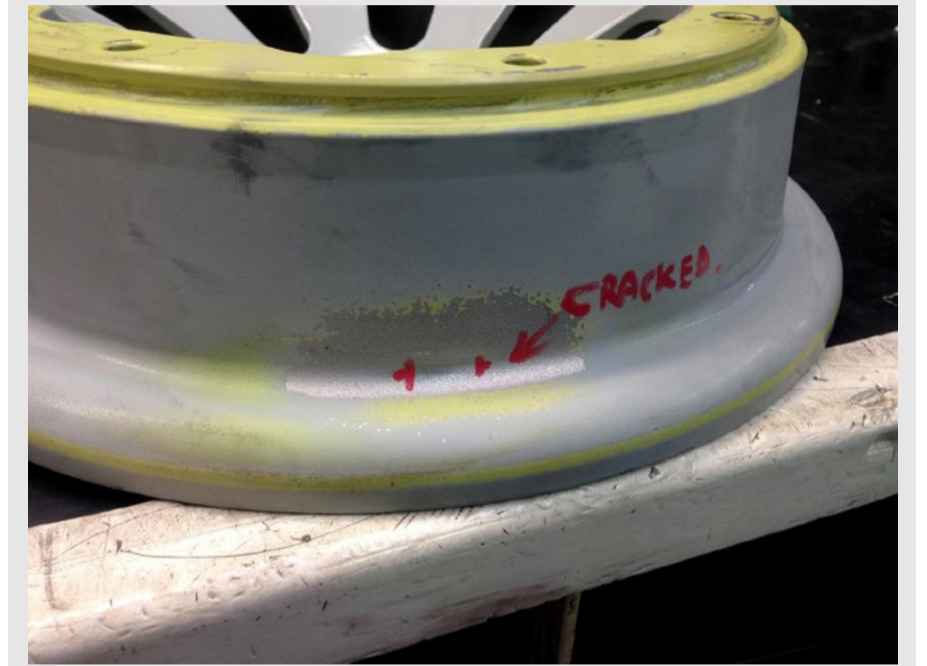
**Bombardier DHC8-102 Wheel hub cracked. SDR 510017704**

During eddy current inspection for a tyre change a 15mm long crack was found in the bead seat of the inboard hub half. This was most likely caused by metal fatigue. P/No: 300654

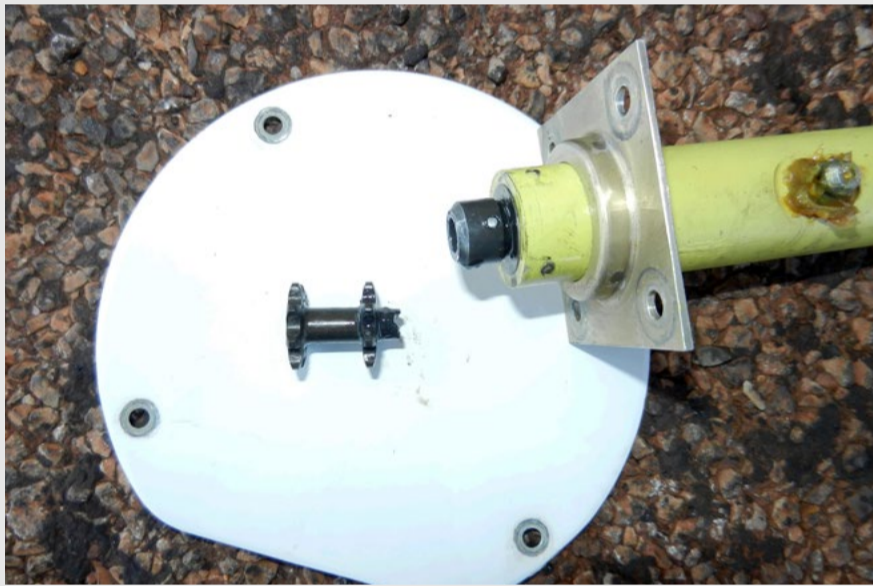
**Cessna 206H Elevator tab control system sprocket sheared. SDR 510017635**

Elevator trim tab actuator drive sprocket failed. P/No: 12601131. TSN: 686 hours/215 cycles/215 landings/6 months

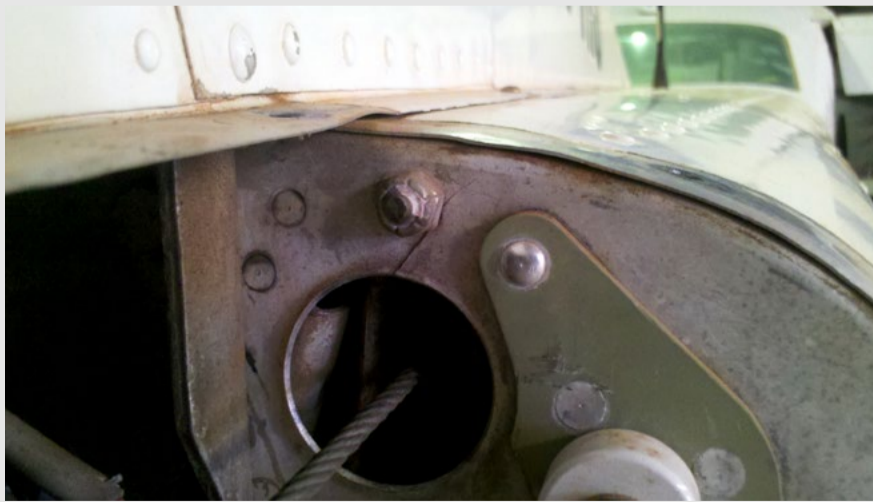
**Cessna 210L Fuselage bulkhead cracked. SDR 510017781**

During routine inspection tail cone bulkhead found to be cracked. P/No: 1212131-5. TSN: 9199 hours

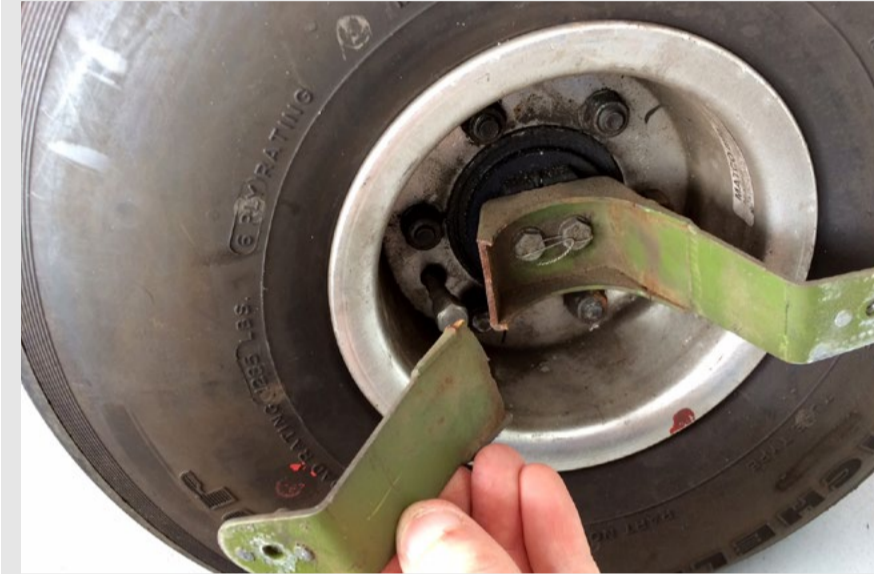
**Czech Aircraft Works PiperSport Landing gear/wheel fairing bracket failed. SDR 510017756**

Wheel spat mounting brackets found cracked during inspection. TSN: 350 hours/1024 cycles

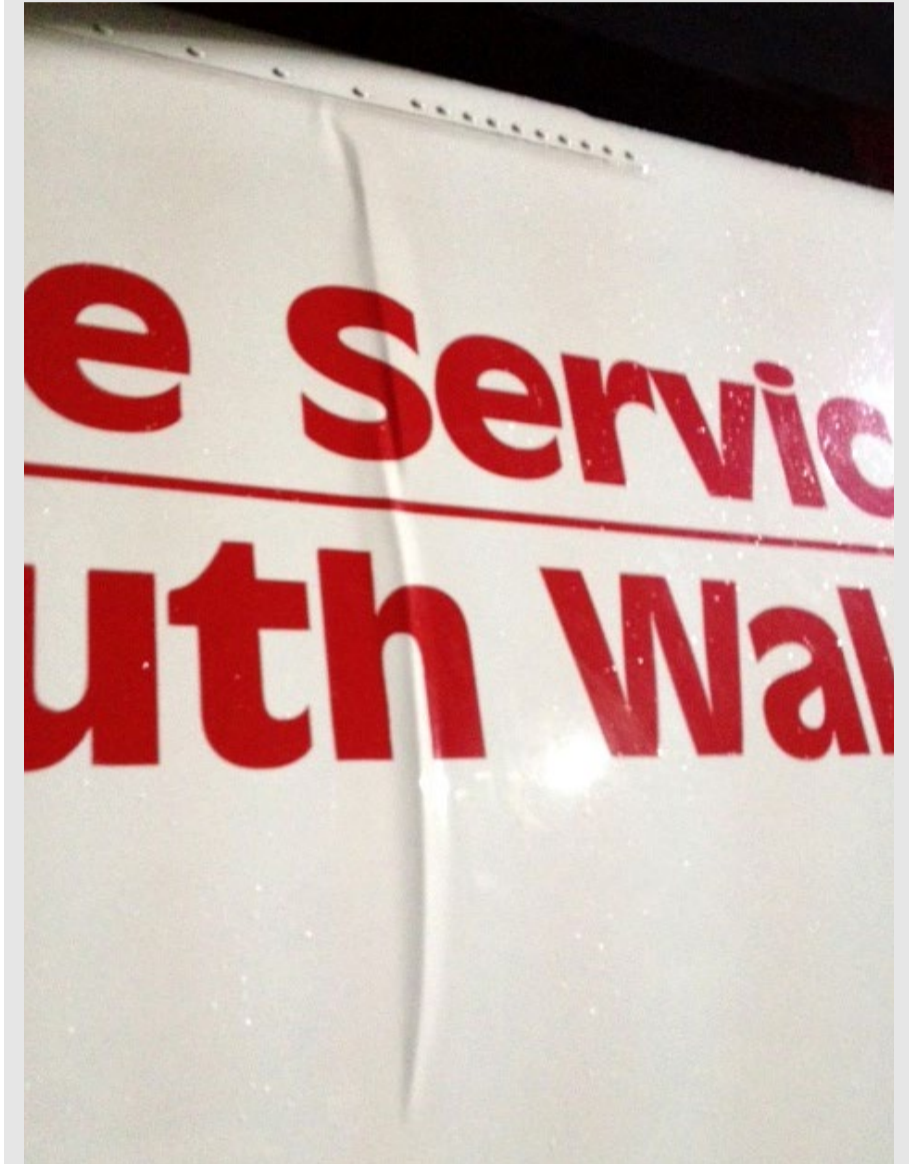
### Agusta Westland AW139 Rotorcraft tail boom creased. SDR 510017827

24-inch crease found on tail boom during post-flight inspection. No significant torque events noted during flight. Investigation continuing. P/No: 3G5350A00134. TSN: 2413 hours/6628 cycles.

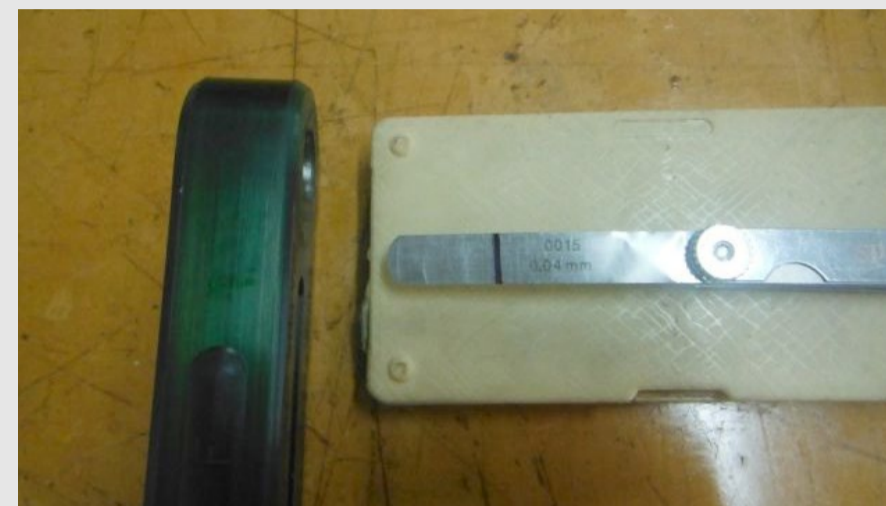
**Bell 206B Main rotor drive system TT strap manufacturing fault. SDR 510017759**

New tension torsion strap found to have a crack/split in the plastic coating covering the wire wrap. Crack/split found to penetrate the full thickness of the wall. Investigation continuing. One other similar defect. P/No: AA206011154107REVB.

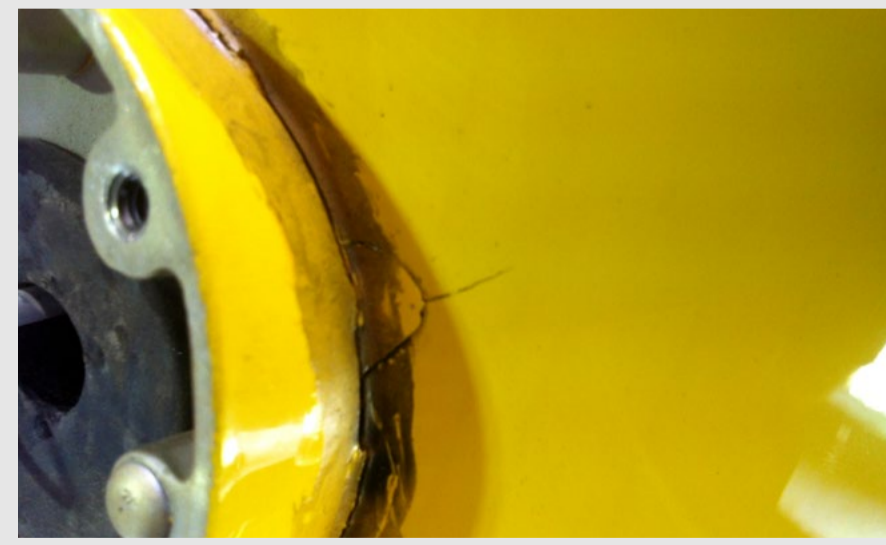
**Robinson R22Beta Rotorcraft tail cone cracked. SDR 510017829**

Strobe light on tail cone found loose during 100-hourly inspection. Crack in the tail cone at the base of the strobe light. P/No: A02323. TSN: 473 hours/8 months.

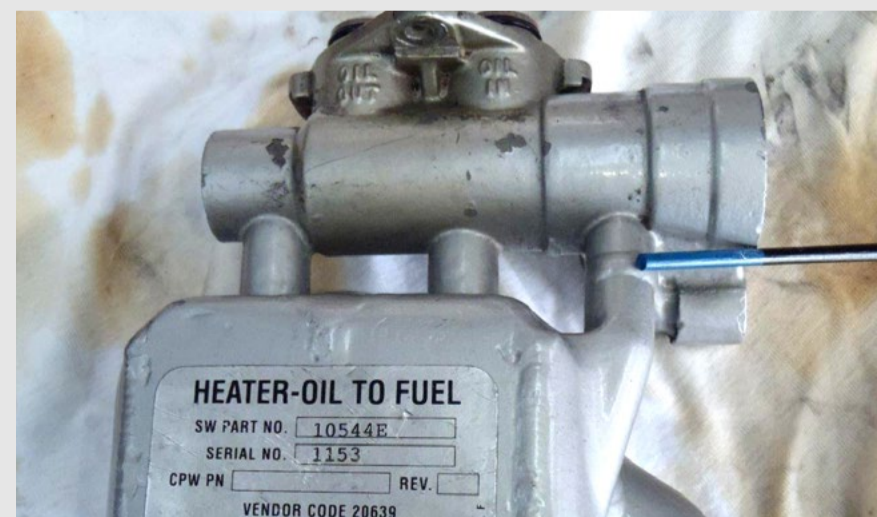
**PWA PT6T3D Fuel heater leaking. SDR 510017710**

Fuel leak in engine noticed. Fuel heater cracked at weld cross section. P/No: 0544E. TSO: 2482 hours
