Safety study into Australian balloon transport operation occurrences from 2014 to 2022

ATSB Transport Safety Report

AS-2023-002

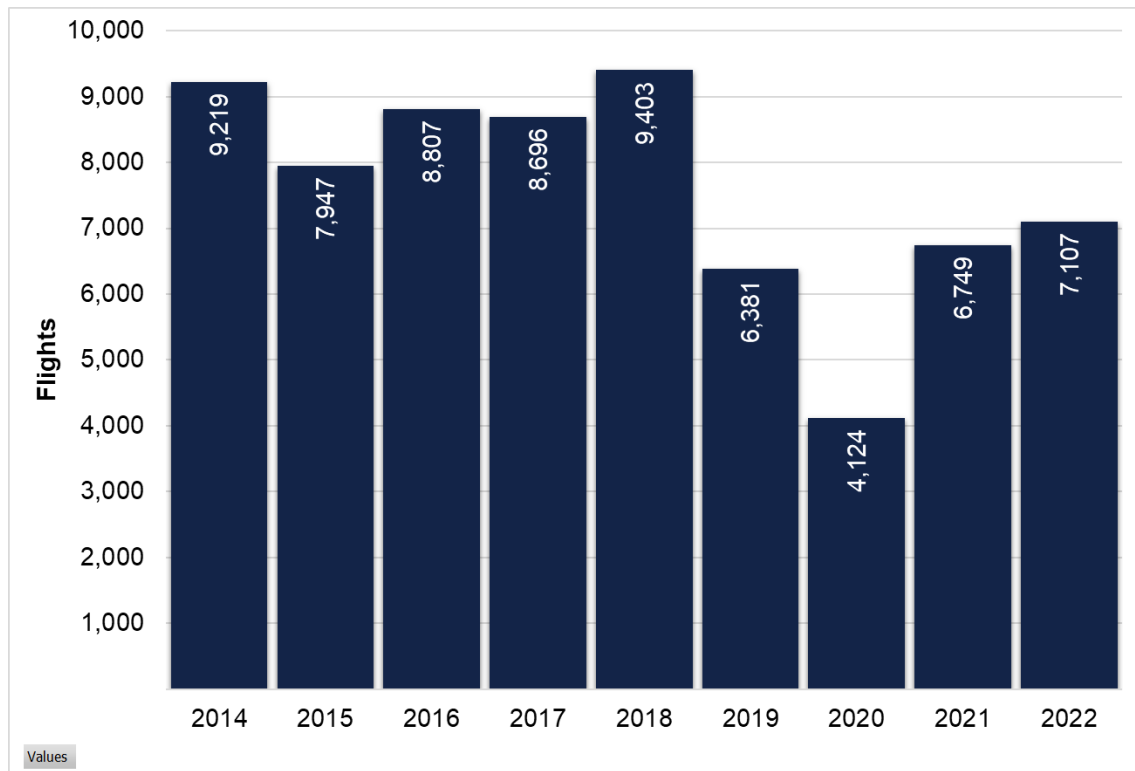
Figure 1: Commercial ballooning flights per year (2014–2022)

- 68,433 commercial ballooning landings (Figure 1)
- 2,190,607 aeroplane joyflights/sightseeing and passenger transport landings (Figure 2)
- 1,795,332 helicopter joyflights/sightseeing and passenger transport landings combined (Figure 2)
- 260,506 aeroplane joyflights/sightseeing landings (Figure 3).
- 496,867 helicopter joyflights/sightseeing landings (Figure 3).

The reduction in total landings between 2019–2021 across the 3 groupings was likely due to effects of the COVID-19 pandemic.

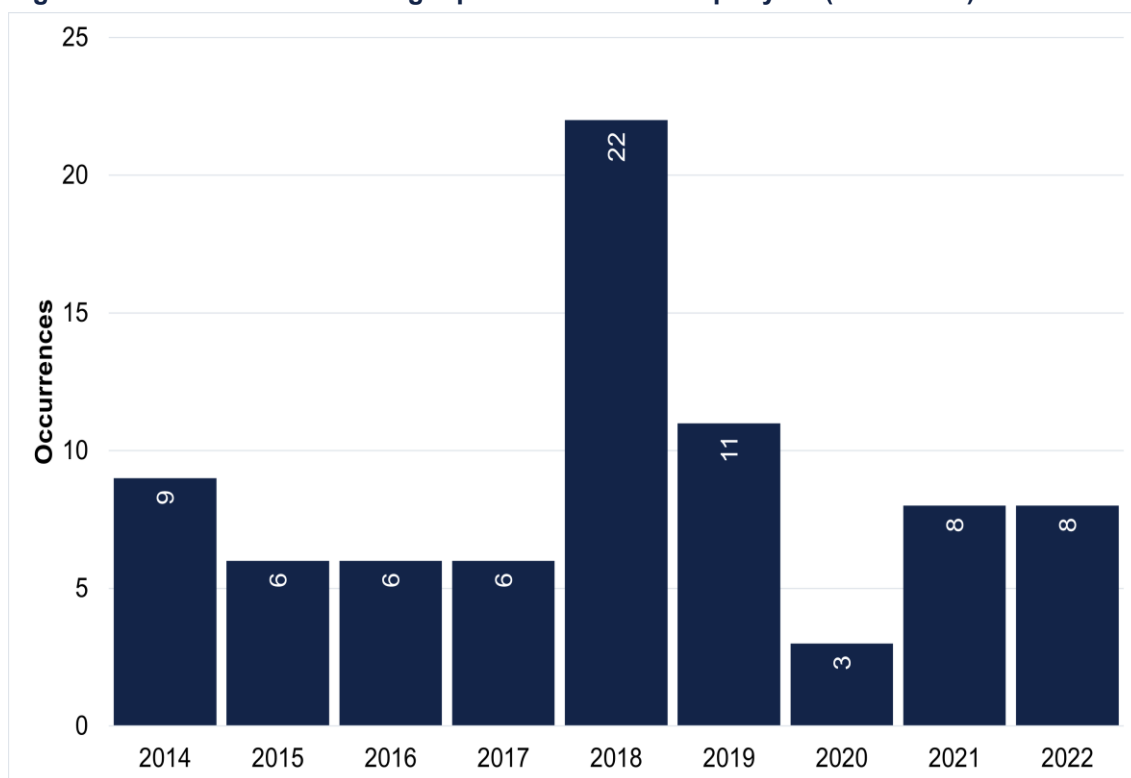
Figure 4: Commercial ballooning reported occurrences per year (2014–2022)

- 79 commercial ballooning occurrences (Figure 4)
- 1,658 aeroplane joyflights/sightseeing and passenger transport occurrences (Figure 5)
- 618 helicopter joyflights/sightseeing and passenger transport occurrences (Figure 5)
- 71 aeroplane joyflights/sightseeing occurrences (Figure 6)
- 62 helicopter joyflights/sightseeing occurrences (Figure 6).

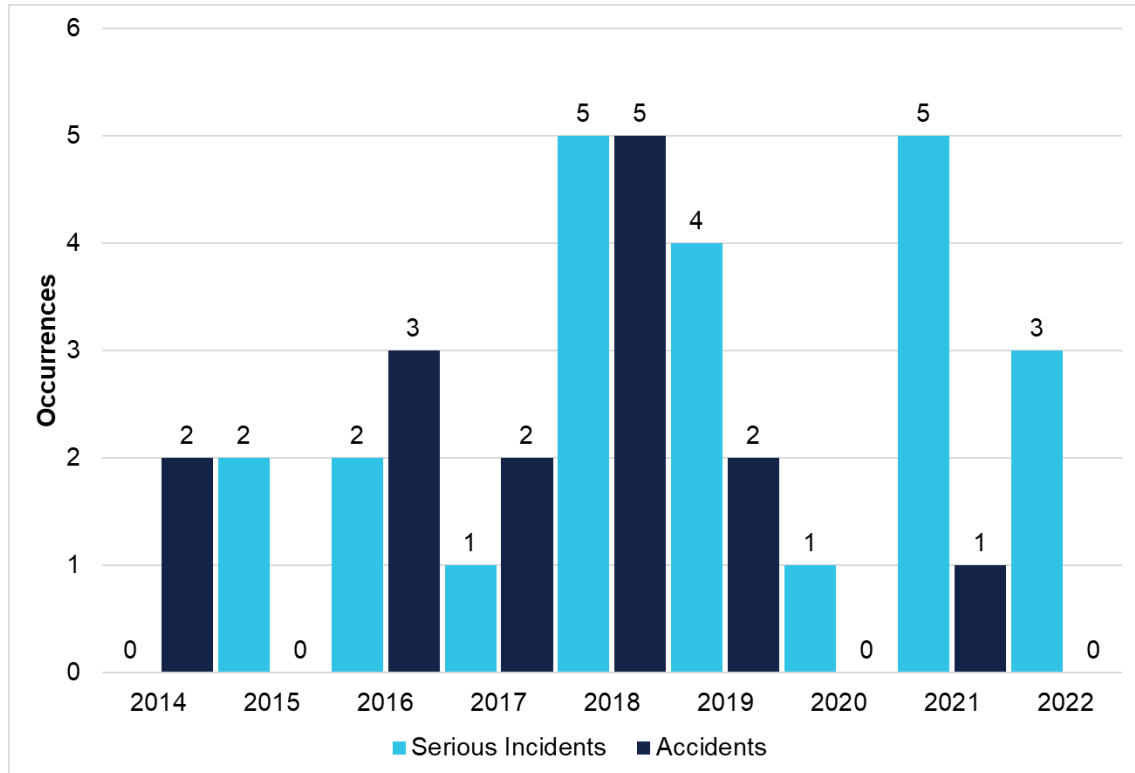
Figure 7: Commercial ballooning serious incident and accidents per year (2014–2022)

- 23 serious incidents and 15 accidents involving commercial balloons (Figure 7)
- 86 serious incidents and 50 accidents involving aeroplanes engaged in joyflights/sightseeing and passenger transport activities (Figure 8)

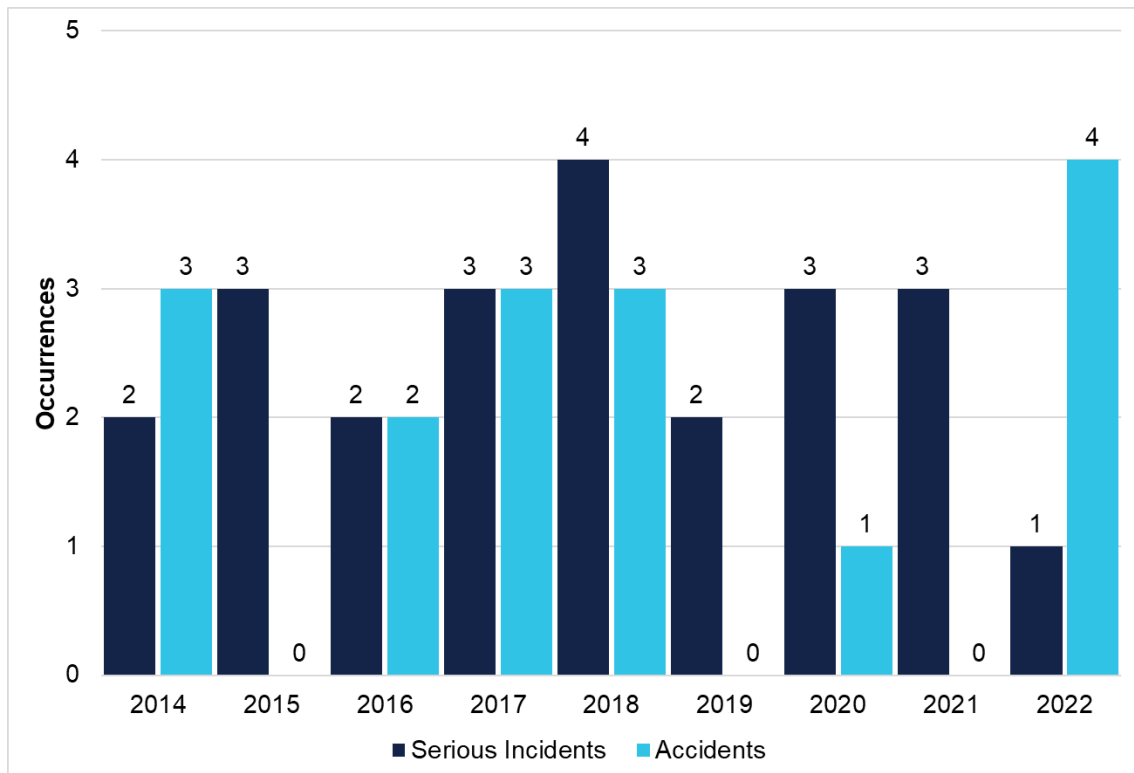
Figure 9: Helicopter joyflights/sightseeing and passenger transport serious incidents and accidents per year (2014–2022)

- 23 serious incidents and 16 accidents involving helicopters engaged in joyflights/sightseeing and passenger transport activities (Figure 9)
- 15 serious incidents and 12 accidents involving aeroplanes conducting joyflights/sightseeing activities (Figure 10)
- 9 serious incidents and 4 accidents involving helicopters conducting joyflights/sightseeing activities (Figure 11).

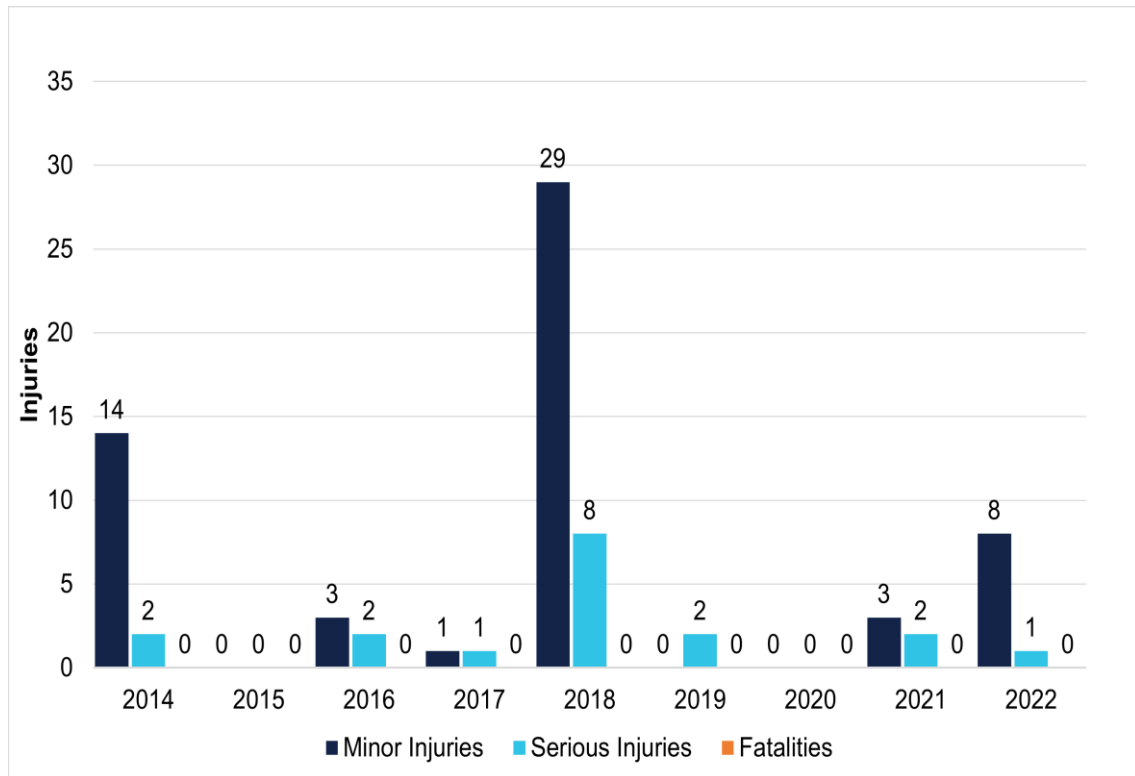
Figure 12: Reported commercial ballooning injuries per year (2014–2022)

- 7 (of the 32) fatalities occurred in aeroplane and helicopter joyflights/sightseeing activities.
- 76 injuries (58 minor, 18 serious) involving commercial ballooning (Figure 12)

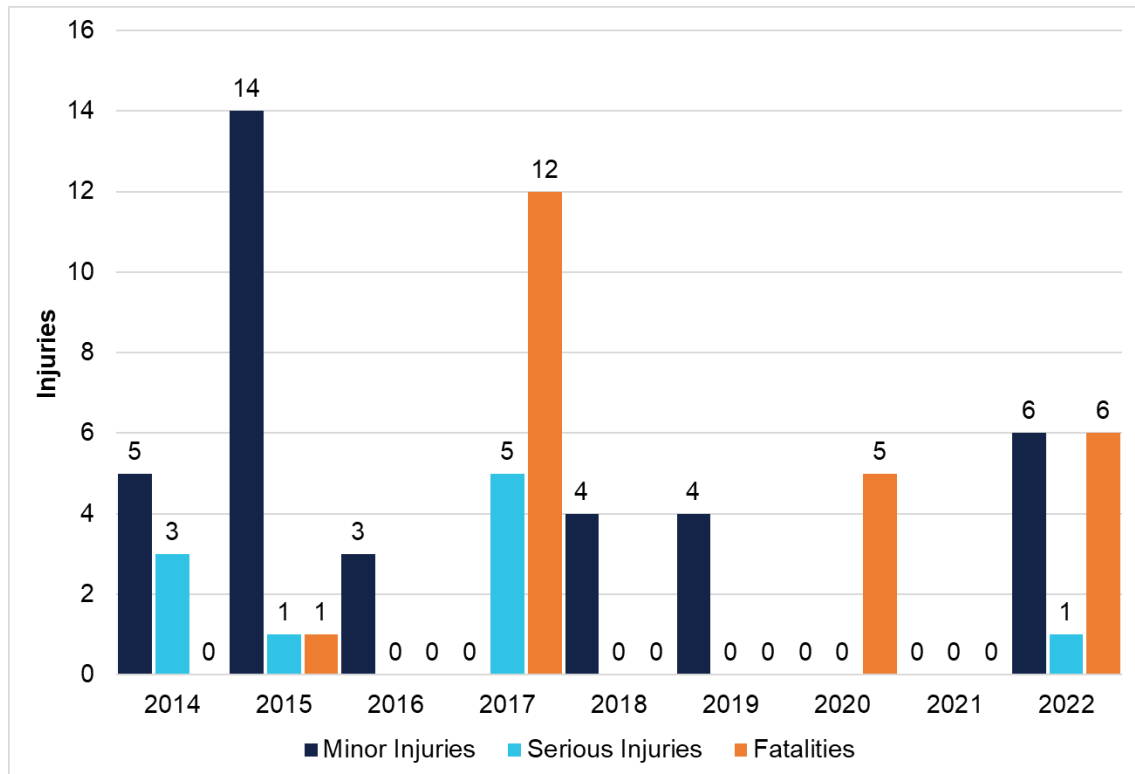
Figure 13: Reported aeroplane joyflights/sightseeing and passenger transport injuries per year (2014–2022)

- 36 minor injuries and 10 serious injuries involving aeroplanes conducting joyflights/sightseeing and passenger transport activities combined (Figure 13)

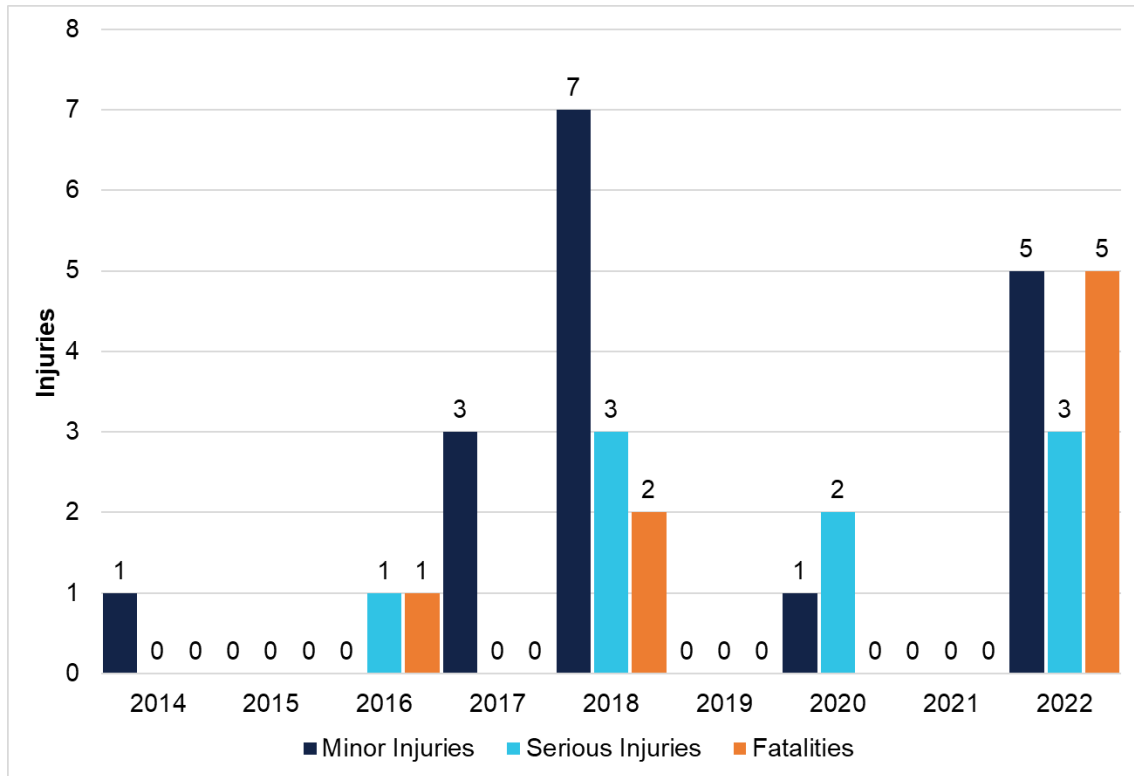
Figure 14: Reported helicopter joyflights/sightseeing and passenger transport injuries per year (2014–2022)

- 17 minor injuries and 9 serious injuries involving helicopters conducting joyflights/sightseeing and passenger transport activities (Figure 14)
- 12 minor injuries and 2 serious injuries involving aeroplanes conducting joyflights/sightseeing activities (Figure 15)

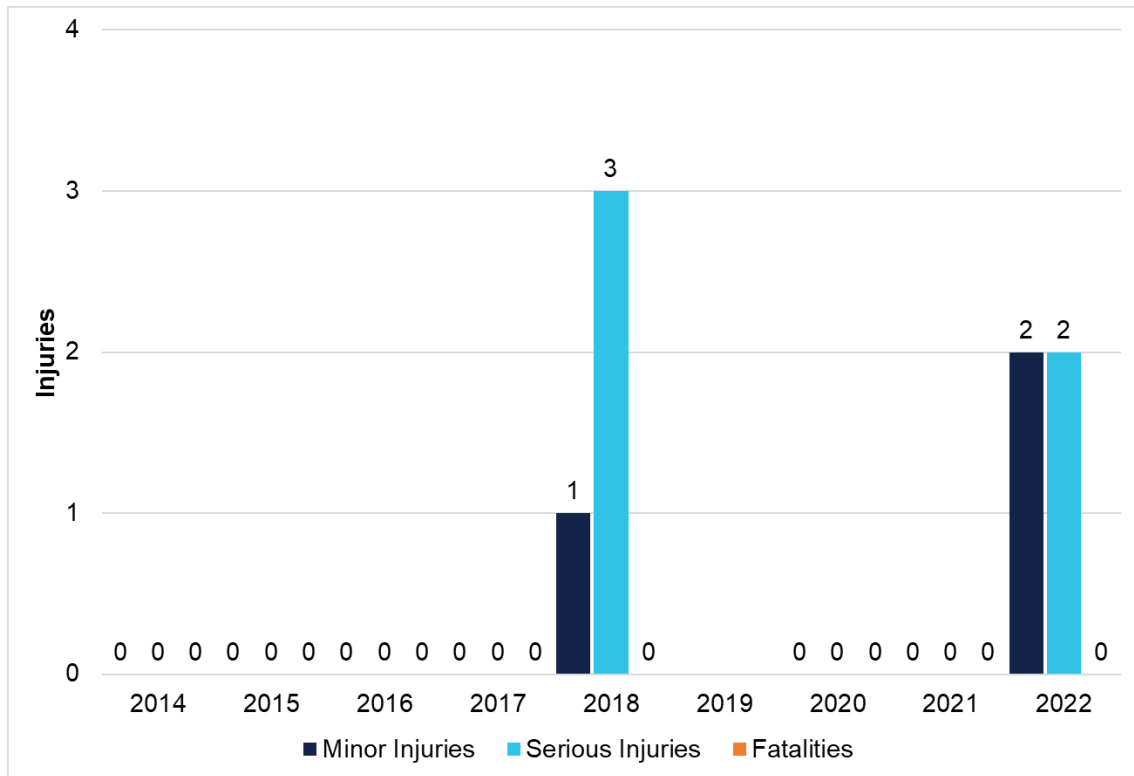
Figure 16: Reported helicopter joyflights/sightseeing injuries per year (2014–2022)

- 3 minor injuries and 5 serious injuries involving helicopters conducting joyflights/sightseeing activities (Figure 16).

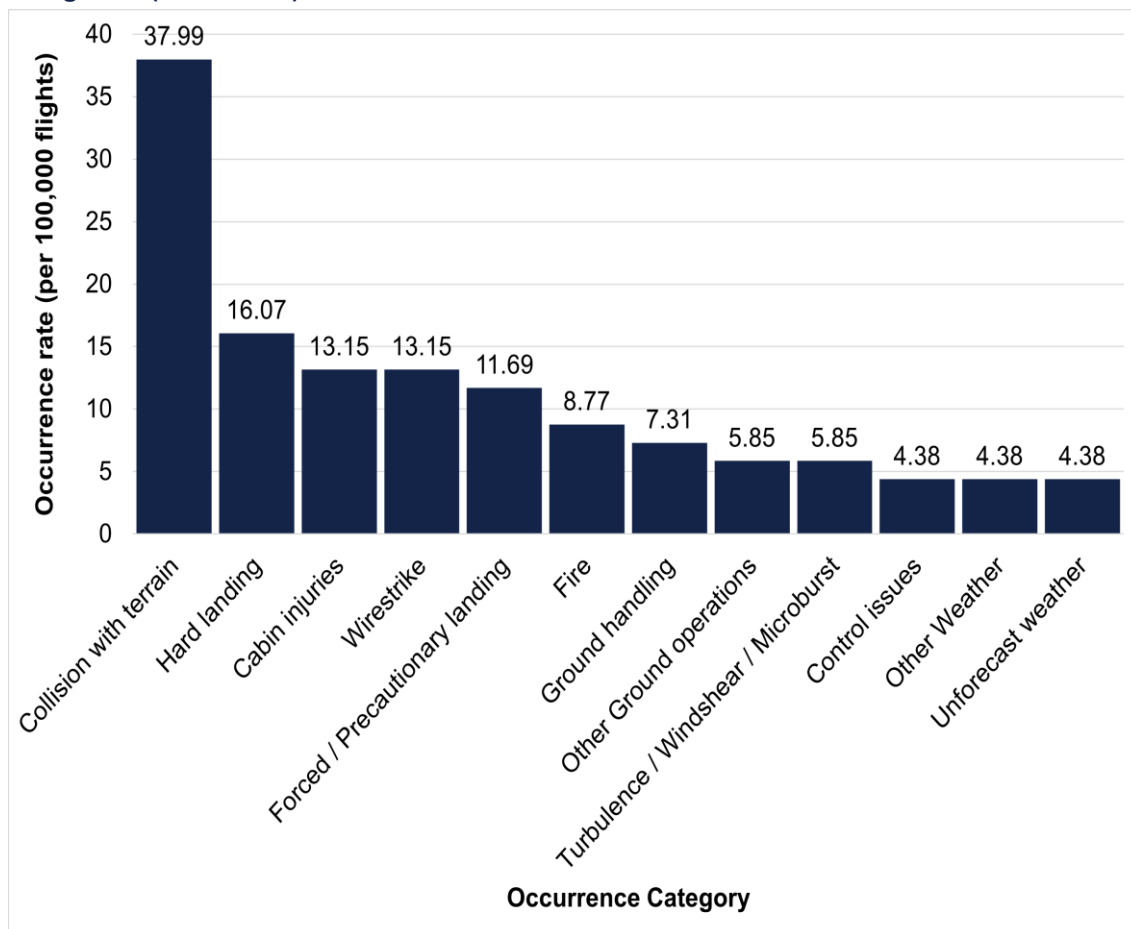
Figure 17: Commercial ballooning occurrence rate per most common occurrence categories (2014–2022)

Figure 17 shows the occurrence rate per most common commercial ballooning occurrence categories for the period 2014–2022.² Collision with terrain was the most common with 38.0 occurrences per 100,000 flights, followed by hard landings (16.1), cabin injuries (13.2) and wirestrikes (13.2).

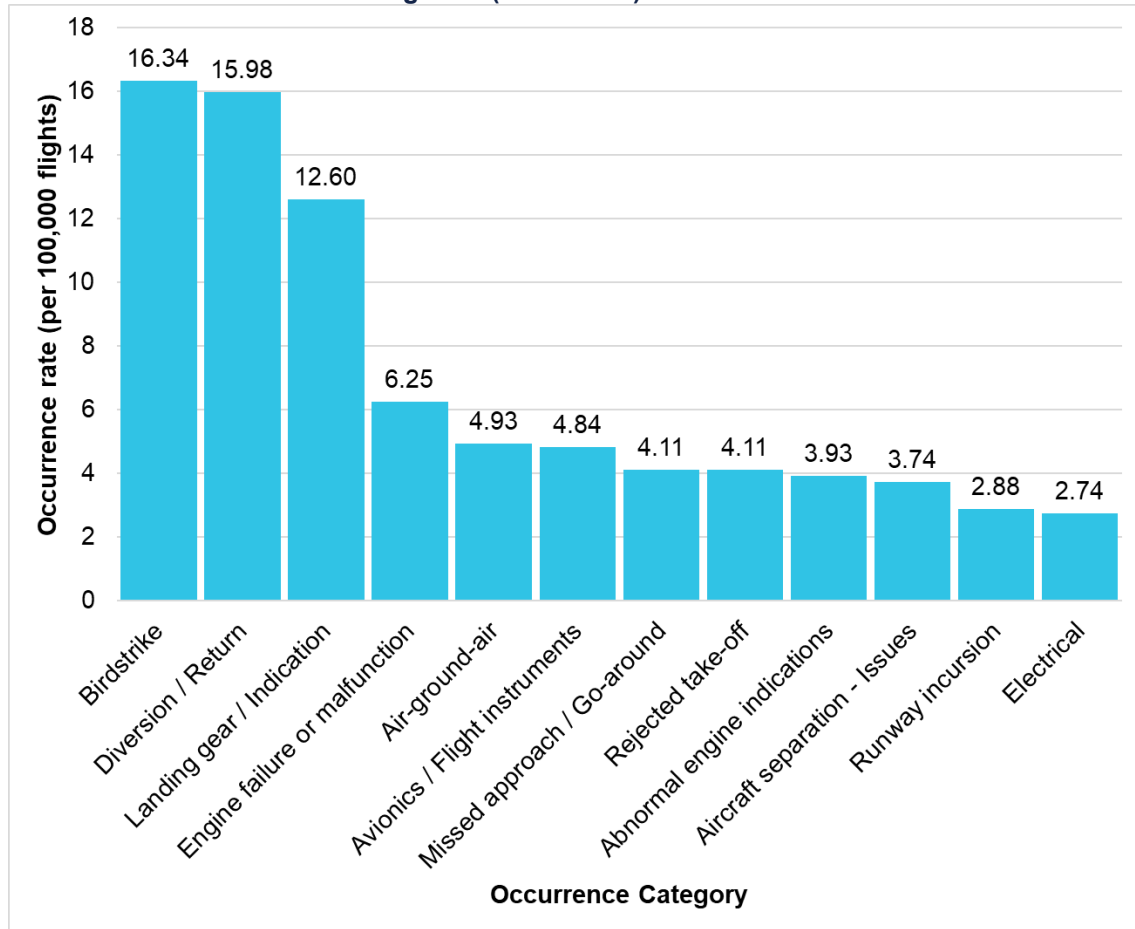
Figure 18: Aeroplane joyflights/sightseeing and passenger transport occurrence rate per most common occurrence categories (2014–2022)

The most common aeroplane and helicopter occurrence categories for joyflights/sightseeing and passenger transport combined are displayed in Figure 18 and Figure 19 respectively. Aeroplane occurrences involving a birdstrike had a rate of 16.3 occurrences per 100,000 flights, this was followed by diversion/returns (16.0), and a landing gear/indication (12.6). An engine failure or malfunction had an occurrence rate of 6.3 per 100,000 flights. Helicopters' most common occurrence category was diversion/returns at 9.0 per 100,000 flights, followed by warning devices (5.8) and birdstrikes (5.2).

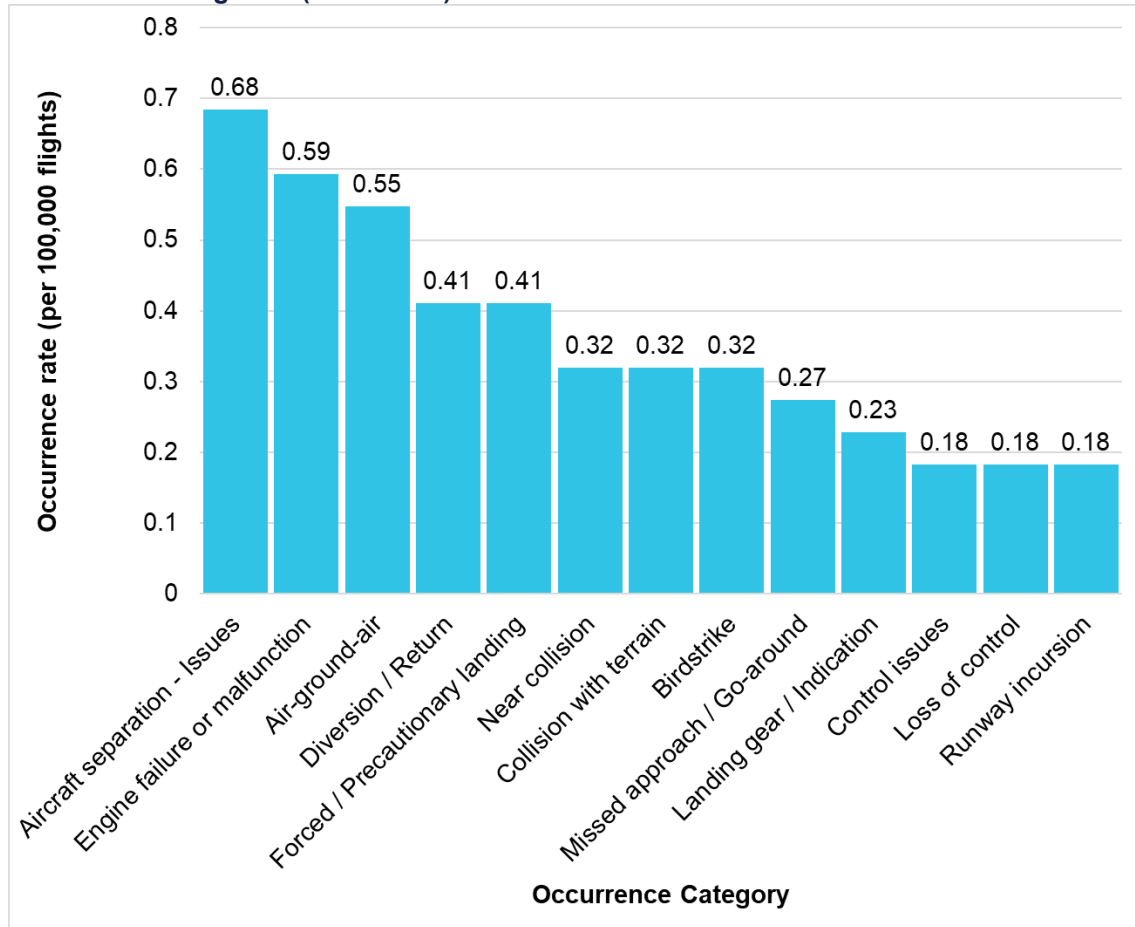
Figure 20: Aeroplane joyflights/sightseeing occurrence rate per most common occurrence categories (2014–2022)

Figure 20 and Figure 21 display the most common aeroplane and helicopter occurrence categorisations for joyflights/sightseeing only. Aircraft separation was the most common category with 0.7 per 100,000 flights, followed by engine failure or malfunction (0.6) and air-ground-air (communications) at 0.6. Helicopters' most common occurrence category was a birdstrike at 0.9 per 100,000 flights, followed by forced/precautionary landing (0.8) and engine failure or malfunction (0.6).

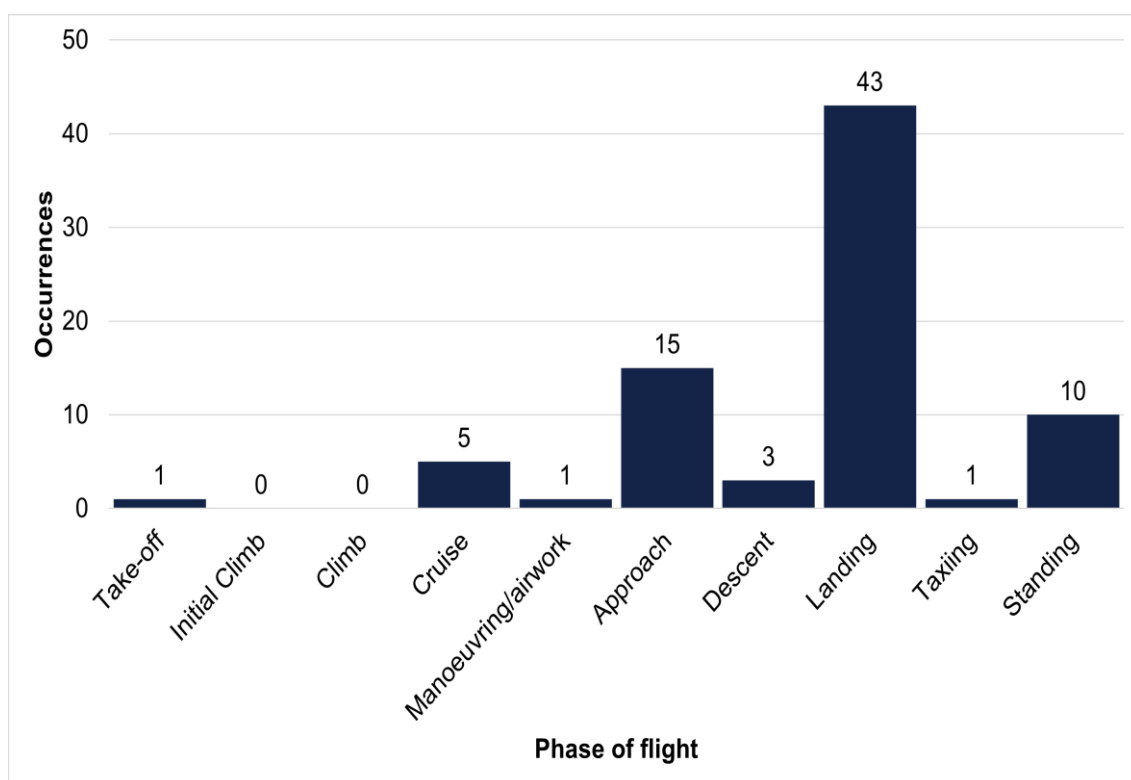
Figure 22: Commercial ballooning occurrences per phase of flight (2014–2022)

For the period 2014–2022, Figure 22 shows the number of occurrences per phase of flight for the 79 commercial ballooning occurrences reported to the ATSB. The majority (43 of 79, or 54%) occurred in the landing phase and a further 19% occurred during the approach phase, equalling a combined 73%.

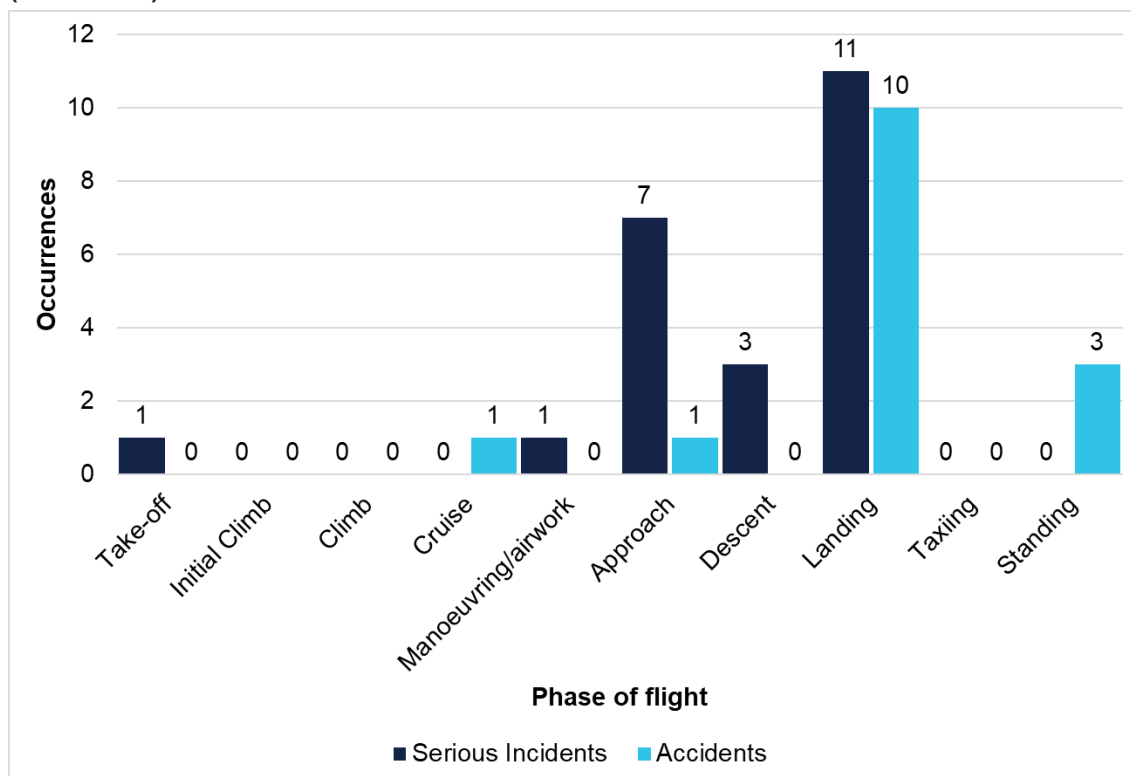
Figure 23: Commercial ballooning serious incidents and accidents per phase of flight (2014–2022)

The reported occurrence data 2014–2022 inclusive identified 23 serious incidents and 15 accidents involving commercial ballooning. Figure 23 shows a breakdown of these serious incidents and accidents with respect to phase of flight.

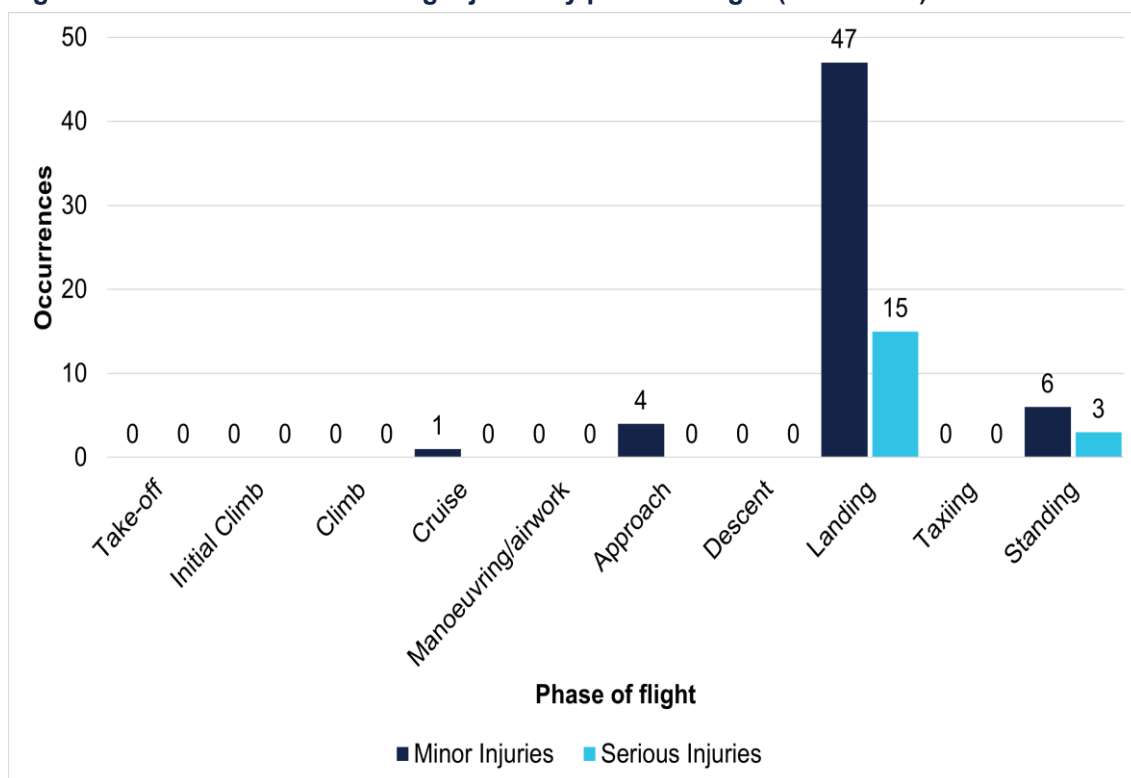
Figure 24: Commercial ballooning injuries by phase of flight (2014–2022)

For the period 2014–2022, the ATSB occurrence database recorded 58 minor injuries, and 18 serious injuries sustained in commercial ballooning. Figure 24 shows the number of minor and serious injuries sustained in each phase of flight with phases that recorded no injuries omitted.

The data identified that 47 (81%) of the minor injuries and 15 (83%) of the serious injuries occurred during landing, significantly higher than all other phases of flight.

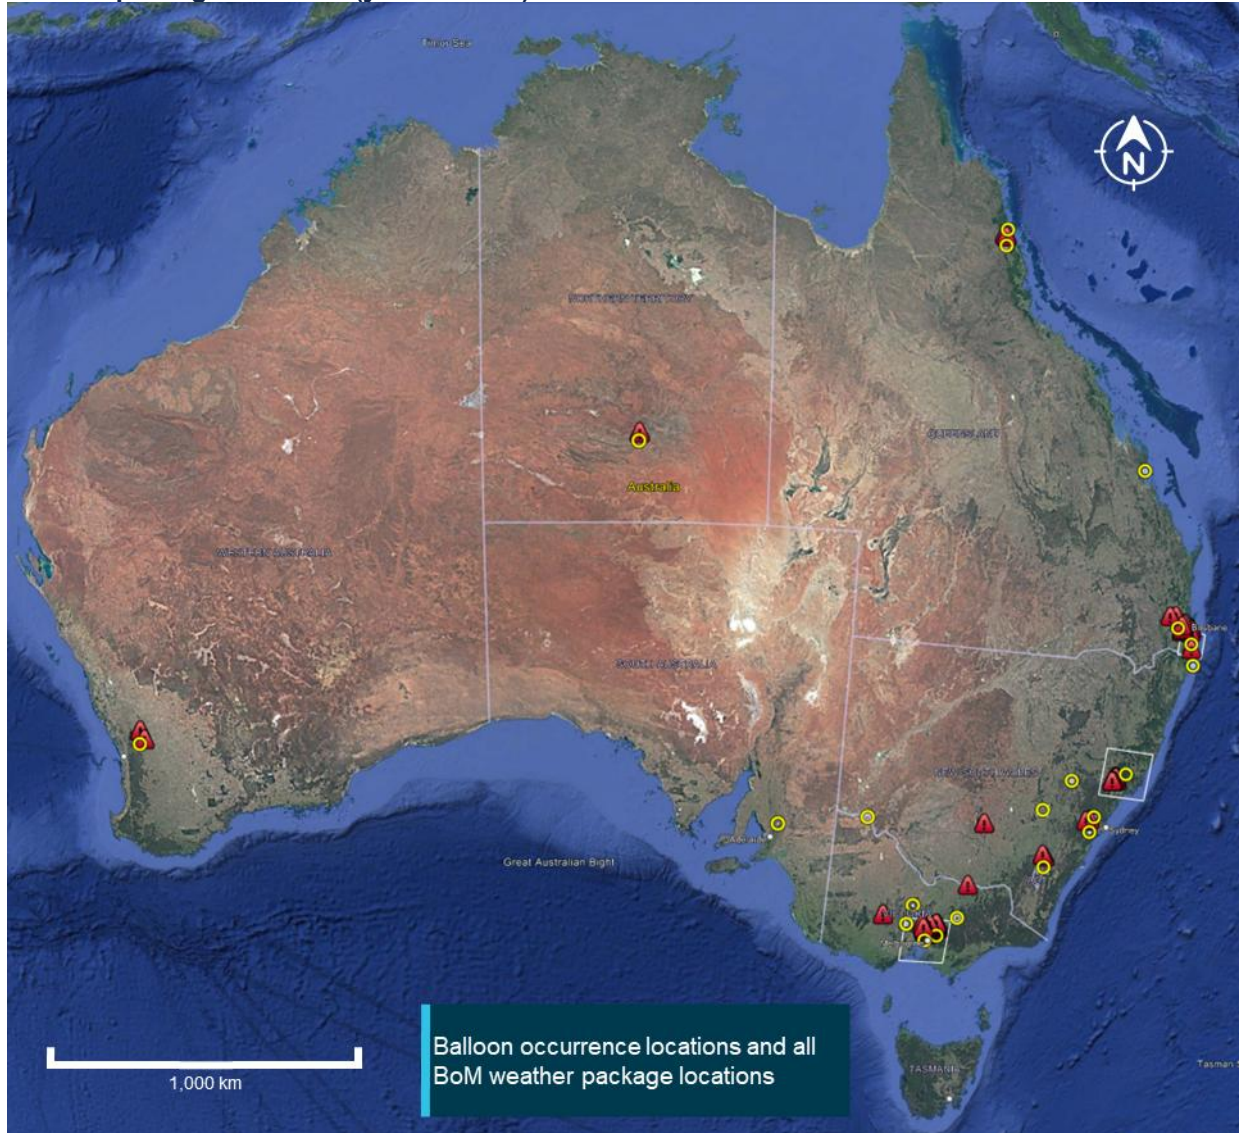
Figure 25: Reported commercial ballooning occurrences 2014–2022 (red triangle) and weather package locations (yellow circle)

As the ATSB occurrence data included location, geographical data for Australian balloon occurrences between 2014–2022 was extracted from the database and plotted using Google Earth (Figure 25).

CASR Part 131 requires balloon operators to obtain a weather forecast from an authorised source, such as the Bureau of Meteorology, valid for a period extending 2 hours beyond their landing time. Since October 2020, the Bureau of Meteorology provided balloon weather packages, available through the Bureau of Meteorology website, containing a compilation of relevant information for balloon flight planning. The weather packages replaced a previous recorded phone service for balloon pilots and a text-based product for Alice Springs. The packages have standardised and automated weather information for 21 locations around Australia that are frequently used by balloonists (Figure 25).

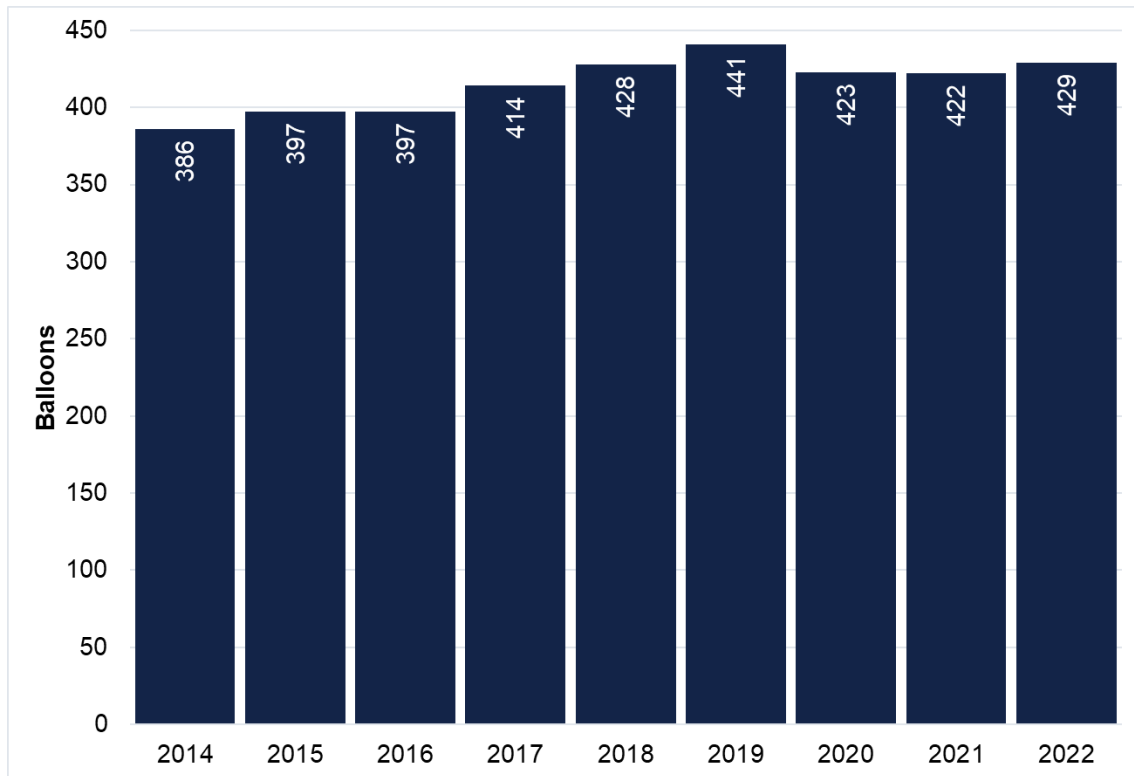
Figure 26: Total number of VH-registered balloons per year (2014–2022)

The Civil Aviation Safety Authority (CASA) maintains a register of all VH-registered aircraft. This register includes the type of aircraft, manufacturer, model, and the registration holder of all VH-registered aircraft. However, the database does not include the type of basket that is used nor the number of passengers that the balloon can carry. The ATSB collected end of calendar year registers from 2014 to 2022 and extracted VH-registered balloon data. The total number of VH-registered balloons by year is shown in Figure 26. This data includes private balloons.

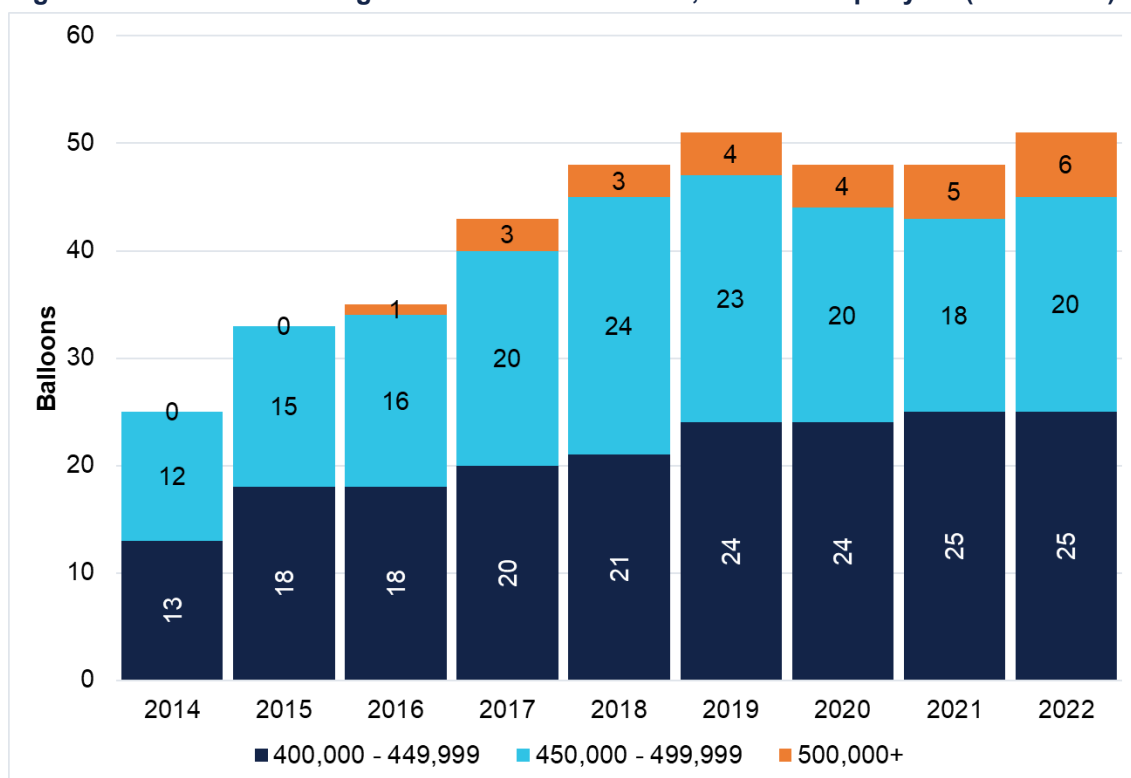
Figure 27: Number of VH-registered balloons over 400,000 cubic ft per year (2014–2022)

Due to the aircraft register not recording envelope size, the designated model of each balloon was extracted from the database and cross-referenced with manufacturer data to determine the envelope size. Between 2014 and 2022, the total number of VH-registered balloons on the Australian civil aircraft register increased from 386 to 429, an 11% increase. The increase in the number of VH-registered balloons over 400,000 cubic ft is shown in Figure 27.

At the end of calendar year 2014 there were 25 balloons over 400,000 cubic ft. By the end of 2022 this number had increased to 51, an increase of 104%, with a breakdown as shown in Table 3:

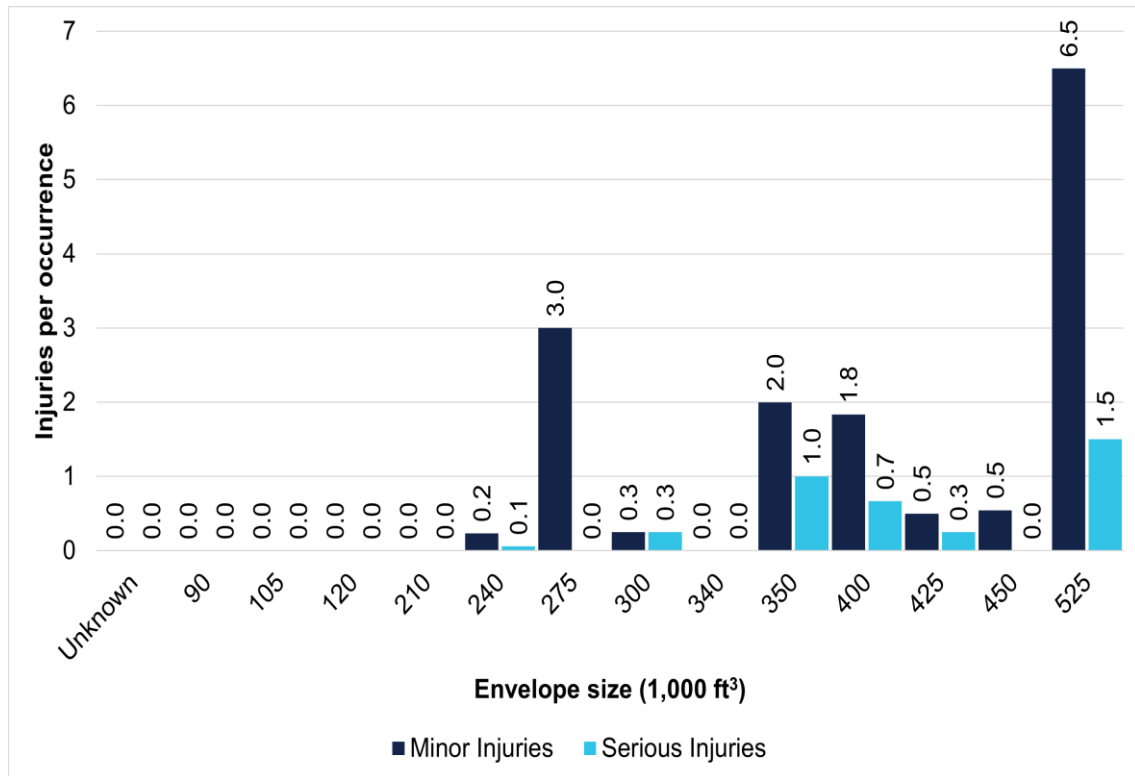
Figure 28: Average injuries per occurrence by balloon envelope size (2014–2022)

Envelope size (1,000 ft ³)	Occurrences	Minor injuries	Serious injuries
unknown	1	0	0
90	1	0	0
105	1	0	0
120	2	0	0
210	1	0	0
240	34	8	2
275	1	3	0
300	4	1	1
340	1	0	0
350	6	12	6
400	6	11	4
425	8	4	2
450	11	6	0
525	2	13	3
Total	79	58	18

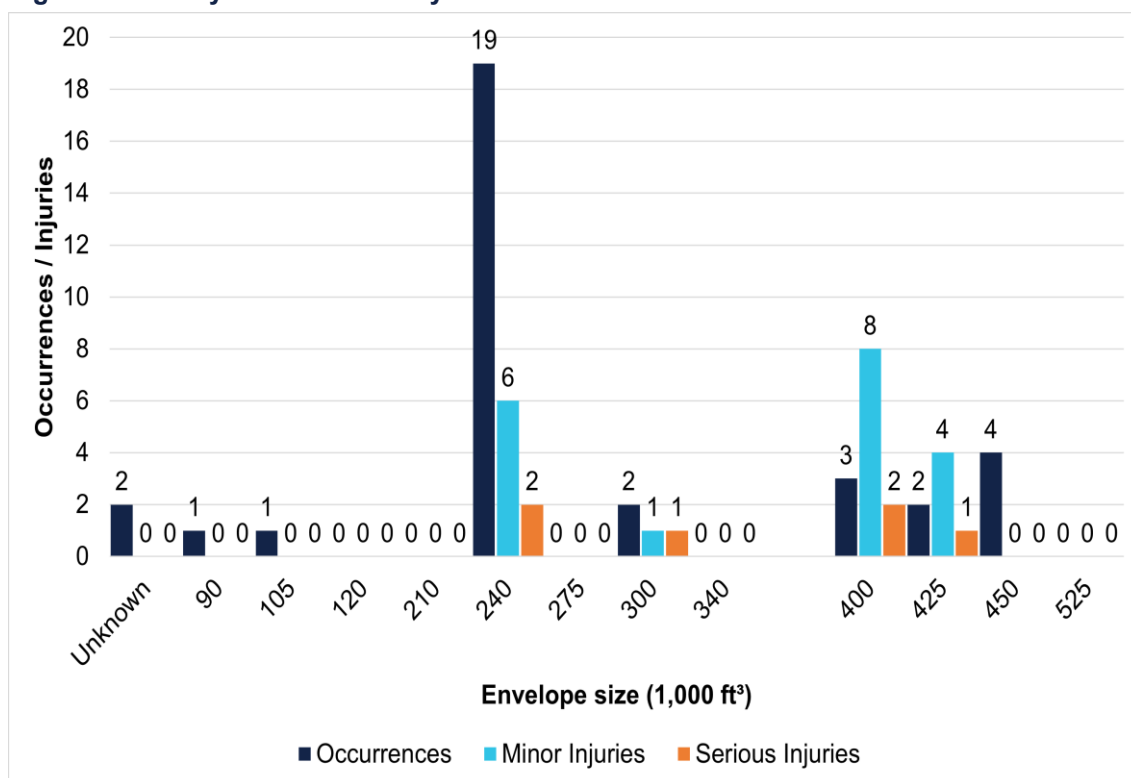
Figure 29: Safety factor of wind by balloon size

The following was identified with wind as a safety factor (Figure 29):

- the 240,000 cubic ft balloons had the highest number of occurrences with 6 minor injuries and 2 serious injuries from 19 wind-related occurrences
- the 350,000 cubic ft balloons had the highest number of serious injuries with 4 serious injuries from 4 wind-related occurrences
- the 350,000, 400,000 and 425,000 cubic ft balloons had 7 serious injuries, 23 minor injuries out of 9 occurrences combined.
