# **Safety study into Australian balloon transport operation occurrences from 2014 to 2022**

**ATSB Transport Safety Report**  
Aviation Safety Study Investigation (Defined)  
AS-2023-002  
Final – 26 November 2025

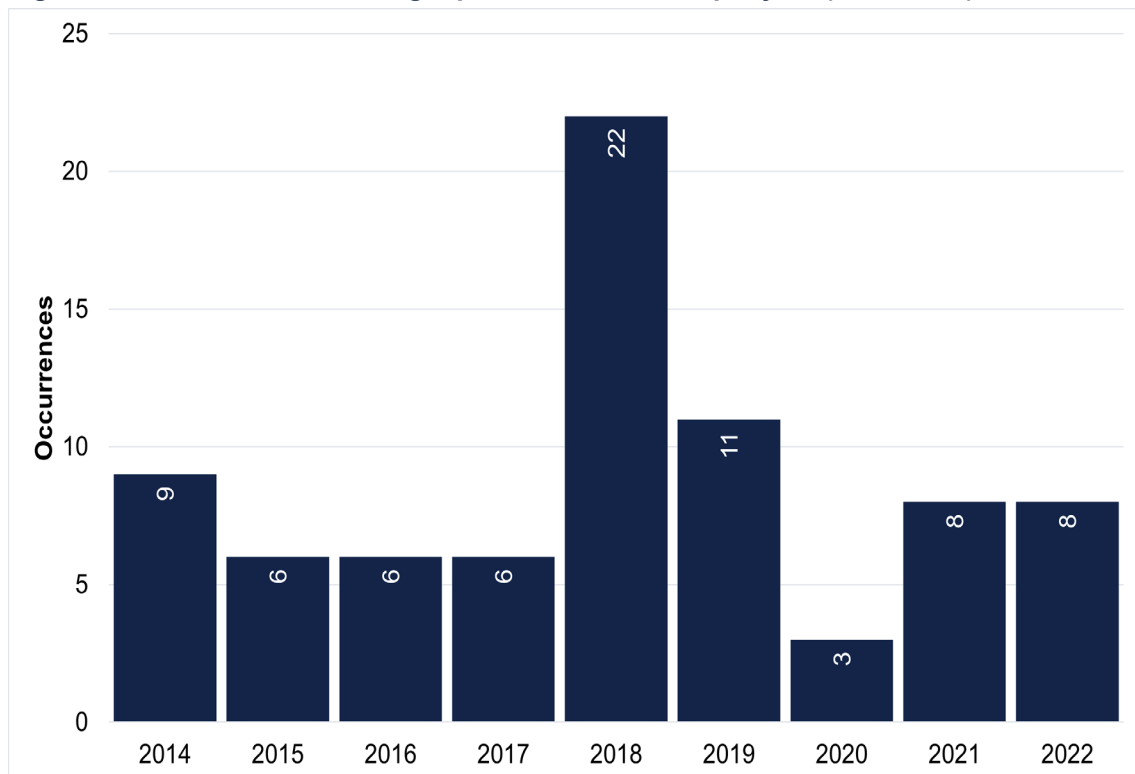
**Figure 4: Commercial ballooning reported occurrences per year (2014–2022)**

- 79 commercial ballooning occurrences (Figure 4)
- 1,658 aeroplane joyflights/sightseeing and passenger transport occurrences (Figure 5)
- 618 helicopter joyflights/sightseeing and passenger transport occurrences (Figure 5)
- 71 aeroplane joyflights/sightseeing occurrences (Figure 6)
- 62 helicopter joyflights/sightseeing occurrences (Figure 6).

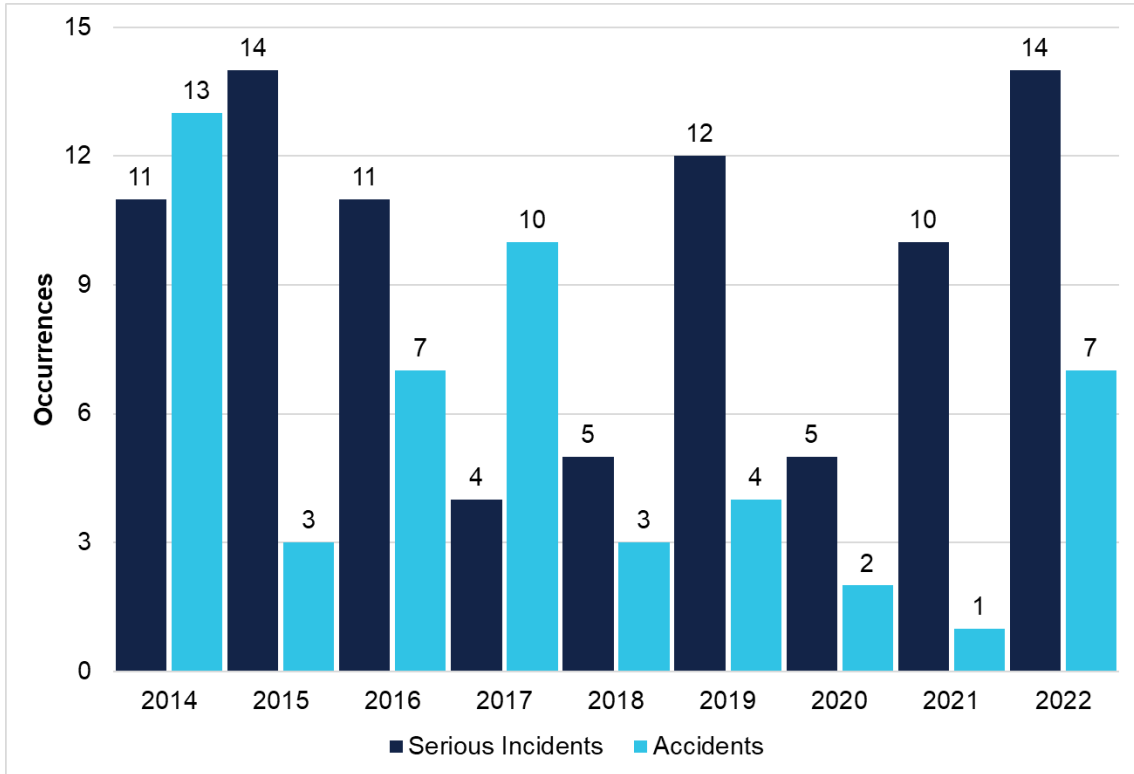
**Figure 8: Aeroplane joyflights/sightseeing and passenger transport serious incidents and accidents per year (2014–2022)**

- 23 serious incidents and 15 accidents involving commercial balloons (Figure 7)
- 86 serious incidents and 50 accidents involving aeroplanes engaged in joyflights/sightseeing and passenger transport activities (Figure 8)

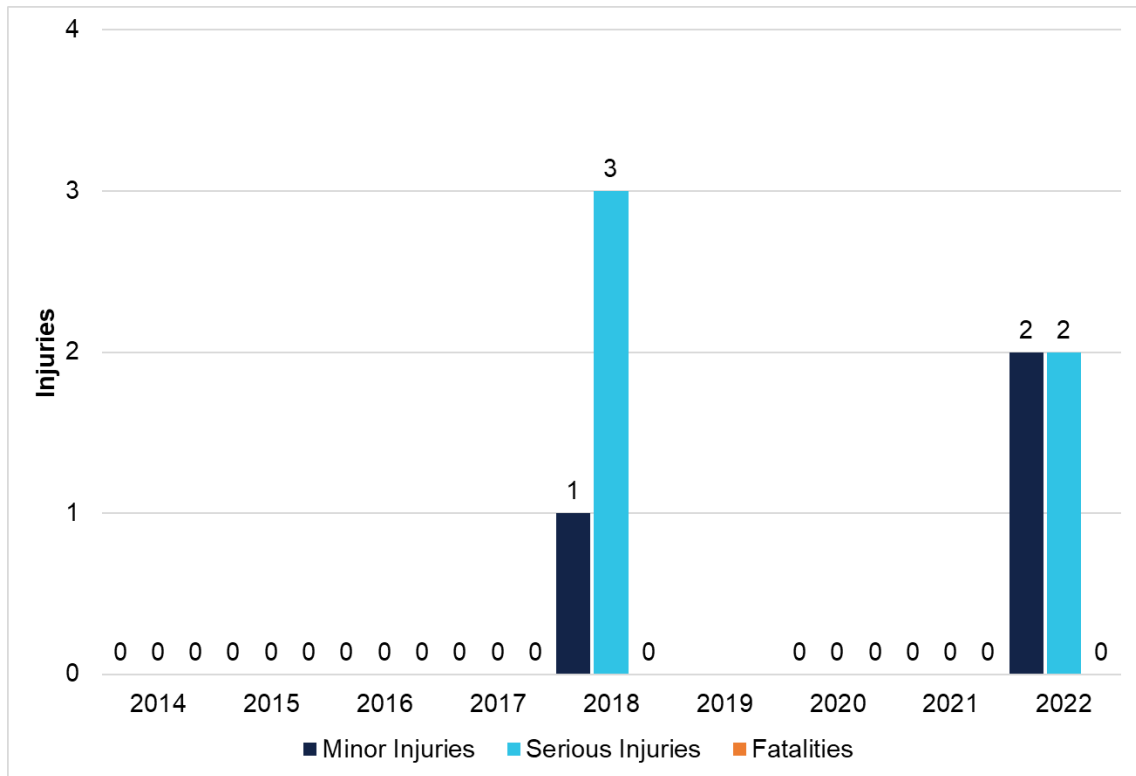
Figure 16: Reported helicopter joyflights/sightseeing injuries per year (2014–2022)

- 3 minor injuries and 5 serious injuries involving helicopters conducting joyflights/sightseeing activities (Figure 16).

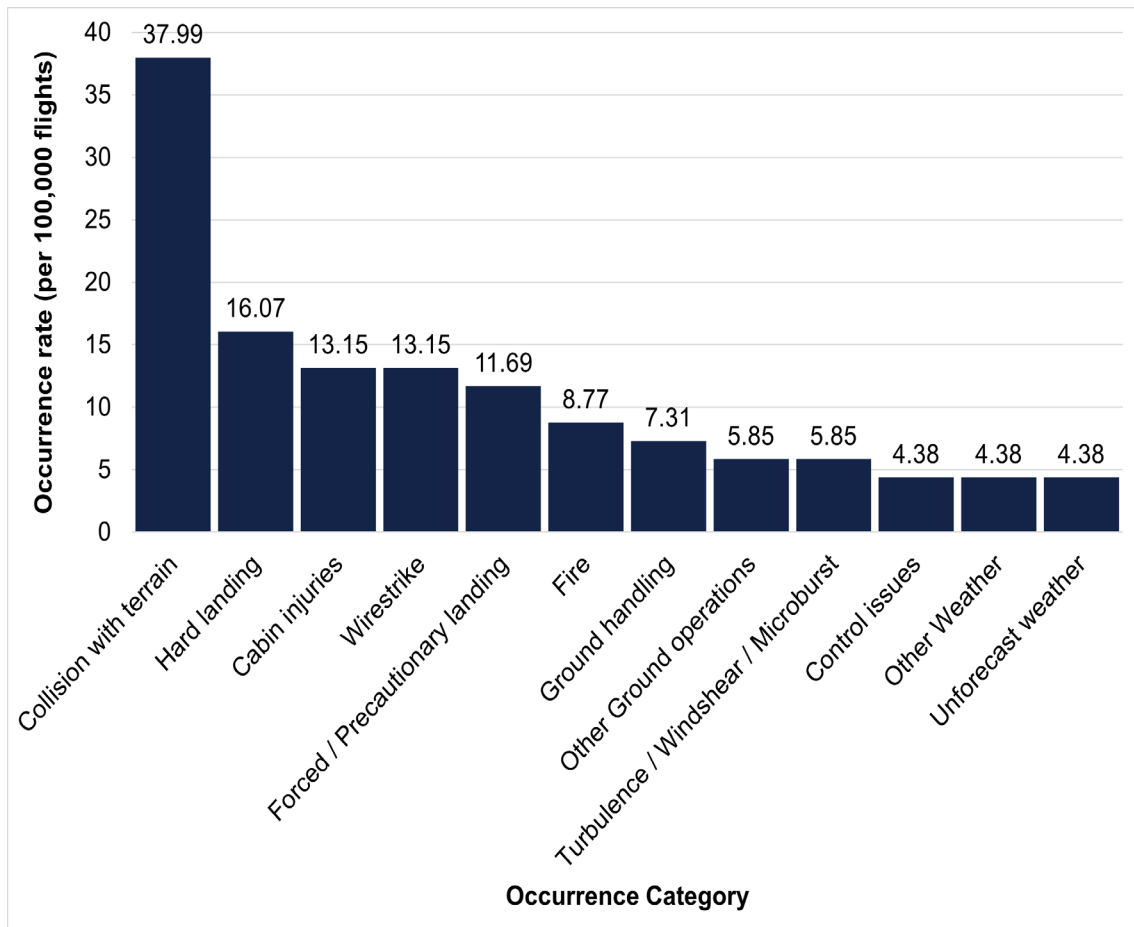
Figure 17 shows the occurrence rate per most common commercial ballooning occurrence categories for the period 2014–2022.<sup>2</sup> Collision with terrain was the most common with 38.0 occurrences per 100,000 flights, followed by hard landings (16.1), cabin injuries (13.2) and wirestrikes (13.2).

**Figure 17: Commercial ballooning occurrence rate per most common occurrence categories (2014–2022)**

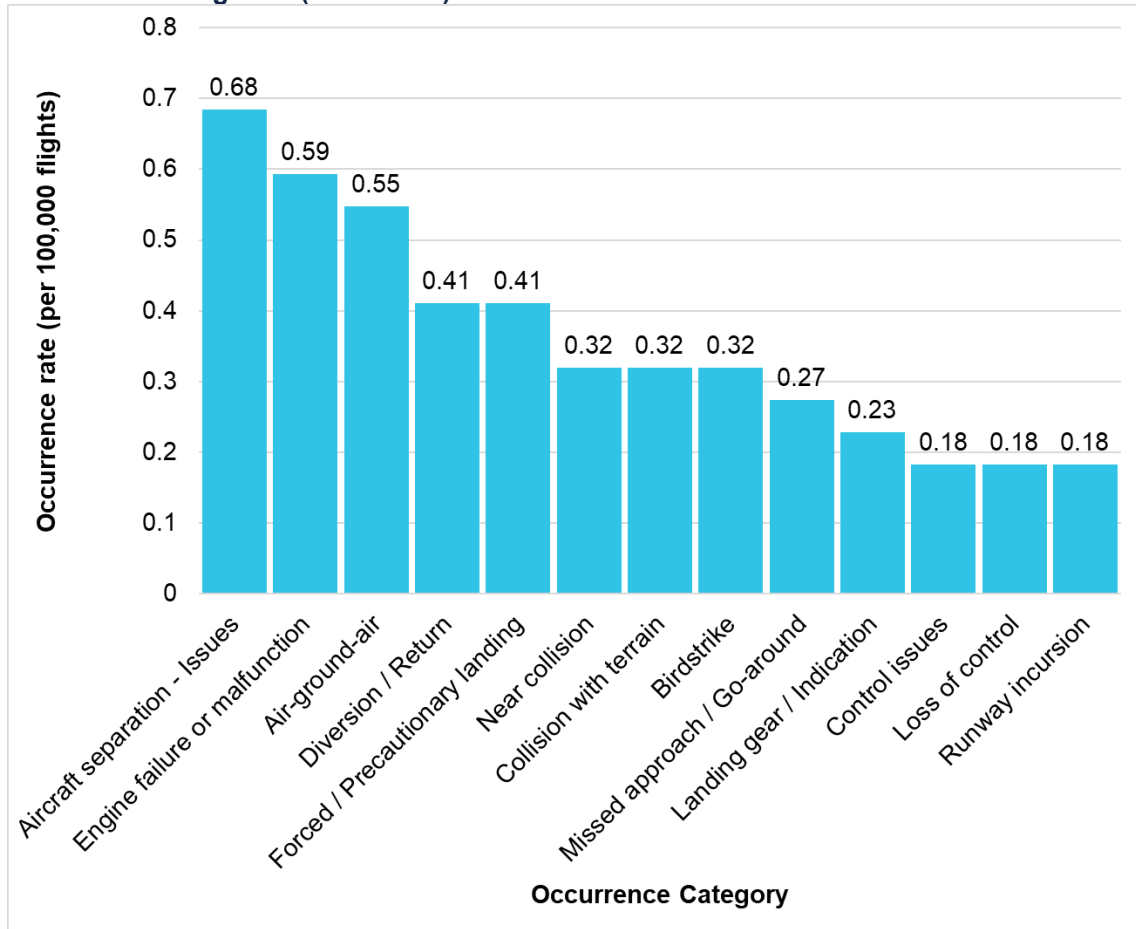
**Figure 20: Aeroplane joyflights/sightseeing occurrence rate per most common occurrence categories (2014–2022)**

Figure 20 and Figure 21 display the most common aeroplane and helicopter occurrence categorisations for joyflights/sightseeing only. Aircraft separation was the most common category with 0.7 per 100,000 flights, followed by engine failure or malfunction (0.6) and air-ground-air (communications) at 0.6. Helicopters' most common occurrence category was a birdstrike at 0.9 per 100,000 flights, followed by forced/precautionary landing (0.8) and engine failure or malfunction (0.6).

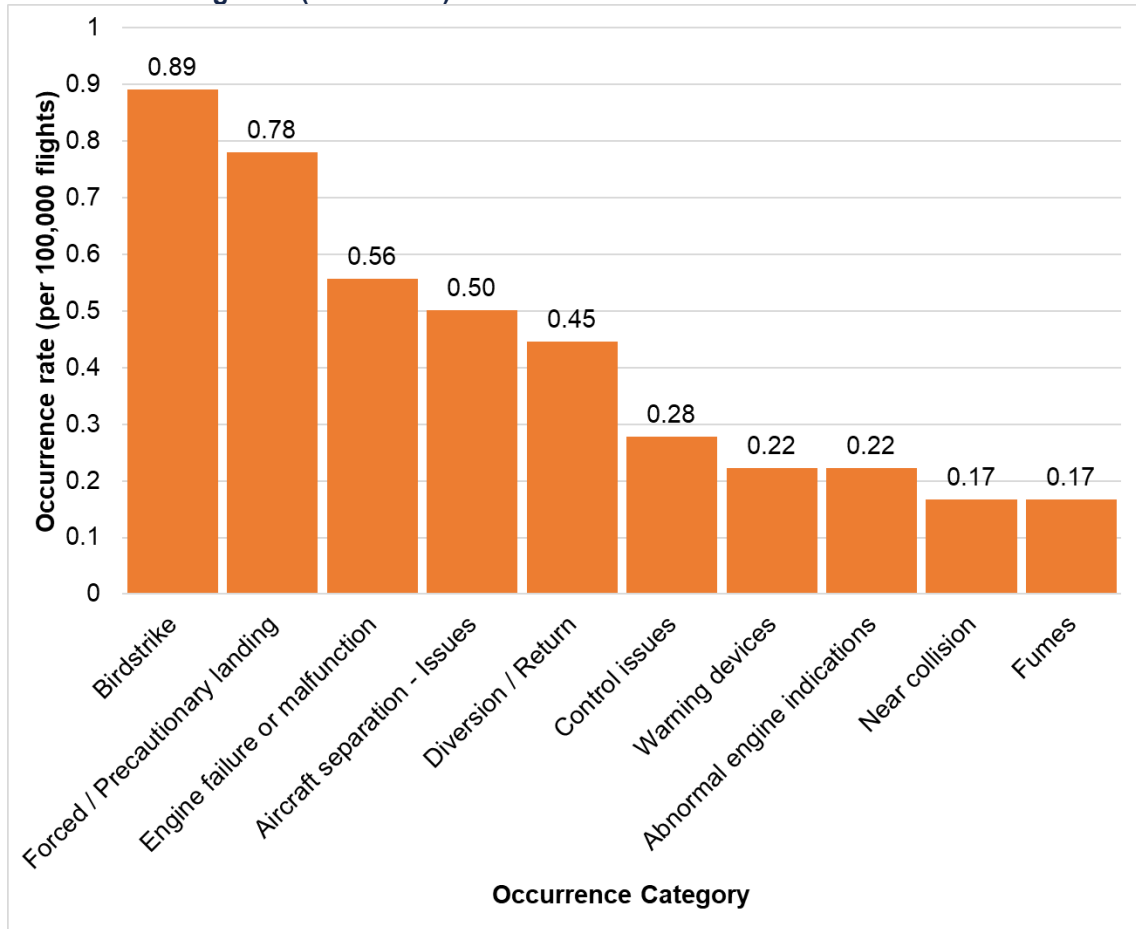
**Figure 21: Helicopter joyflights/sightseeing occurrence rate per most common occurrence categories (2014–2022)**

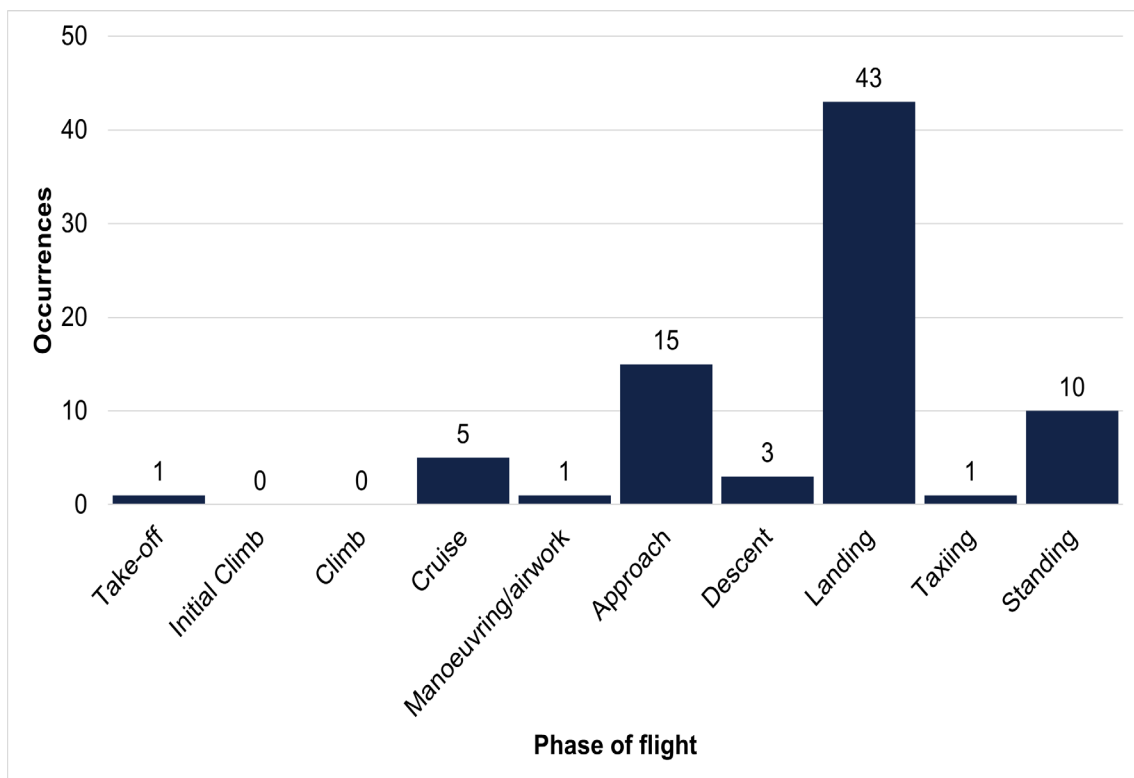
For the period 2014–2022, Figure 22 shows the number of occurrences per phase of flight for the 79 commercial ballooning occurrences reported to the ATSB. The majority (43 of 79, or 54%) occurred in the landing phase and a further 19% occurred during the approach phase, equalling a combined 73%.

**Figure 22: Commercial ballooning occurrences per phase of flight (2014–2022)**

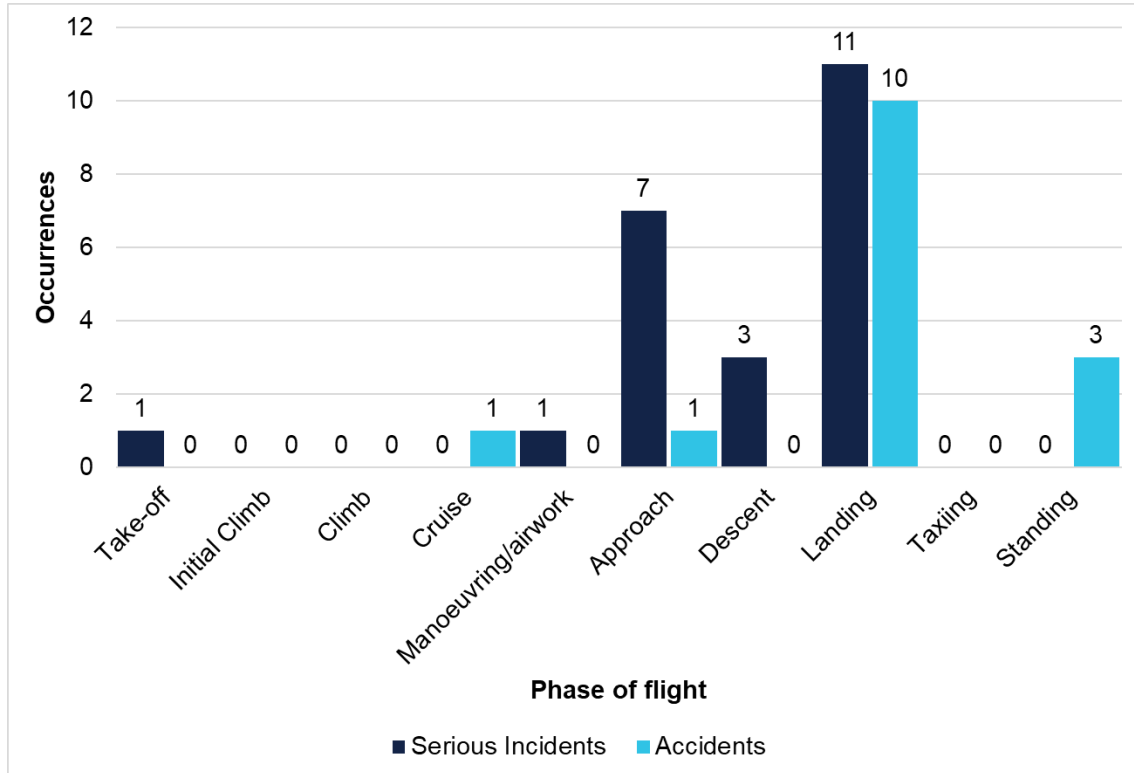
The reported occurrence data 2014–2022 inclusive identified 23 serious incidents and 15 accidents involving commercial ballooning. Figure 23 shows a breakdown of these serious incidents and accidents with respect to phase of flight.

**Figure 23: Commercial ballooning serious incidents and accidents per phase of flight (2014–2022)**

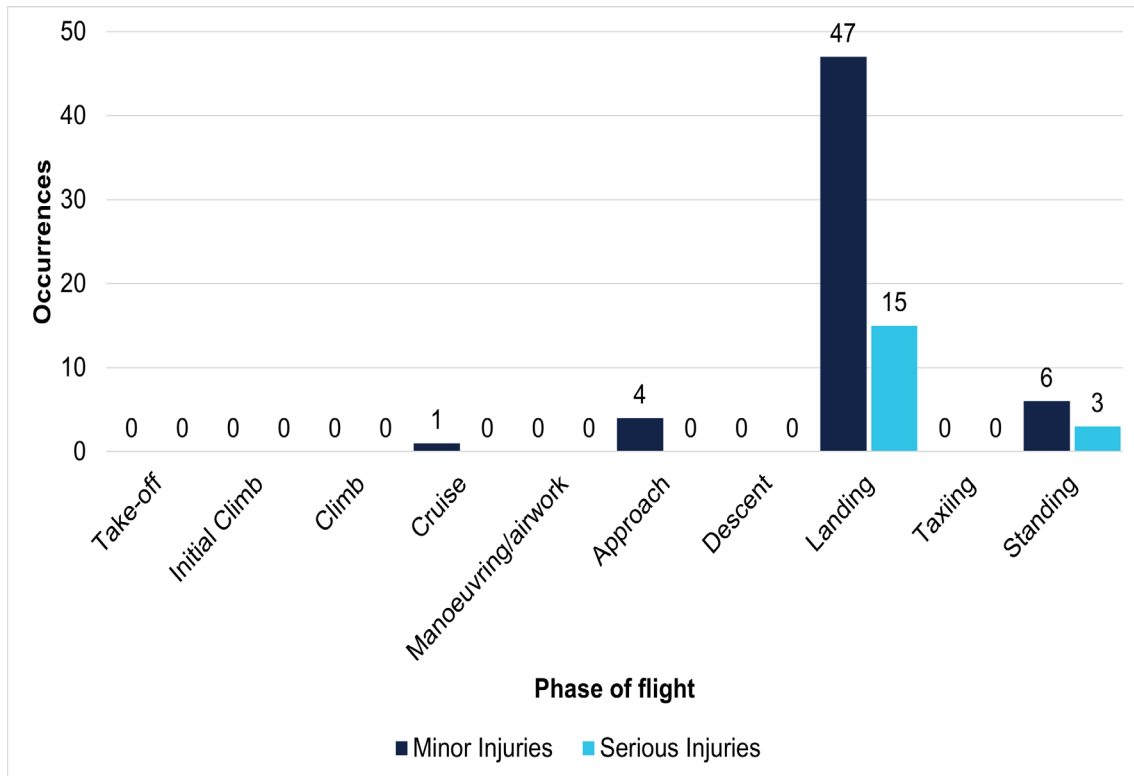
For the period 2014–2022, the ATSB occurrence database recorded 58 minor injuries, and 18 serious injuries sustained in commercial ballooning. Figure 24 shows the number of minor and serious injuries sustained in each phase of flight with phases that recorded no injuries omitted.

**Figure 24: Commercial ballooning injuries by phase of flight (2014–2022)**

The data identified that 47 (81%) of the minor injuries and 15 (83%) of the serious injuries occurred during landing, significantly higher than all other phases of flight.

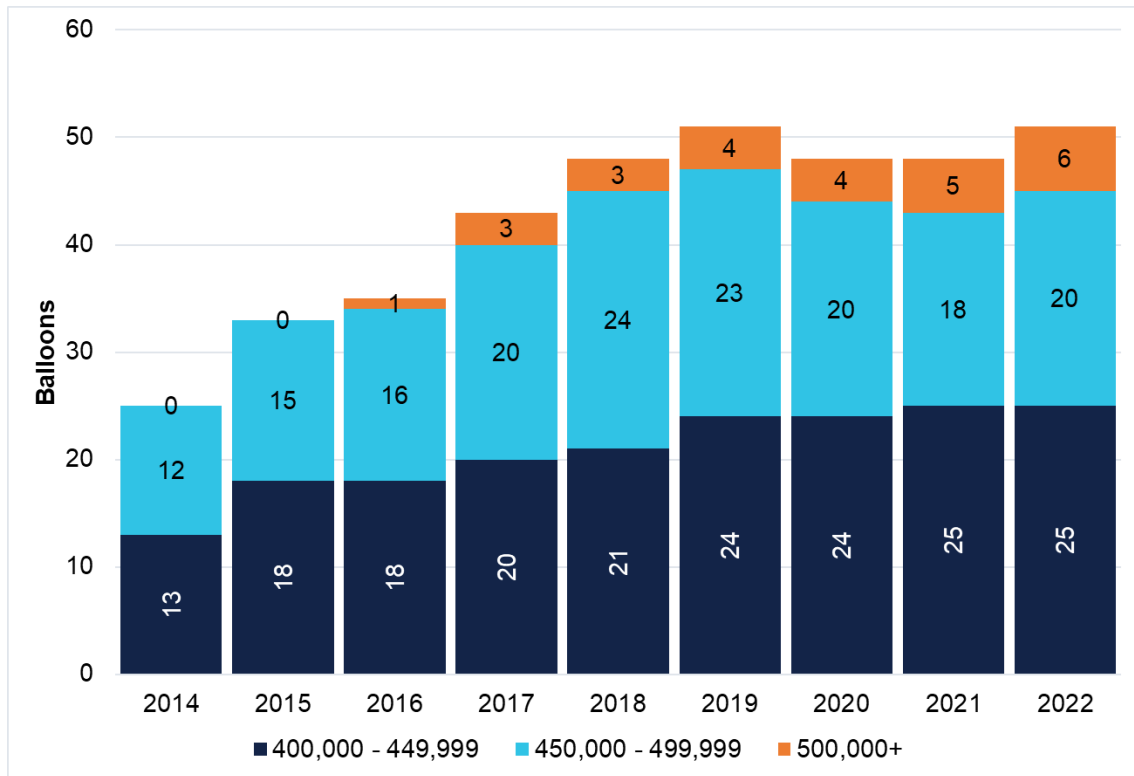
Due to the aircraft register not recording envelope size, the designated model of each balloon was extracted from the database and cross-referenced with manufacturer data to determine the envelope size. Between 2014 and 2022, the total number of VH-registered balloons on the Australian civil aircraft register increased from 386 to 429, an 11% increase. The increase in the number of VH-registered balloons over 400,000 cubic ft is shown in Figure 27.

**Figure 27: Number of VH-registered balloons over 400,000 cubic ft per year (2014–2022)**

At the end of calendar year 2014 there were 25 balloons over 400,000 cubic ft. By the end of 2022 this number had increased to 51, an increase of 104%, with a breakdown as shown in Table 3:

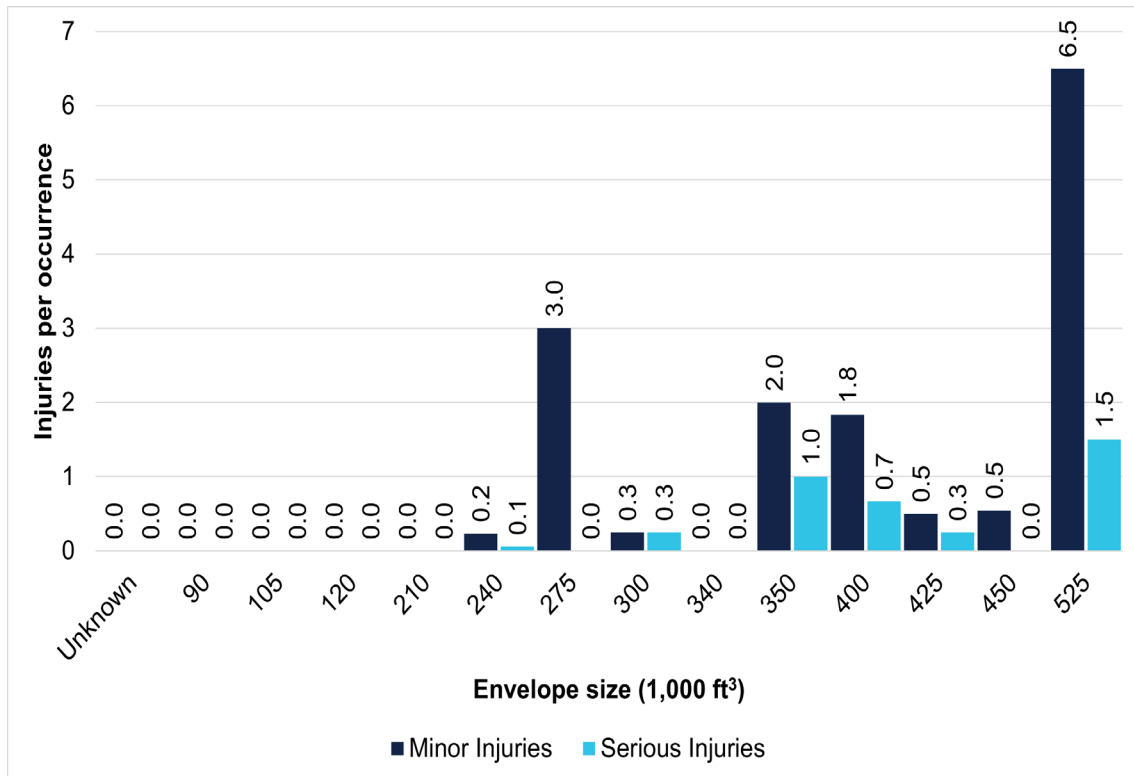
**Figure 28: Average injuries per occurrence by balloon envelope size (2014–2022)**

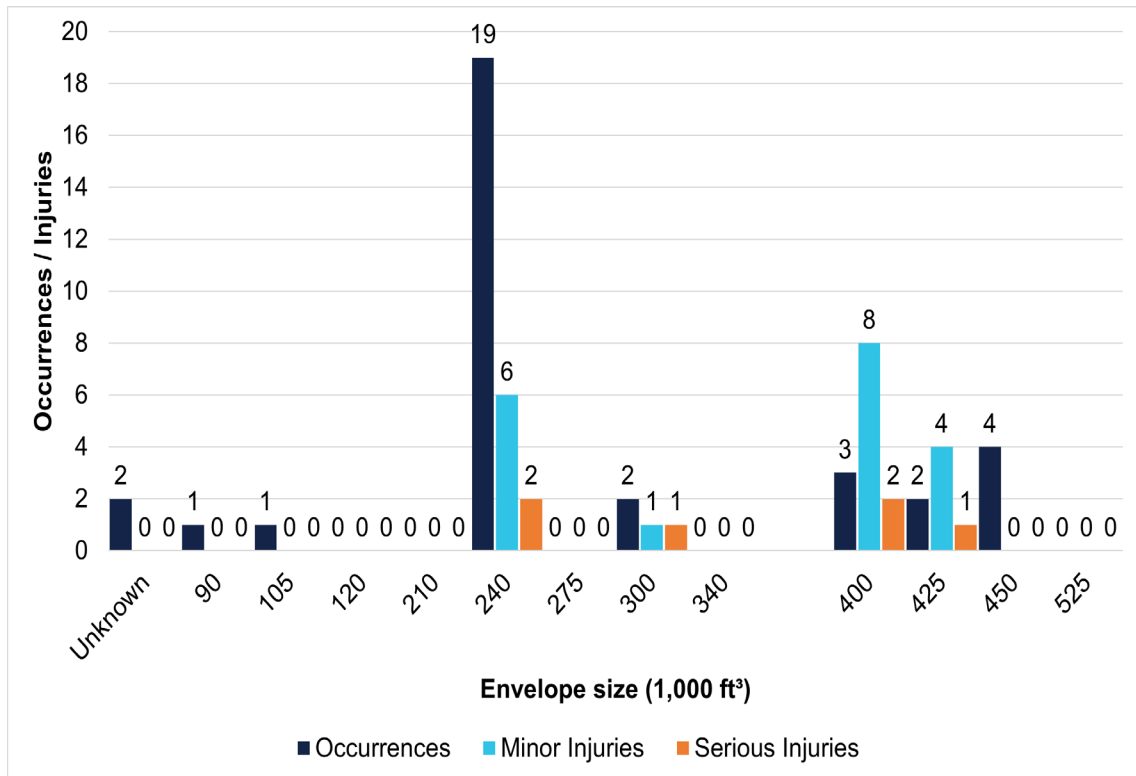
The following was identified with wind as a safety factor (Figure 29):

- the 240,000 cubic ft balloons had the highest number of occurrences with 6 minor injuries and 2 serious injuries from 19 wind-related occurrences
- the 350,000 cubic ft balloons had the highest number of serious injuries with 4 serious injuries from 4 wind-related occurrences
- the 350,000, 400,000 and 425,000 cubic ft balloons had 7 serious injuries, 23 minor injuries out of 9 occurrences combined.

Figure 29: Safety factor of wind by balloon size
