ATSB TRANSPORT SAFETY INVESTIGATION REPORT

Aviation Occurrence Report – 200603111

**Breakdown of separation
17 km west of Melbourne Airport
31 May 2006
VH-VBH
Boeing Company 737-7Q8
VH-UJA
Aero Commander Division 680-FL**

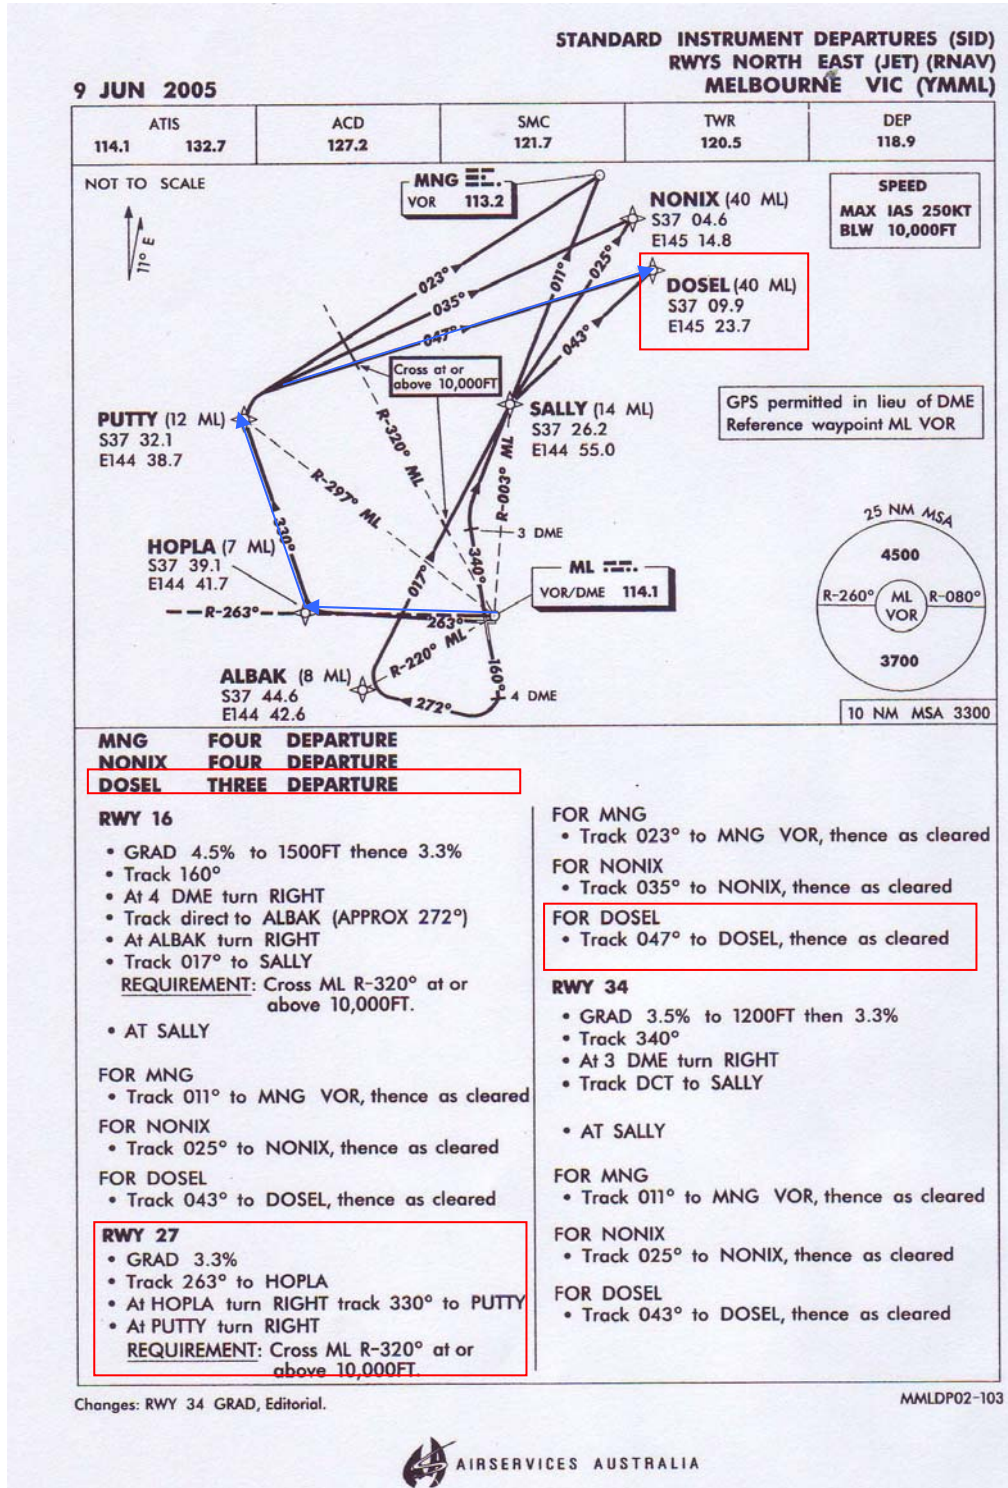
APPENDIX A

Appendix A: Departures and Approach chart showing the runway 27 DOSEL 3 standard instrument departure (SID)
