**ATSB TRANSPORT SAFETY INVESTIGATION REPORT**

Aviation Occurrence Investigation 200700231

**Runway incursion - Port Macquarie Airport**

**Bombardier Inc. DHC-8-315, VH-TQZ**

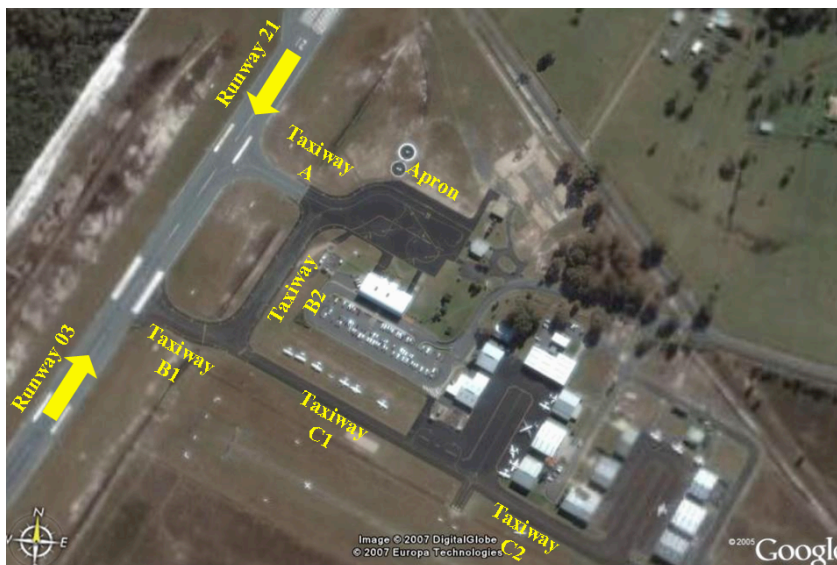
**Figure 1: Aerial photograph of Port Macquarie Airport**

Figure 1 courtesy of Google Earth.
