Aircraft loading occurrences

July 2003 to June 2010

This report documents the number and types of safety occurrences involving loading of high capacity aircraft across a 7-year period to raise awareness within the aviation industry of the associated issues. Incorrect loading of containers, pallets or bags into aircraft can result in them being outside of weight or centre of gravity operating limits, and this may influence aircraft controllability. Most high capacity aircraft loading occurrences are relatively minor, with cargo locks not being raised being the most common. More serious occurrences have involved shifting cargo and unlisted cargo being loaded onto aircraft. Aircraft performance has been affected in a small number of cases, and the result has been rejected takeoff, extra stabiliser trim, or aircraft control difficulties.

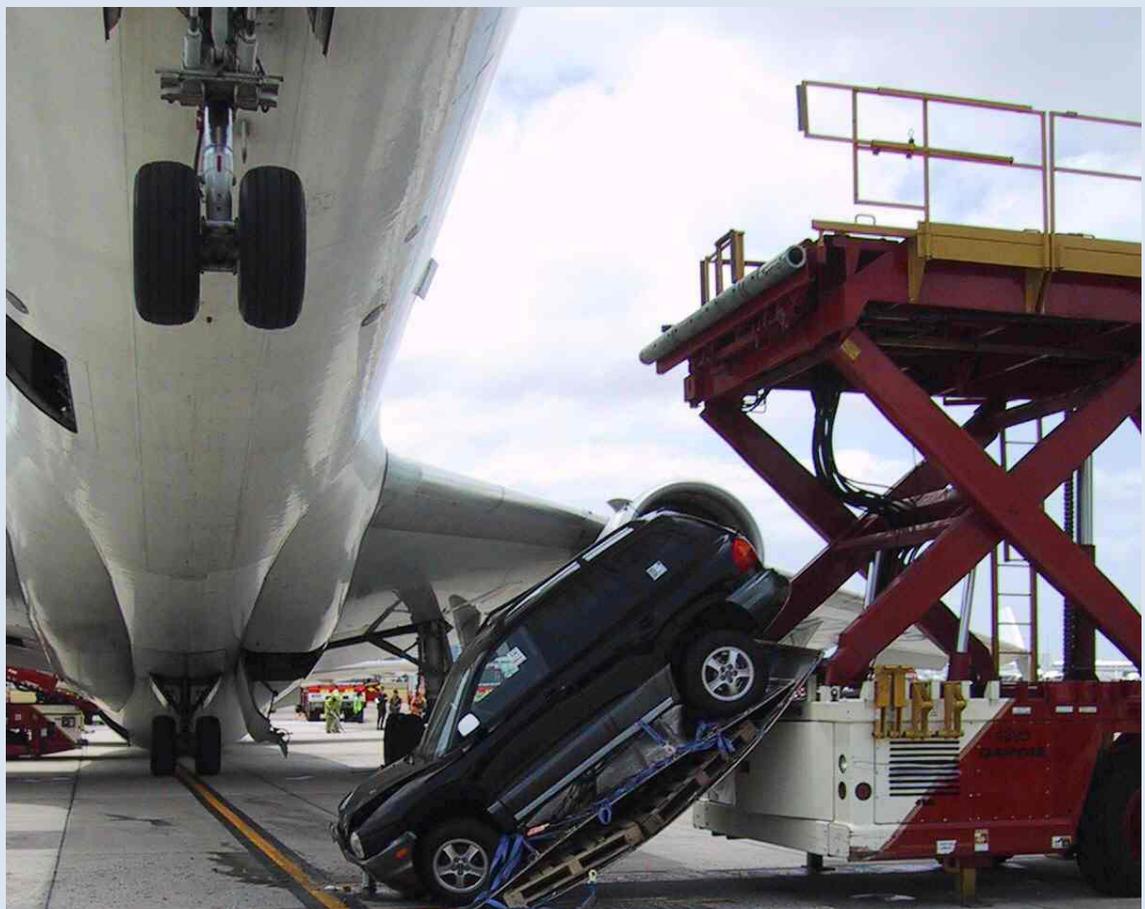
Weight and balance event during unloading

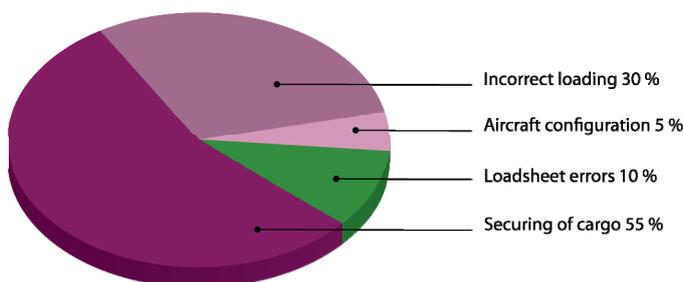
Figure 1: Loading occurrences

Of the 260 loading occurrences, about 55 per cent related to securing of cargo, 30 per cent related to incorrect loading, about 10 per cent to loadsheet errors and 5 per cent to aircraft configuration (Figure 1). Since 2006, reported incorrect loading and securing of cargo occurrences have increased, while configuration and loadsheet errors have remained relatively static.

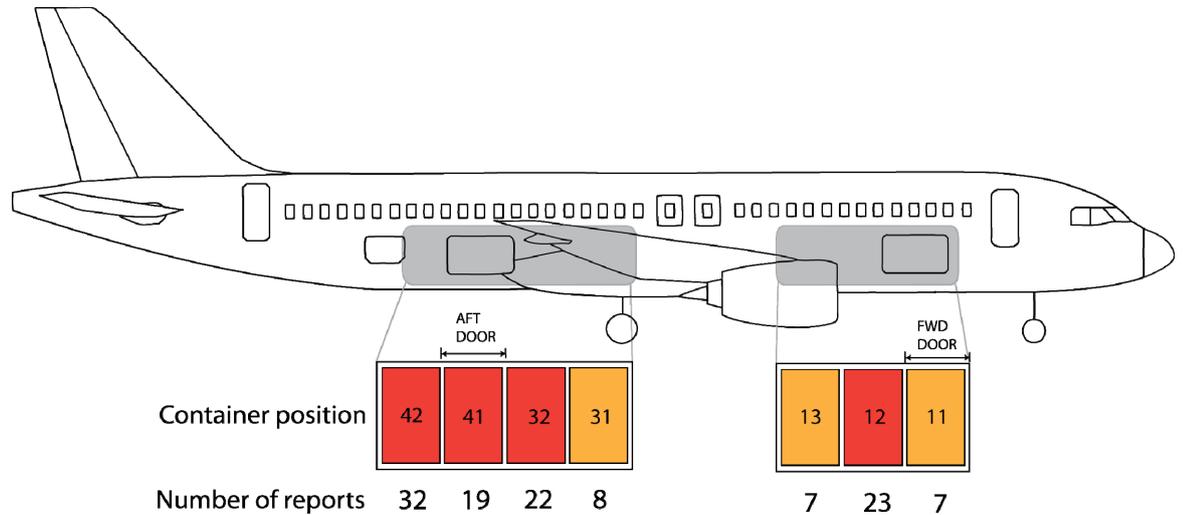
Figure 2: Airbus A320 Cargo locks not raised

The distribution of cargo positions in the Airbus A320-200 (A320) aircraft are shown in Figure 2. The aircraft has forward and aft cargo compartments, with the three forward cargo compartments being in positions 11, 12, and 13, while the aft compartment usually has four positions - 31, 32, 41, 42 (depending on how the aircraft is configured). The red labels in Figure 2 highlight positions where cargo locks are most frequently not raised - these are positions 12, 32, 41 and 42.

The number of reported A320 cargo locks occurrences has diminished since the major portion of the Australian fleet was introduced in late 2005 and early 2006. This seems to suggest that operational experience has improved use of cargo locks by ground staff. The vast majority of occurrences involving cargo locks not being raised were discovered when the aircraft was being unloaded, but occasionally a bump or bang was heard in flight, and inspection of the hold, at the request of the flight crew, found a lock in the lowered position. Not all occurrence notifications specifically mentioned cargo lock serviceability, but where they did, the locks were found to be serviceable. This suggests that these occurrences are related to loading procedures, rather than cargo lock wear and tear.

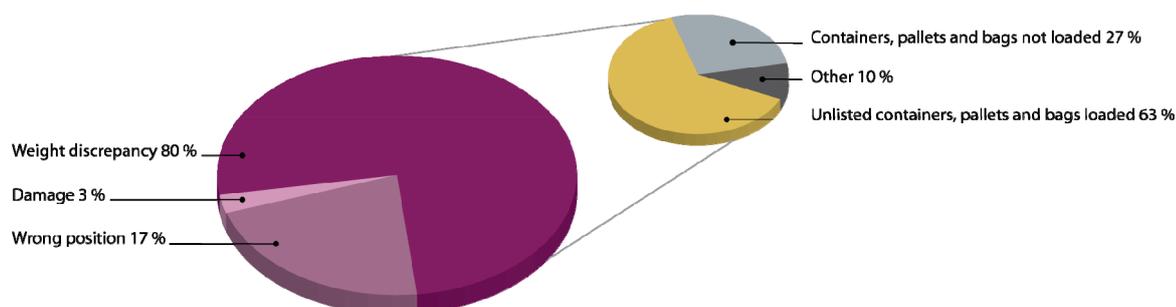
Figure 3: Incorrect loading occurrences

Seventy-eight incorrect loading occurrences were reported to the ATSB over the period 1 July 2003 to 30 June 2010. These related to three main occurrence types: aircraft weight discrepancies; wrong position of containers, pallets or bags in the aircraft; and damage to the aircraft hold (Figure 3). The hazard associated with this type of occurrence is the potential for an aircraft to be out-of-balance.

Weight discrepancy occurrences were mostly a result of either unlisted containers, pallets or bags being loaded, or containers, pallets or bags not being loaded (Figure 3).

The majority of occurrences involving the *Other* category (Figure 3) related to incorrect fuel loads. These were either because too much fuel was loaded on the aircraft, unusable fuel was factored into the fuel uplift, or fuel tanks assumed to be empty contained fuel. One international flight involved a calculation error when pounds were not converted into kilograms. This resulted in the aircraft being lighter by 2,250 kg than the figure recorded on the LIR.

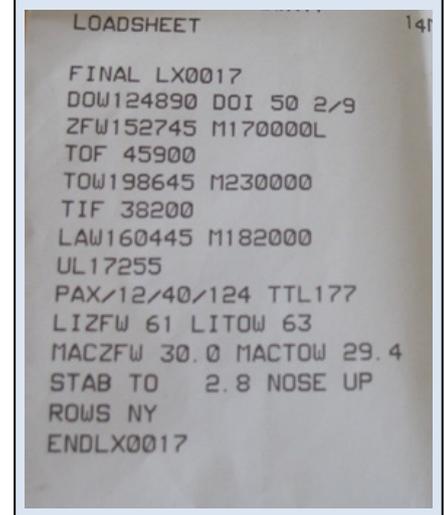
The loadsheet errors have involved incorrect zero fuel weights, receipt of a new loadsheet after takeoff, documentation in relation to rafts and over-water operations not included on the loadsheet, incorrectly recorded weights of cargo and freight items, incorrect aircraft registrations, and calculation of the weight of passengers where there are groups of small children.

Example of a loadsheet printout

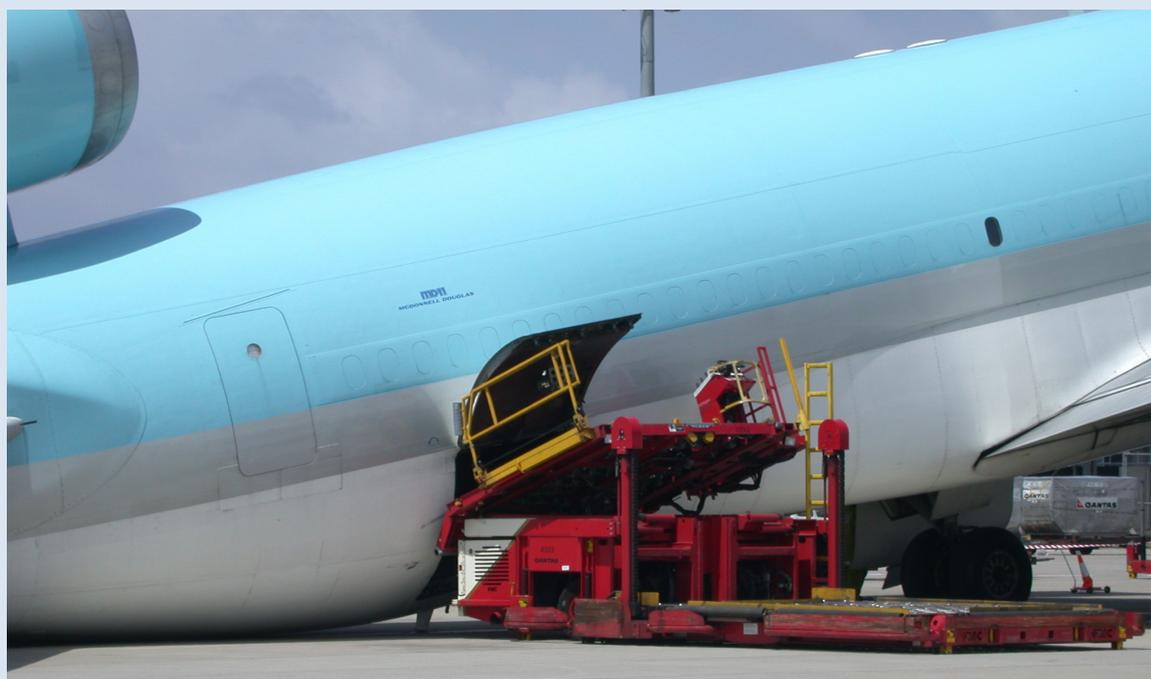
The two disembarkation occurrences involved tail-heavy Boeing 737 aircraft developing nose high attitudes when passengers and cargo were being unloaded. These disembarkation occurrences were identified by ground staff. In the first occurrence, passengers were asked to be seated while the aft cargo holds were emptied. In the second occurrence when the nose of the aircraft rose, the cabin door made contact with stairs.

Incorrect unloading can cause an aircraft to pitch up
