ATSB TRANSPORT SAFETY REPORT

Aviation Occurrence Investigation AO-2008-002

**Operational event
Melbourne Airport, Vic.
31 December 2007
VH-VQT
Airbus Industrie A320 - 200**

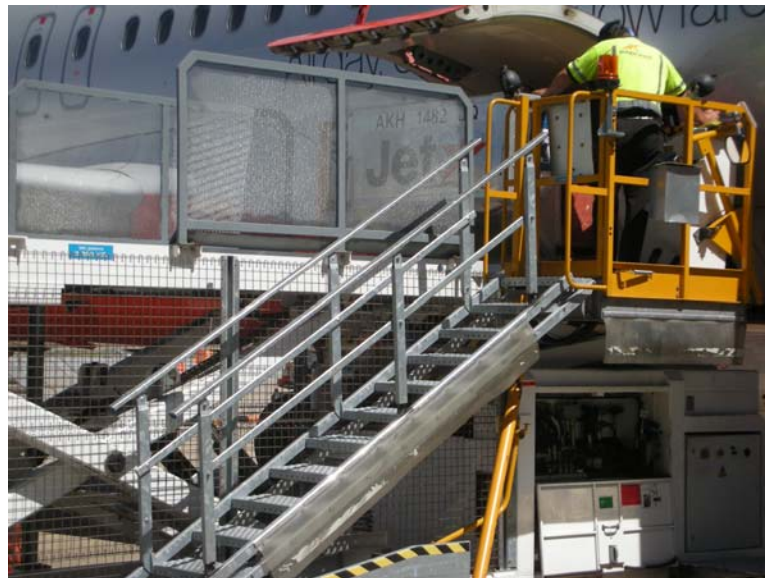
Figure 1: Example of a baggage unit load device being loaded into a similar aircraft

The ground-handling team consisted of a leading hand and three ground crew, one of whom also operated the pallet loader. The team was loading and unloading a number of unit load devices (ULDs) from the aircraft's right forward and aft under-floor compartments (Figure 1).
