REPORT ON THE
PRELIMINARY INVESTIGATION INTO THE
GROUNDING OF MV NELLA DAN
AT MACQUARIE ISLAND ON 3 DECEMBER 1987

April 1988

NELLA DAN PRELIMINARY INVESTIGATION
OUTLINE OF INCIDENT

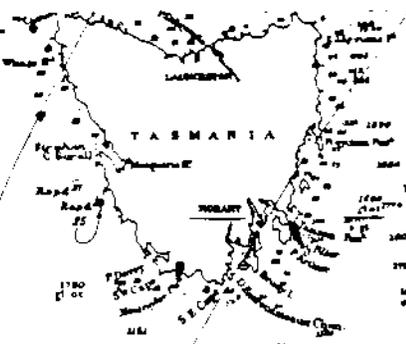
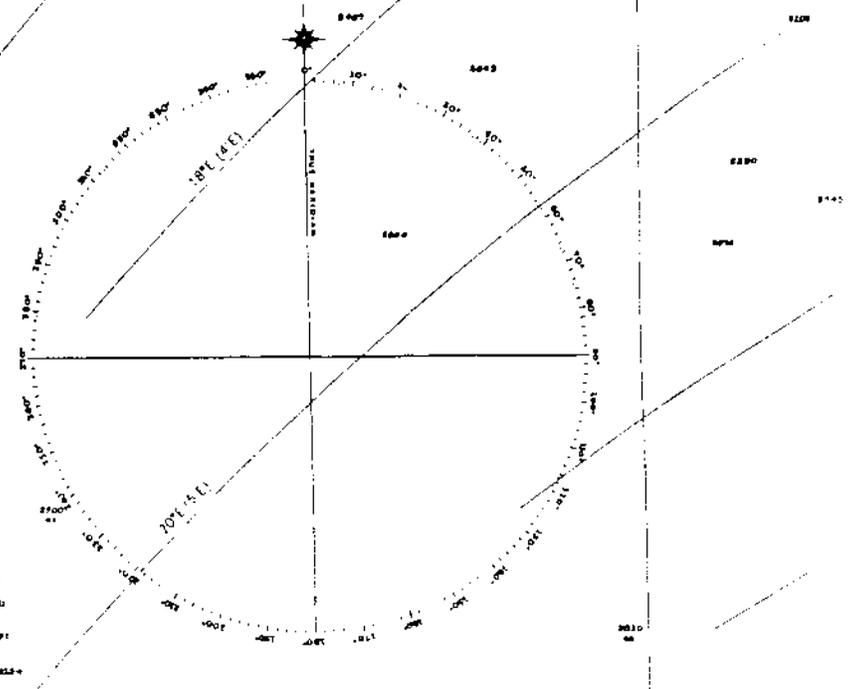
EXTRACT FROM CHART
BA788 SOUTH PACIFIC OCEAN—
WESTERN SHEET

MACQUARIE ISLAND

1970 Rev. 4 30
1966
Aero RC
Macquarie Island Chart No. 1022
1954. Depth to 100 fathoms
from charted soundings

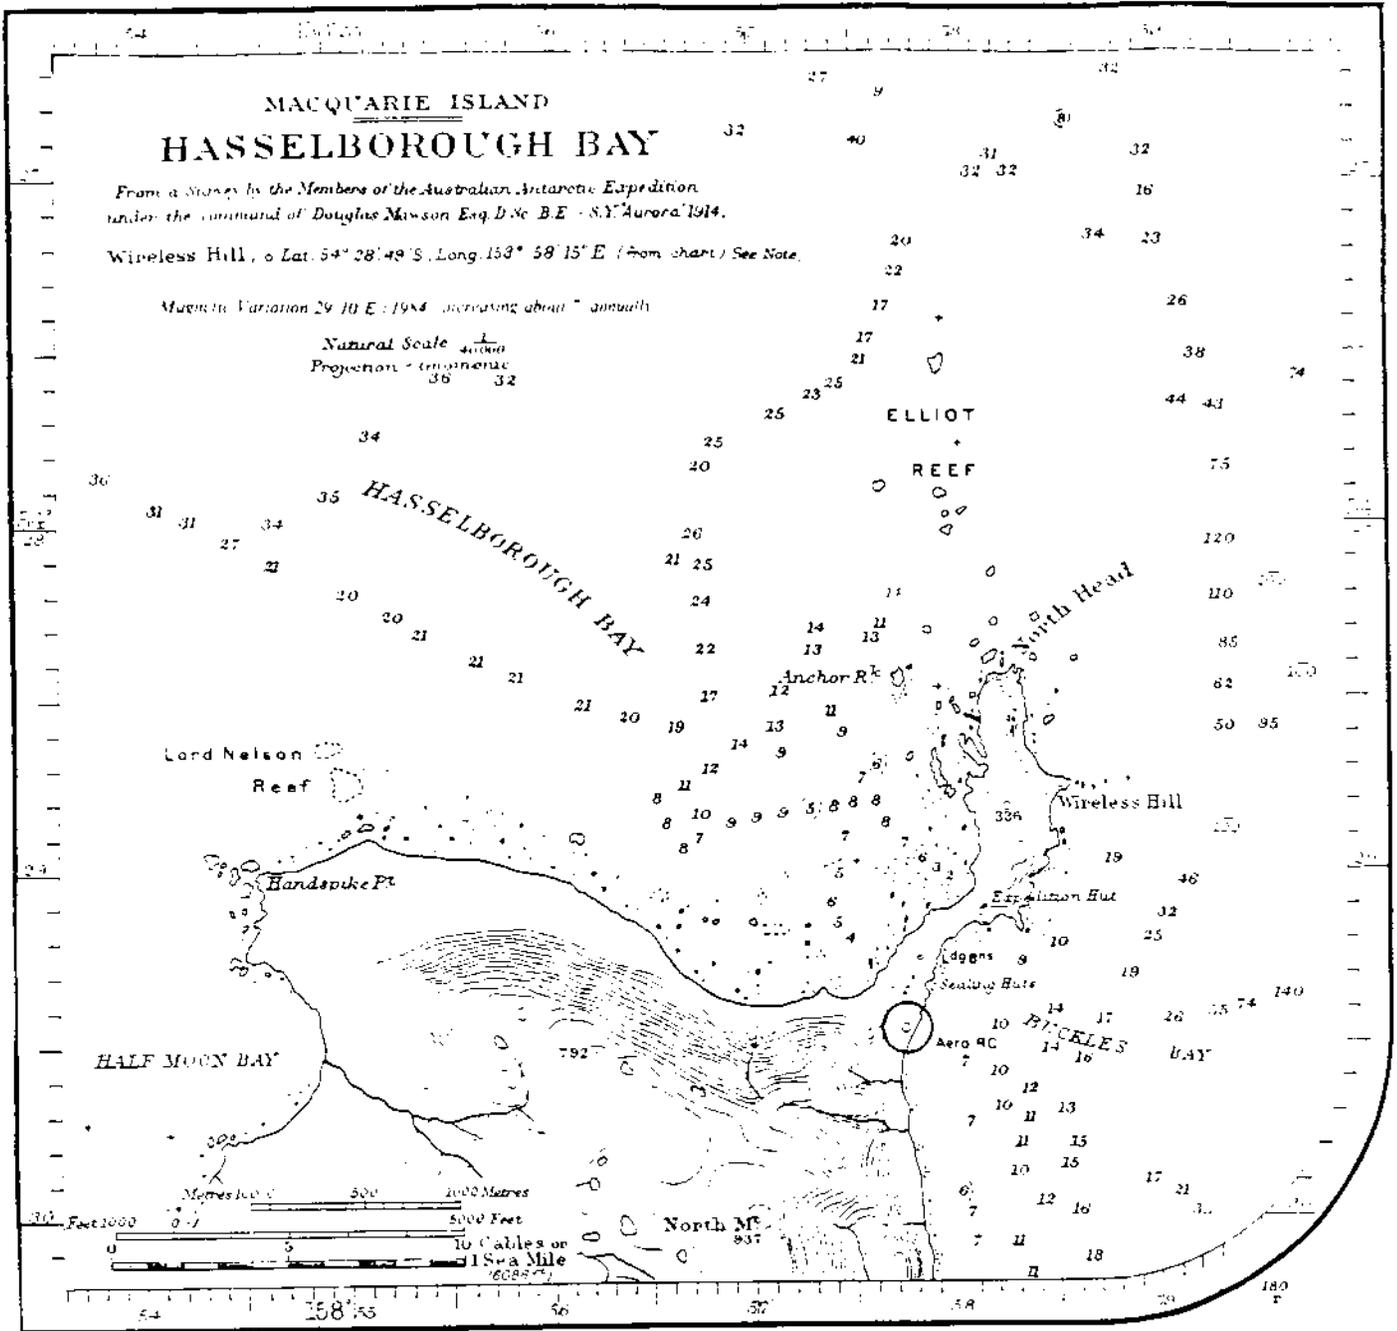
ENLARGMENT OF PORTION OF B.A. CHART 1022 WITH ADDITIONAL

Radius of anchorage with centre C 0.32 miles from front beacon

BUCKLES BAY

SOUNDINGS BY M.V. MAGGA DAN IN 1960

SOUNDINGS IN FATHOMS

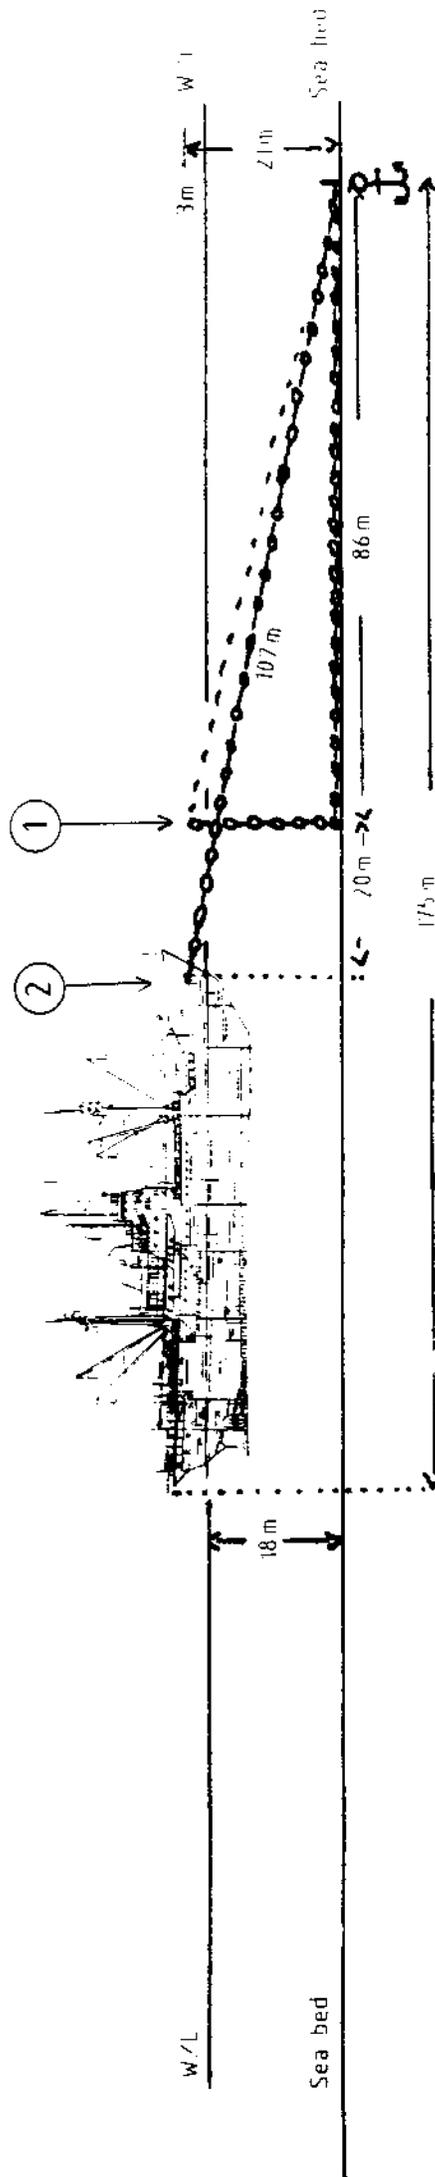
Position 1 cable leading up and down

Position 2 cable taut to anchor no catenary

Vessels at anchor in still conditions normally lie with the anchor and cable fine on the appropriate bow. Wind and tide, however, can cause a ship to yaw* from side to side on the anchor cable. The degree of yaw depends upon the size and trim of the ship and the strength of wind and tide. In certain circumstances the yaw can cause an anchor to break out of its holding ground. From the data log record run in conjunction with the marine science program it is apparent that the 'NELLA DAN' tended to yaw or swing at anchor throughout 2 December (Appendix 3).
