# Under reporting of aviation wirestrikes

**ATSB Transport Safety Report**  
Aviation Research Report  
AR-2011-004  
Final

AR-2011-004

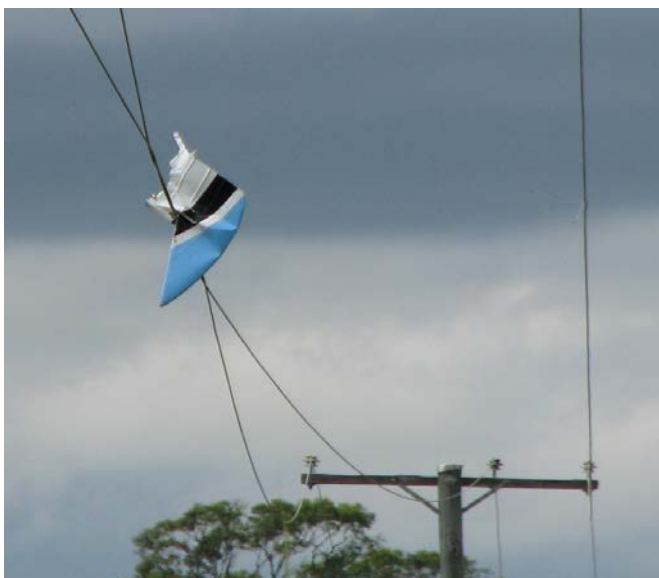
Electricity conductors and detached rudder horn (Investigation AO-2010-026)

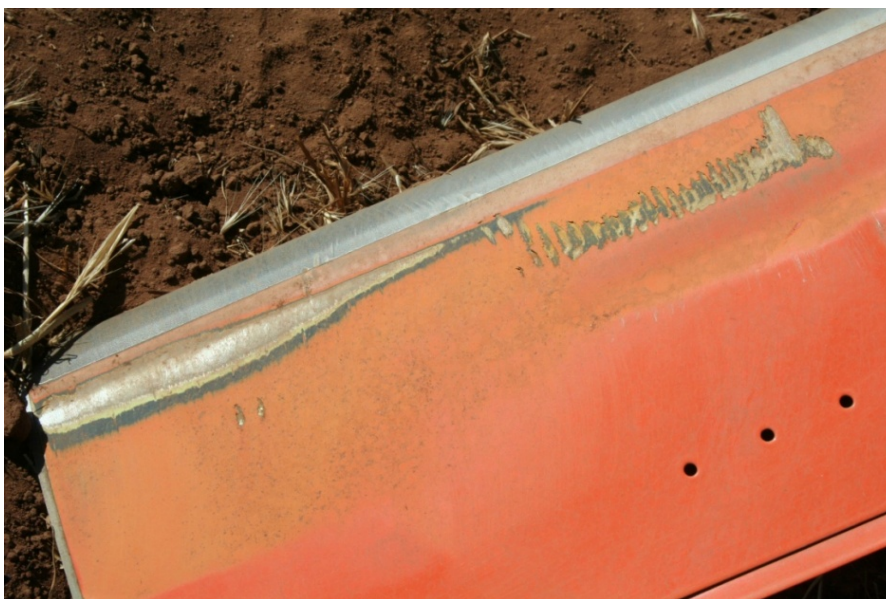
Main rotor blade witness mark tip damage (Investigation AO-2008-078)
