# Collision between two road-rail vehicles

Haig, Western Australia | 24 May 2012

**ATSB Transport Safety Report**  
Rail Occurrence Investigation  
RO-2012-006  
Final – 15 September 2014

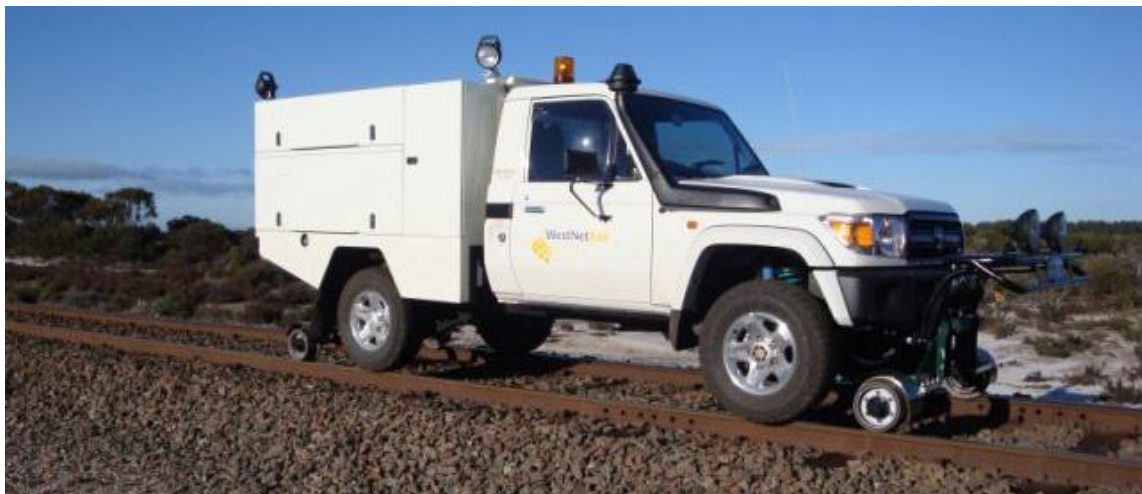
**Figure 4: Non-elevation type rail guidance equipment fitted to a Toyota Landcruiser**

This guidance system is suitable for road vehicles where the vehicle chassis width and tyre position allow for the road tyres to run on the head of the rail. The equipment is lowered into position and the rail wheels engage the rails while all four vehicle road tyres maintain contact on the rail head (Figure 4).

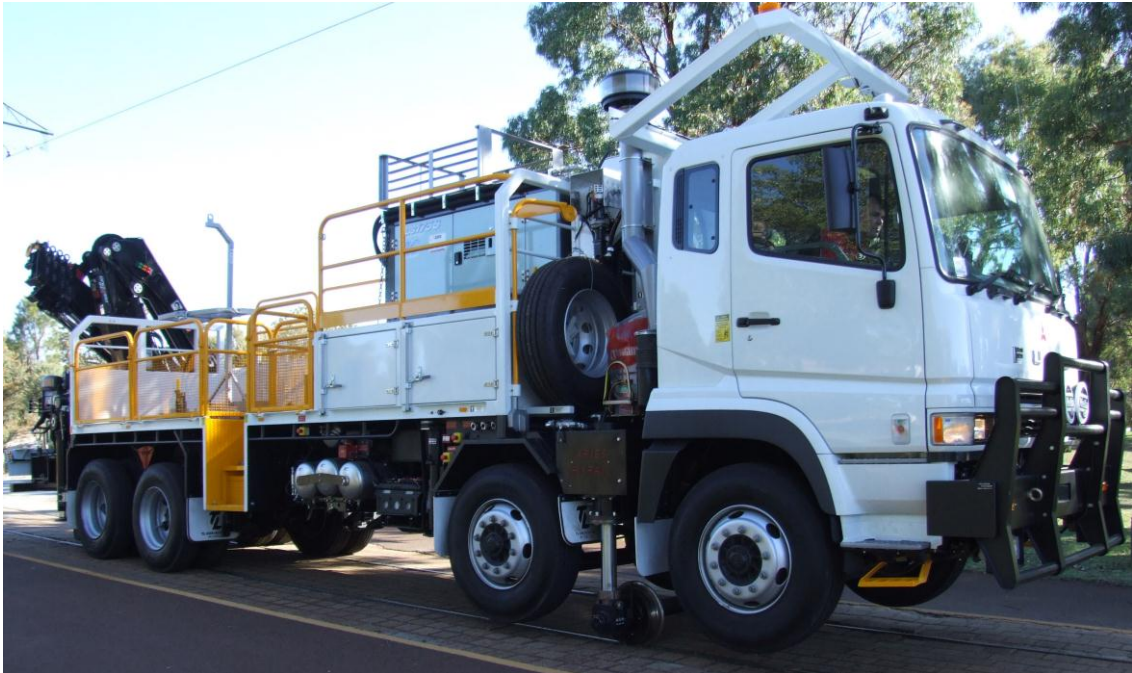
**Figure 5: Elevation type rail guidance equipment fitted to a dual-rear-axle truck**

For dual-wheel rear axle vehicles (such as that of Hino TS63), the rear inner road tyre achieves contact with the head of the rail without modification to the axle and the outer tyre sits outside the head of the rail (Figure 5, Note that the illustration shows a dual-rear-axle truck whereas TS63 was a single-rear-axle truck).
