Emerging trends in Australian aviation safety

July – December 2014

ATSB Transport Safety Report

Aviation trend monitoring

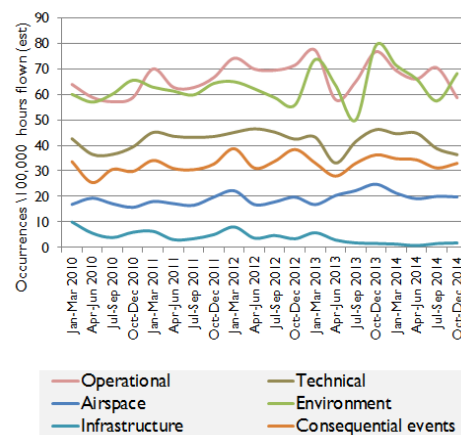
Safety occurrence reporting across all types of Australian aviation – last 5 years

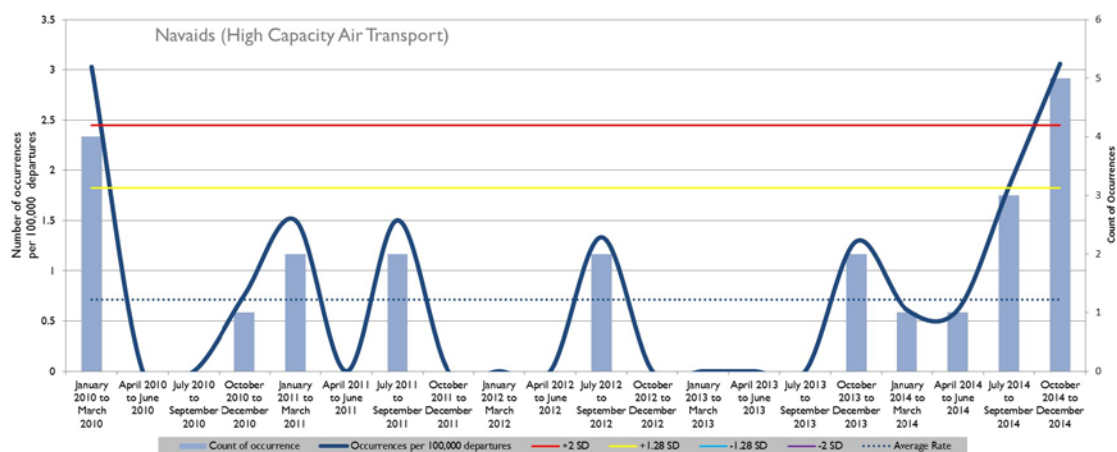
The rate of occurrences reported to the ATSB involving *navigation aids* (navaid) that affected high capacity air transport operations has been consistently above average in the last two quarters.

All eight of the *navaid* occurrences in high capacity operations in the last two quarters involved occurrences on approach to Sydney aerodrome. All eight also involved the same operator and aircraft type (Boeing 737). Seven of the eight occurred on approach to runways 16L and 16R, with the other on runway 07. All of the occurrences were during a GNSS Landing System (GLS) approach and describe a loss of GLS guidance on the aircraft. The GLS is an ILS replacement technology currently installed only at Sydney and previously trialled by one operator only but is now available to all GLS equipped operators. At least six of the eight GLS failures occurred in visual meteorological conditions (VMC) – in two occurrences the flight conditions were not reported. In six of the occurrences the failure was detected between 150 feet and 300 feet above ground level (AGL), one occurrence happened quite a bit higher at 1,300 feet, and in one the altitude was not reported. Although two of the occurrences resulted in an autopilot disconnect, none resulted in missed approaches, and all were classified by the ATSB as low risk occurrences with no accident outcome. None of the *navaid* occurrences between Jul- Dec were investigated by the ATSB.

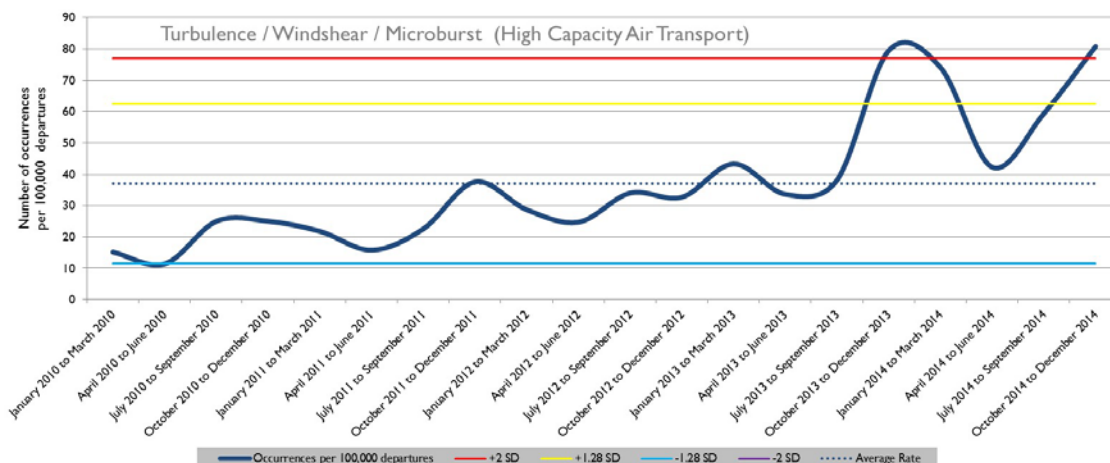
In the second half of 2013 the rate of *turbulence / windshear / microburst* occurrences spiked to a 5-year high. Despite dipping in the first half of 2014 back to near the 5-year average, the rate has spiked again to a similar level as in Oct-Dec 2013.

In the Jul-Dec period there were 229 *turbulence / windshear / microburst* occurrences reported to the ATSB involving high capacity operation. A review of these 229 occurrences shows most involved windshear (57%), clear air turbulence (14%) or wake turbulence (7%), and involve a wide range of operators and aircraft types. A single operator was the major reporter of all *turbulence / windshear / microburst* (42% of all reports). More than half (55%) of all *turbulence / windshear / microburst* occurrences happened on approach. Aircraft overspeed (13%), runway undershoot (11%) and long landing (11%) were the most common effects of *turbulence / windshear / microburst*.

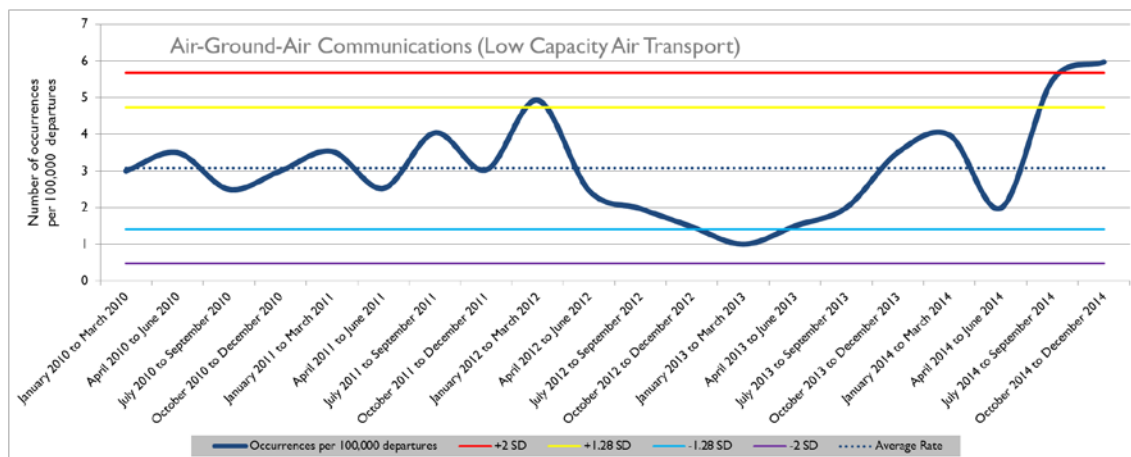
While the number of occurrences is relatively small, the rate of *air-ground-air* communications issues involving low capacity air transport aircraft has been above the 5-year quarterly average in both the Jul-Sep 2014 and Oct-Dec 2014 quarters. A majority of the occurrences involved aircraft undertaking charter operations (16), while seven of the occurrences included an aircraft undertaking low capacity RPT operations.

Most of the occurrences (20 out of 23) in the Jul – Dec 2014 period related to aircraft separation issues, either in the air or on the runway. Two of these occurrences related to *Near Collision* occurrences, both of which occurred within CTAF areas. One of these *Near Collision* occurrences was the subject of an ATSB investigation (AO-2014-175).

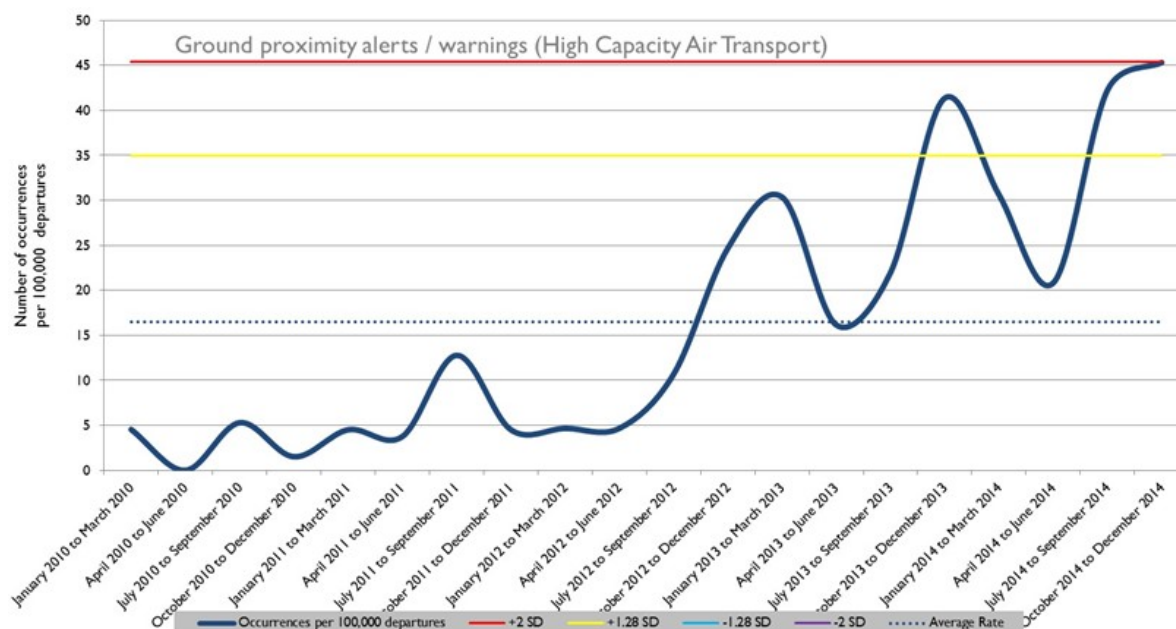
Rates of high capacity air transport *ground proximity alerts / warnings* increased significantly in the first reporting quarter (Jul – Sep 2014), and fell very slightly in the second (Oct -Dec 2014), although the occurrence rate remained significantly higher than the 5-year average.

Between Jul – Dec 2014 there were 143 *ground proximity alerts / warnings* (GPWS) in high capacity operations. Forty-three of these occurred at Sydney, with 23 at Melbourne and 15 at Brisbane. The remaining 63 occurrences were spread over a variety of locations. Of the GPWS occurrences at Sydney, 18 occurred on approach or landing with 24 occurring on climb / initial climb. The majority of the alerts at Sydney were bank angle warnings (20), followed by windshear (14), glideslope (6), pitch (1), and landing gear not down (1). Bank angle warnings were also the most common across all locations with 64 of the 143 (45%) being bank angle warnings, with all but 3 being recorded as genuine warnings.
