Australian Government
Australian Transport Safety Bureau

Safe work on track across Australia

Analysis of incident data, 2009 – 2014

RI-2014-011

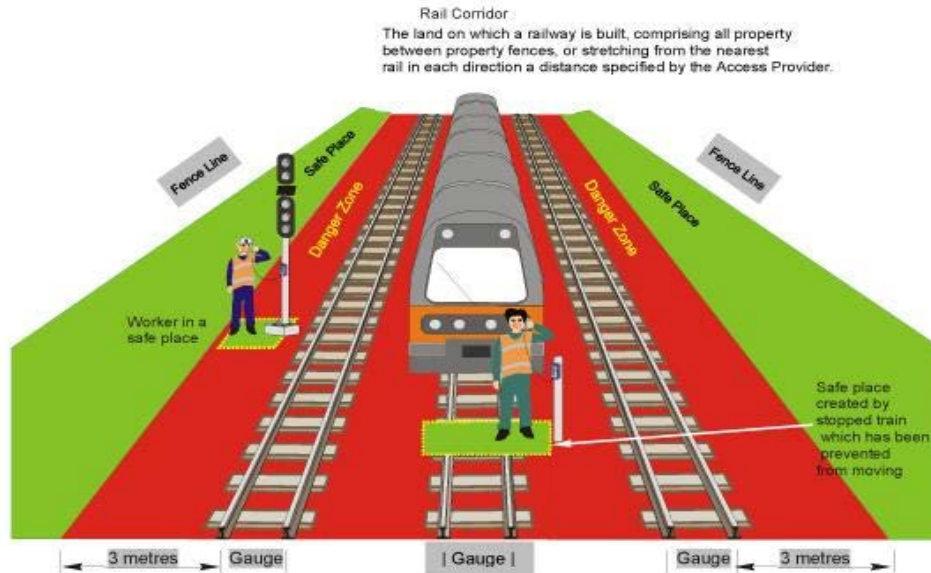
Figure 1: The danger zone

The hierarchical safety measures adopted by all RTO's are generally consistent with the published suite of Australian Network Rules and Procedures (ANRP) developed by the Rail Industry Safety Standards Board (RISSB). Track workers planning work in a rail corridor must assess the implications to safety and the potential for their work to intrude into the *danger zone* (Figure 1). Usually, any work in the danger zone must not:

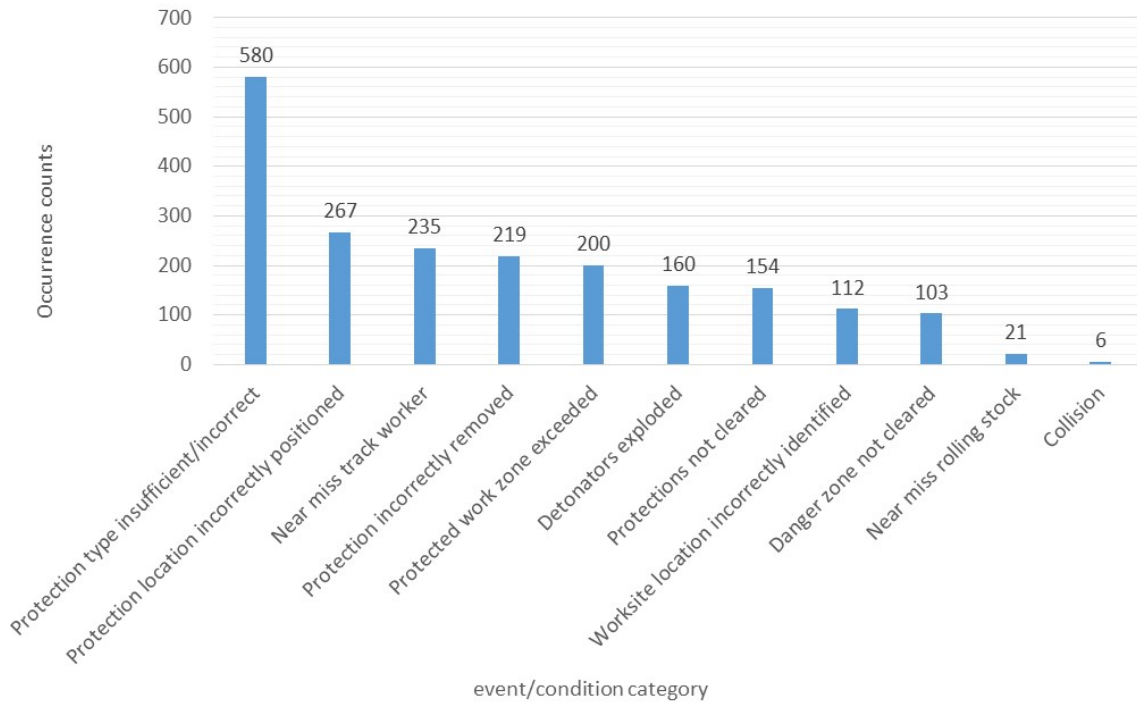
Figure 2: Counts of work on track occurrences by event/condition categories category, June 2009–June 2014

The distribution of the 1,779 safe work on track occurrences between the 11 categories is shown in Figure 2. It can be seen that occurrences where the protection applied was either insufficient or incorrect were the most commonly featured event category between July 2009 and July 2014. This occurrence category (580 occurrences) was nearly twice as common as the next most frequent, where protection systems were incorrectly positioned (267 occurrences).

Protection type insufficient or incorrect was the most commonly featured (Figure 2) of all the work on track occurrences. Although there were a large number of occurrences (581), the assessed risk exposure for majority were either neutral or low. However, the number of occurrences when multiplied with the assigned risk value resulted in the relatively high ranking (Figure 5) of this event category.

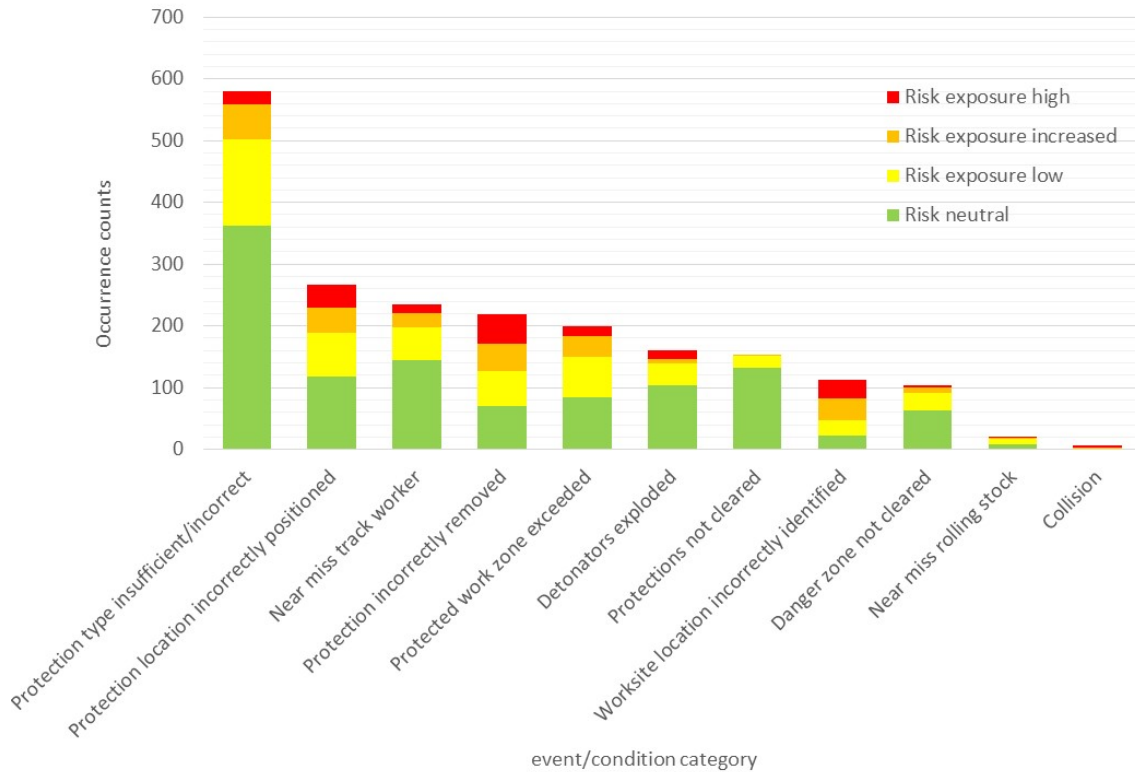
Figure 3: Occurrence counts as a function of event/condition category and risk rating

Figure 3 shows the number of occurrences per risk level for each of the 11 event/condition categories. Figure 4 shows the risk ratings as a proportion of the total number of occurrences within that category.

While most of the event/condition categories had a high proportion of risk neutral classified occurrences, of particular concern were the occurrences where the defences that were in place failed to maintain track worker safety. These higher risk occurrences, (red in Figure 3 and Figure 4), give an indication of the event/condition categories more likely to result in injury to track workers.

The classification of a risk category for each occurrence allows the sum of risk for each of the occurrence categories to be considered. The sum of risk takes into account both the frequency of occurrences shown in Figure 2 as well as risk rating, shown in Figure 3.

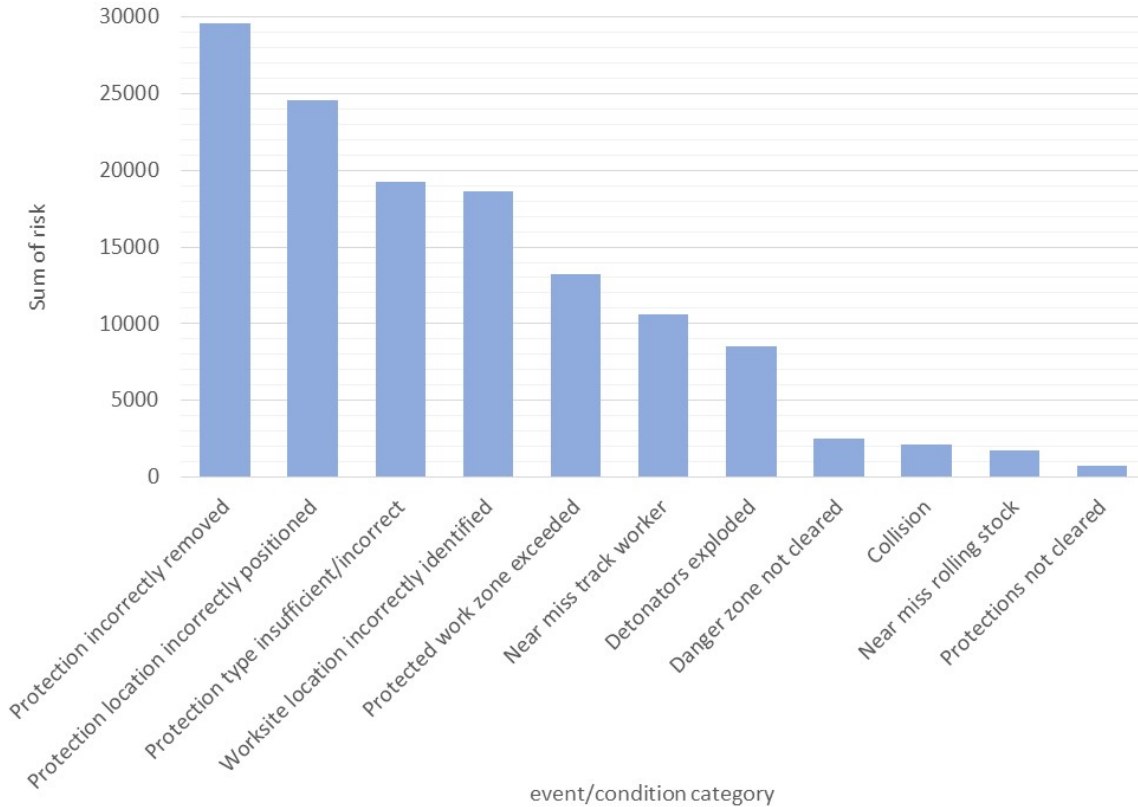
Figure 5: Sum of risk for each event/condition category

Using a similar methodology, the four risk categories discussed above were assigned a risk value and multiplied by the number of occurrences to obtain the sum of risk. In this way the sum of risk integrates both the frequency and severity of potential outcomes for each of the occurrence categories. Figure 5 illustrates the occurrence categories in order of sum of risk.

The four categories assessed as having the highest sum of risk were:

- protection incorrectly removed
- protection location incorrectly positioned
- protection type insufficient/incorrect
- worksite location incorrectly identified.

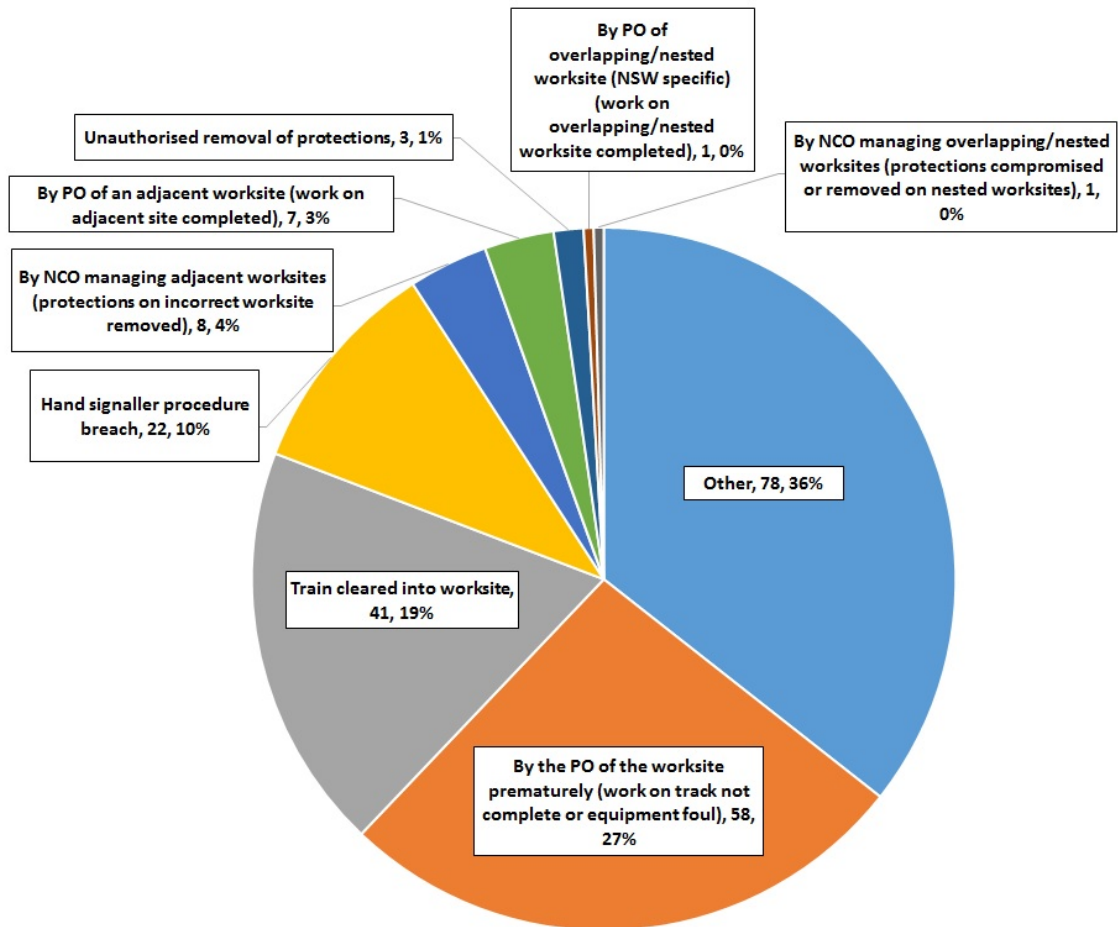
Figure 6: Protections incorrectly removed and subcategories

There were 219 occurrences where the protections were incorrectly removed. About 22 per cent of these occurrences exposed workers to a high risk. Figure 6 illustrates the most common (subcategory) events that contributed to protections being incorrectly removed.

About a quarter (26%) of occurrences where protection was incorrectly removed were attributable to the protection officer prematurely removing site protections before the work on track was complete or before work equipment was removed from the danger zone. Another 41 (19%) were as a result of trains inadvertently being cleared into active worksites. Twenty-two occurrences (10%) were a result of incorrect procedures used by hand signallers.

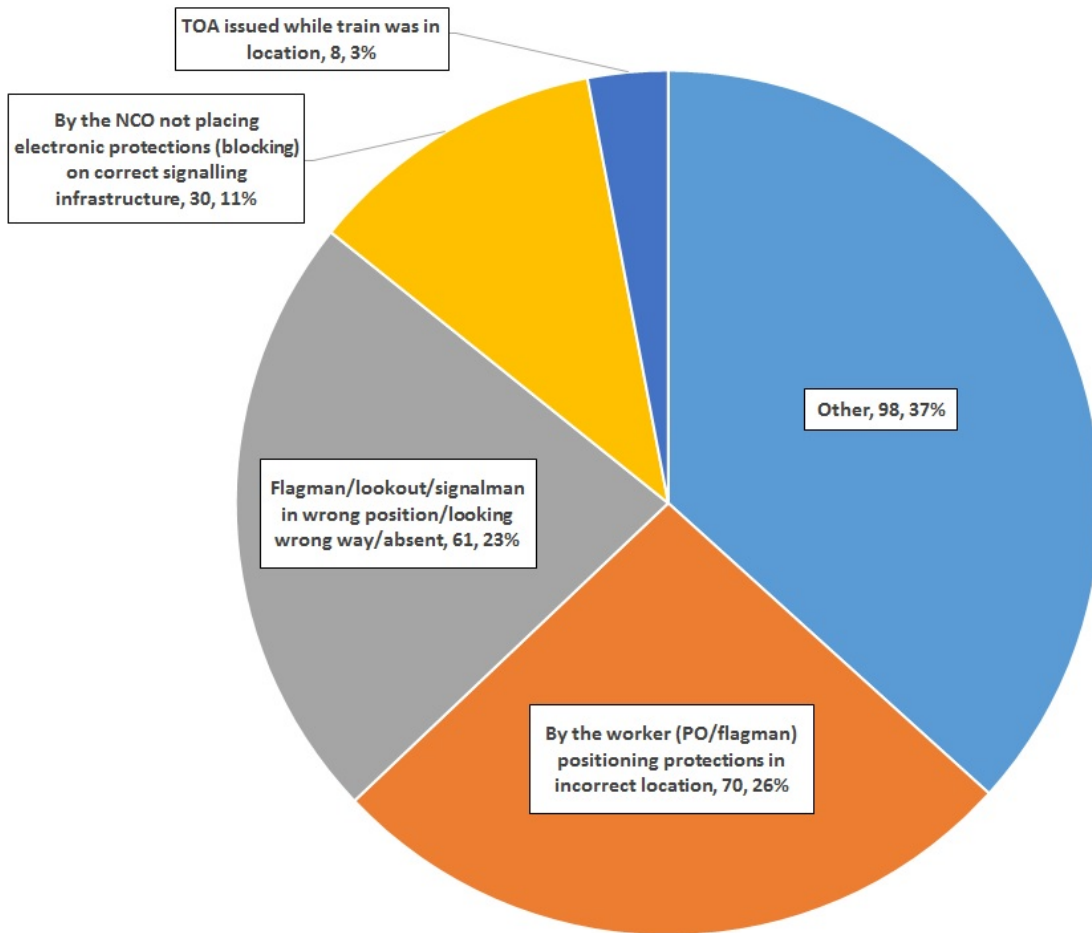
Figure 7: Protections incorrectly positioned and subcategories

There were 267 occurrences where the protections were incorrectly located. About 14 per cent of these exposed workers to a high risk. Figure 7 illustrates the most common (subcategory) events that contributed to the protections being incorrectly located.

About a quarter (26%) of occurrences where the protections were incorrectly located were due to either the protection officer or flagman putting the protections in the wrong location. There were 61 instances (23%) where the flagman was facing the wrong way, absent, or in the wrong position, (these also include accounts of flagmen in their vehicles, and/or having lunch, and/or on telephones, and/or asleep while on duty). There were 30 accounts (11%) where network control officers did not implement electronic (blocking) protections in the correct location. The remaining eight were due to the issuing of TOA's while trains were still in the section.

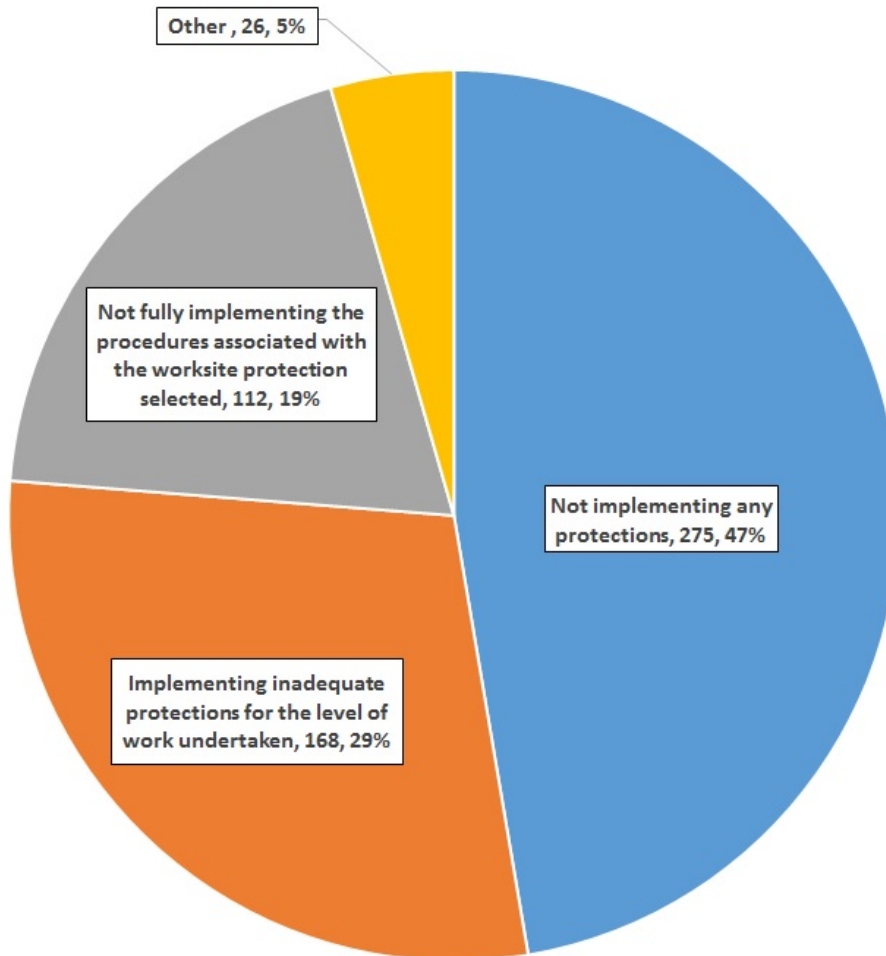
Figure 8: Protection type insufficient / incorrect and subcategories

Figure 8 illustrates the most common (subcategory) events that contributed to reports of incorrect or insufficient protection.

Occurrences relating to the protection type being insufficient or incorrect contained a broad spectrum of reported events and conditions. Almost half (47%) related to train drivers observing persons or vehicles within the rail corridor, without any advice to the train crew or discernible trackside protection arrangements in place. Many reports by the drivers arose from the unauthorised entry by rail maintenance crews, utility providers or contractors into the rail corridor, but not necessarily within the danger zone itself.

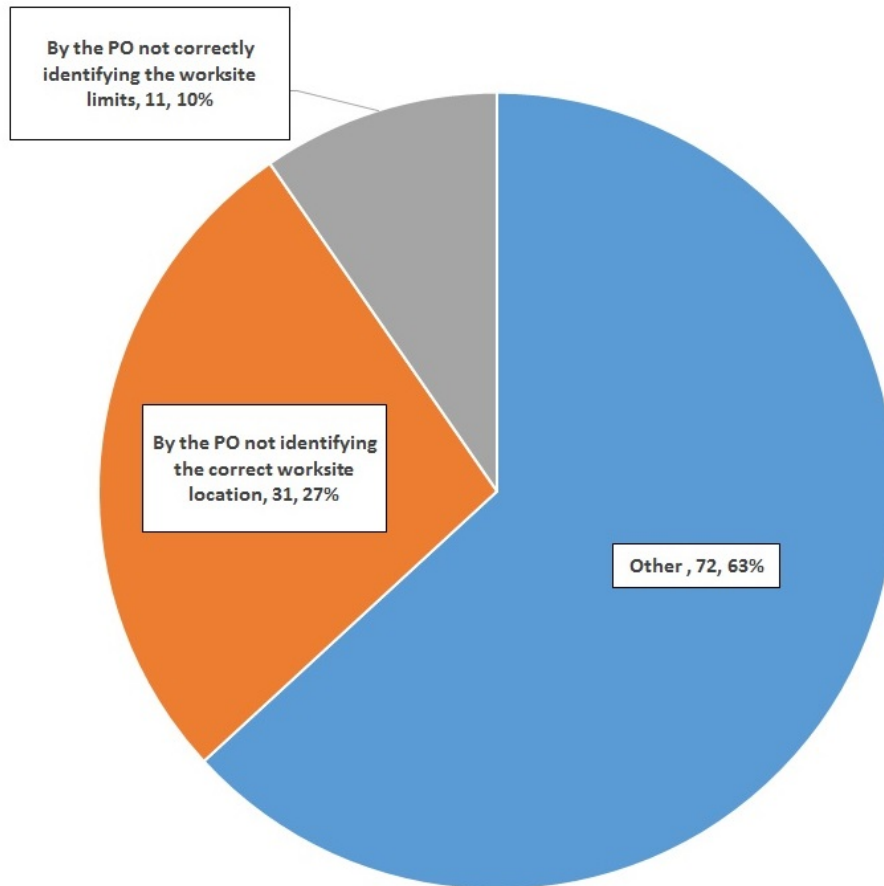
Figure 9: Worksite location incorrectly identified and subcategories

There were 114 occurrences where the worksite location had been incorrectly identified. Figure 9 illustrates the most common (subcategory) events that led to the incorrect identification of worksite locations.

Thirty-one occurrences (27%) reported that the protection officer did not identify the correct worksite location. In another 11 occurrences (10%), the protection officer did not correctly identify the worksite limits.

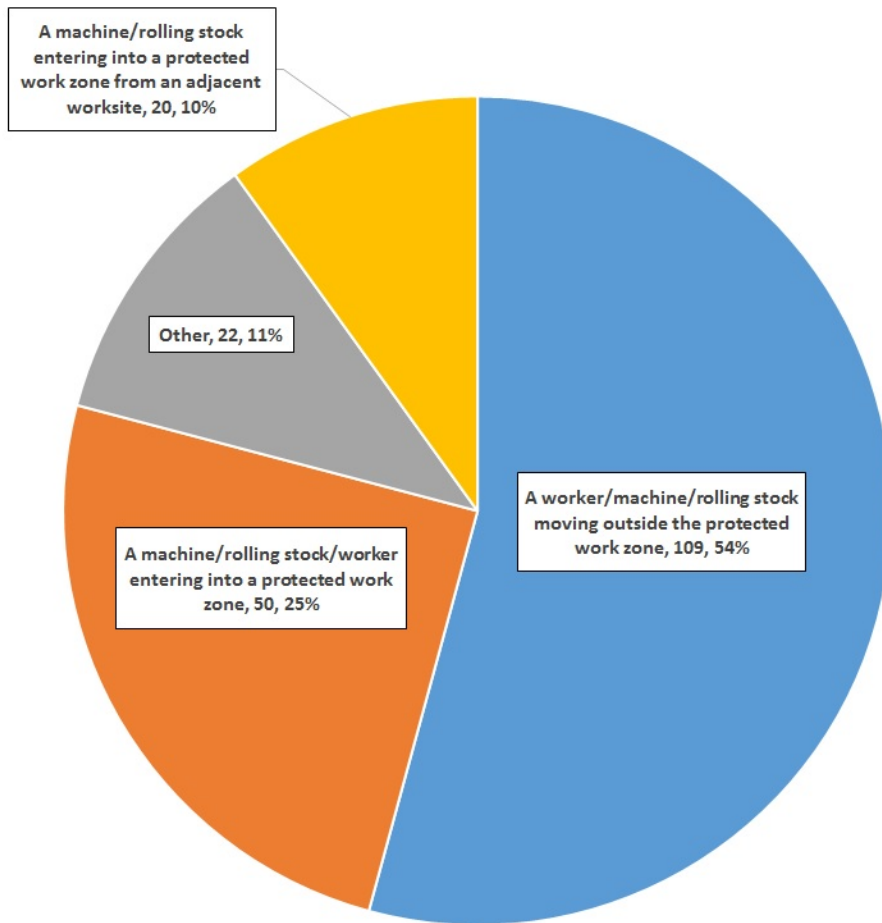
Figure 10: Protected work zone exceeded and subcategories

Occurrences where the protected work zone was exceeded included where workers, machines or equipment were in the danger zone but outside of the protected area. The category also picked up occurrences where other workers or machines had entered a worksite without the knowledge of the protection officer.

Of the 201 occurrences, just over half (54%) were as a result of a workers or machines moving outside the protected work zone. Fifty (25%) were due to workers or machines entering into a protected work zone and another 20 (10%) due to workers or machines entering from an adjacent worksite.

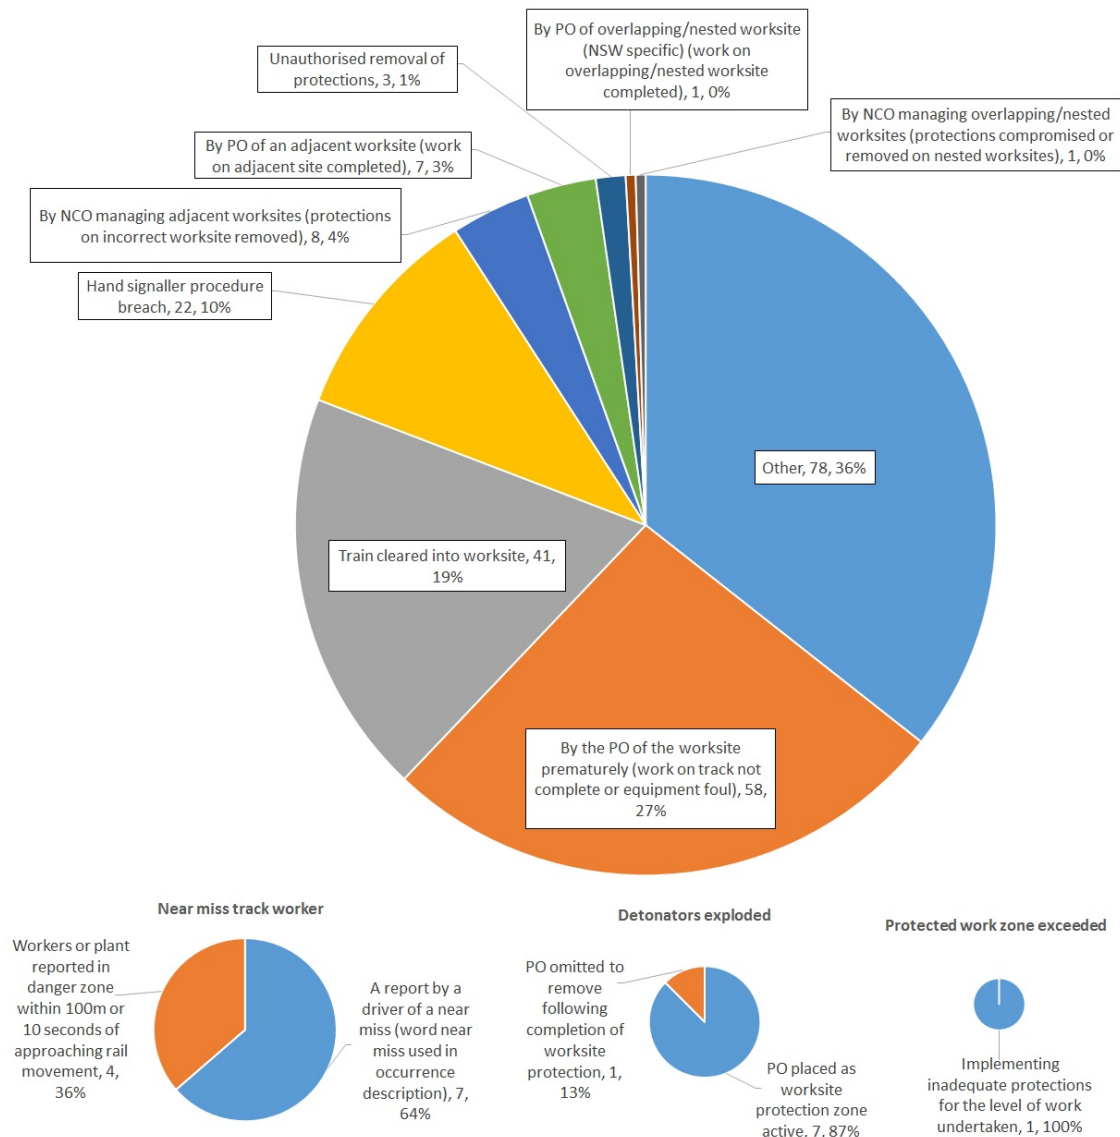
Figure 12: Protections incorrectly removed

Figure 12 illustrates the types of events (likely antecedents) which resulted in occurrences reports (219) where the protections were incorrectly removed. The diagram also illustrates the 20 recorded occurrences which featured in three other occurrence categories.

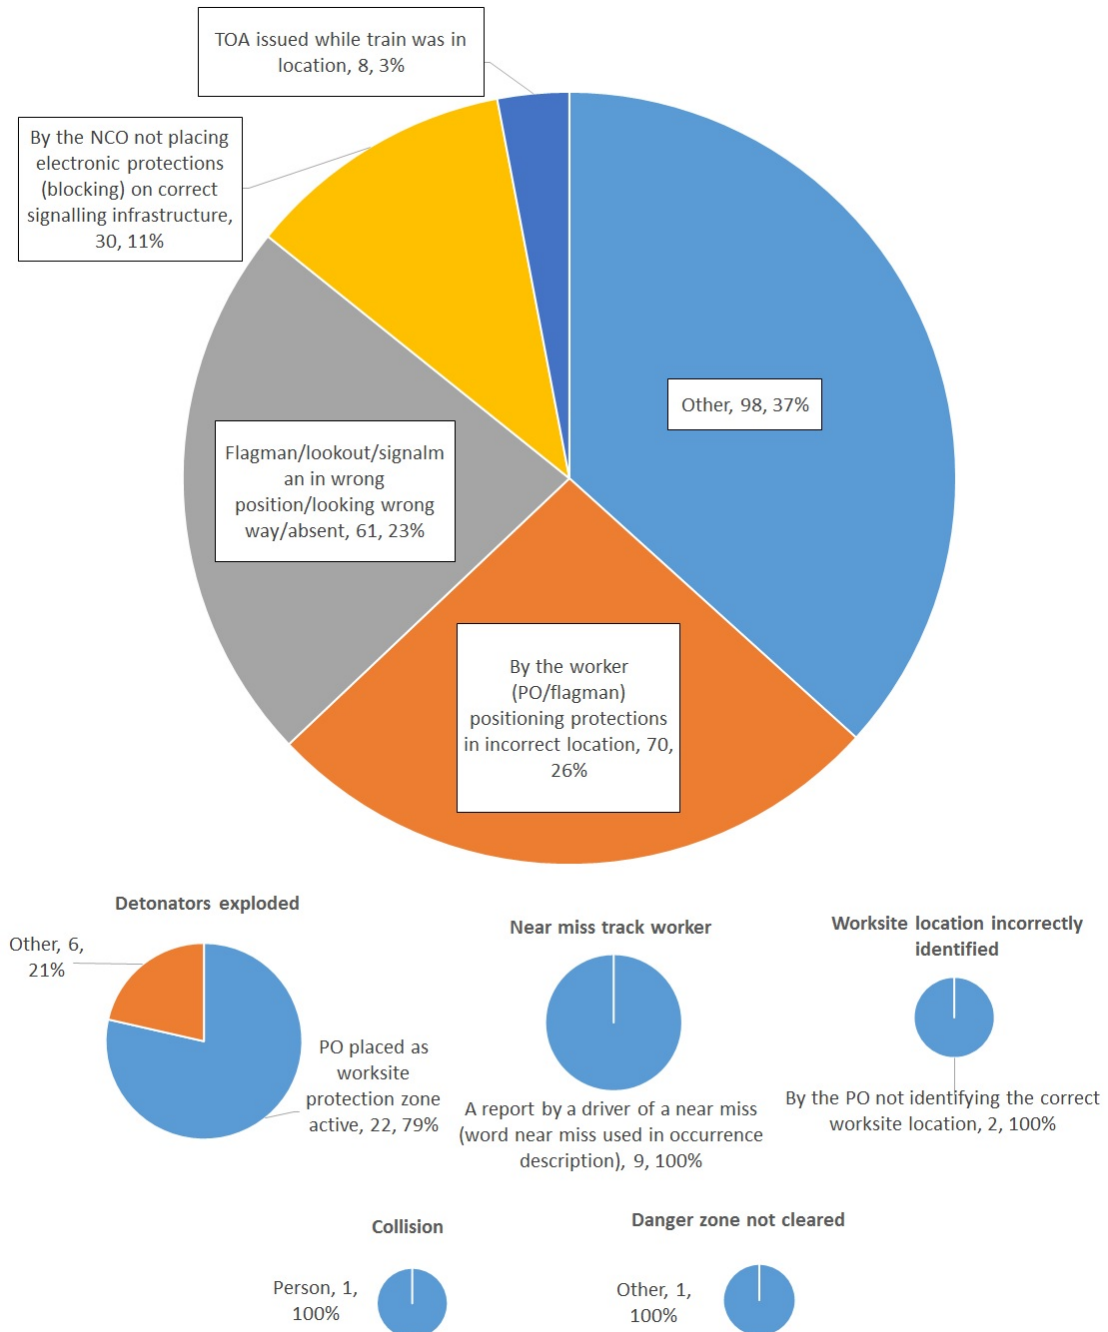
Figure 13: Protection location incorrectly positioned

Figure 13 illustrates the types of events (likely antecedents) which resulted in occurrences reports (267) where the protections were incorrectly positioned. The diagram also illustrates the 41 recorded occurrences which featured in five other occurrence categories.

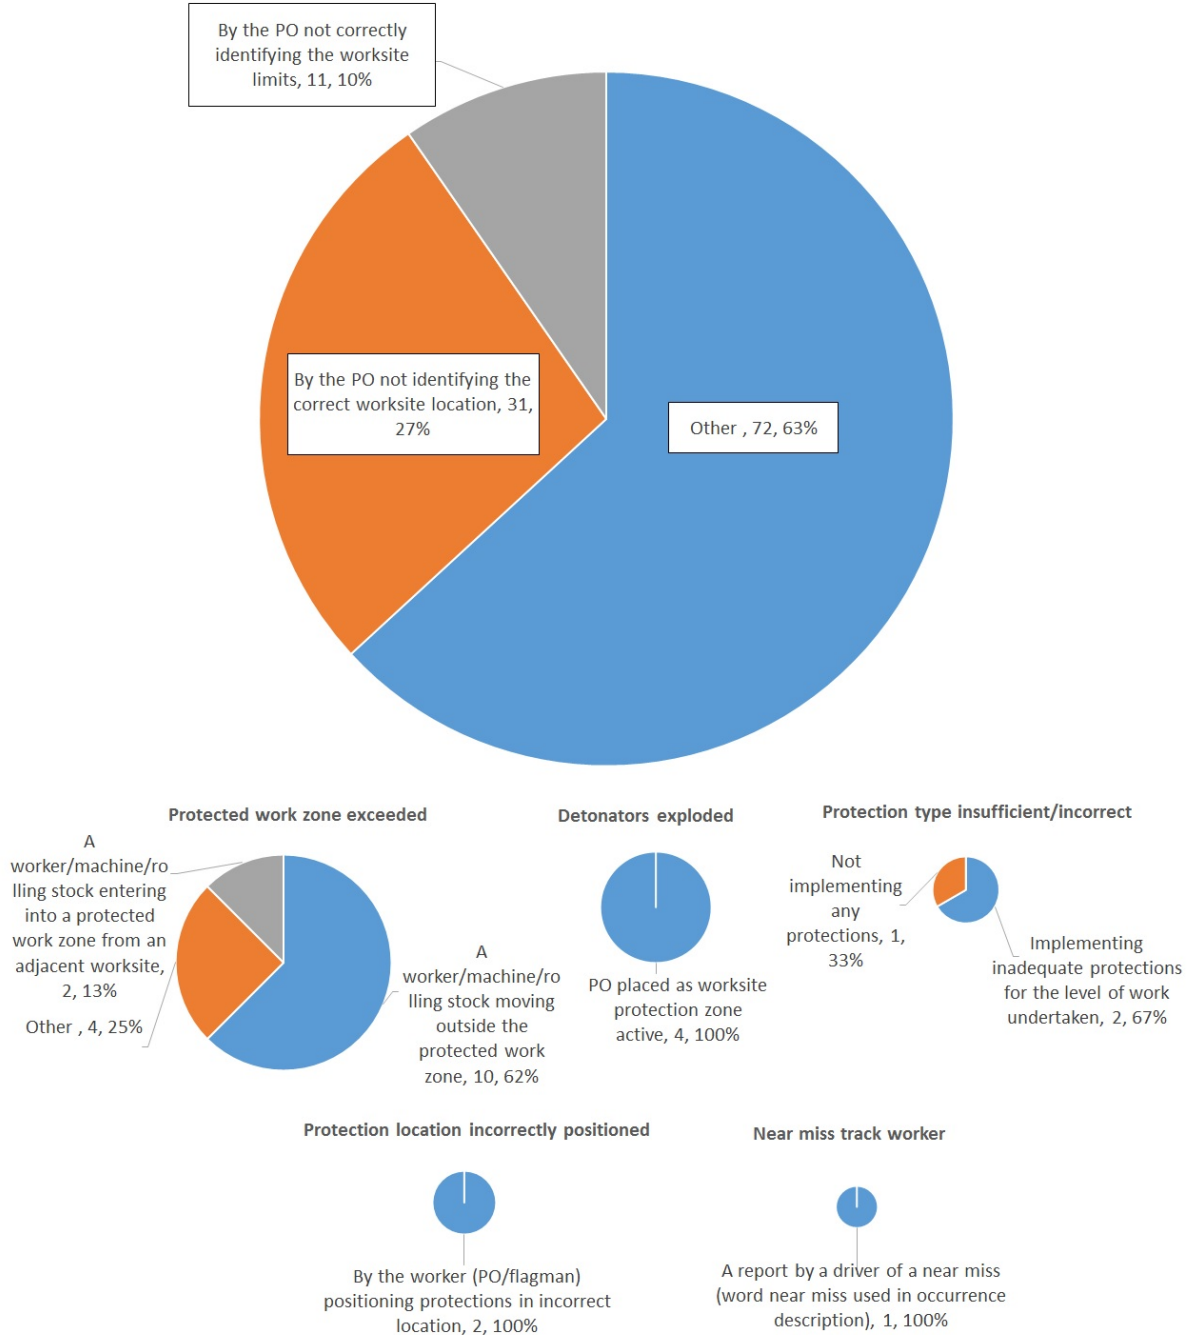
Figure 15: Worksite location incorrectly identified

Figure 15 illustrates the types of events (likely antecedents) which resulted in occurrences (114) where the worksite location was incorrectly identified. The diagram also illustrates the 26 recorded occurrences which featured in five other occurrence categories.

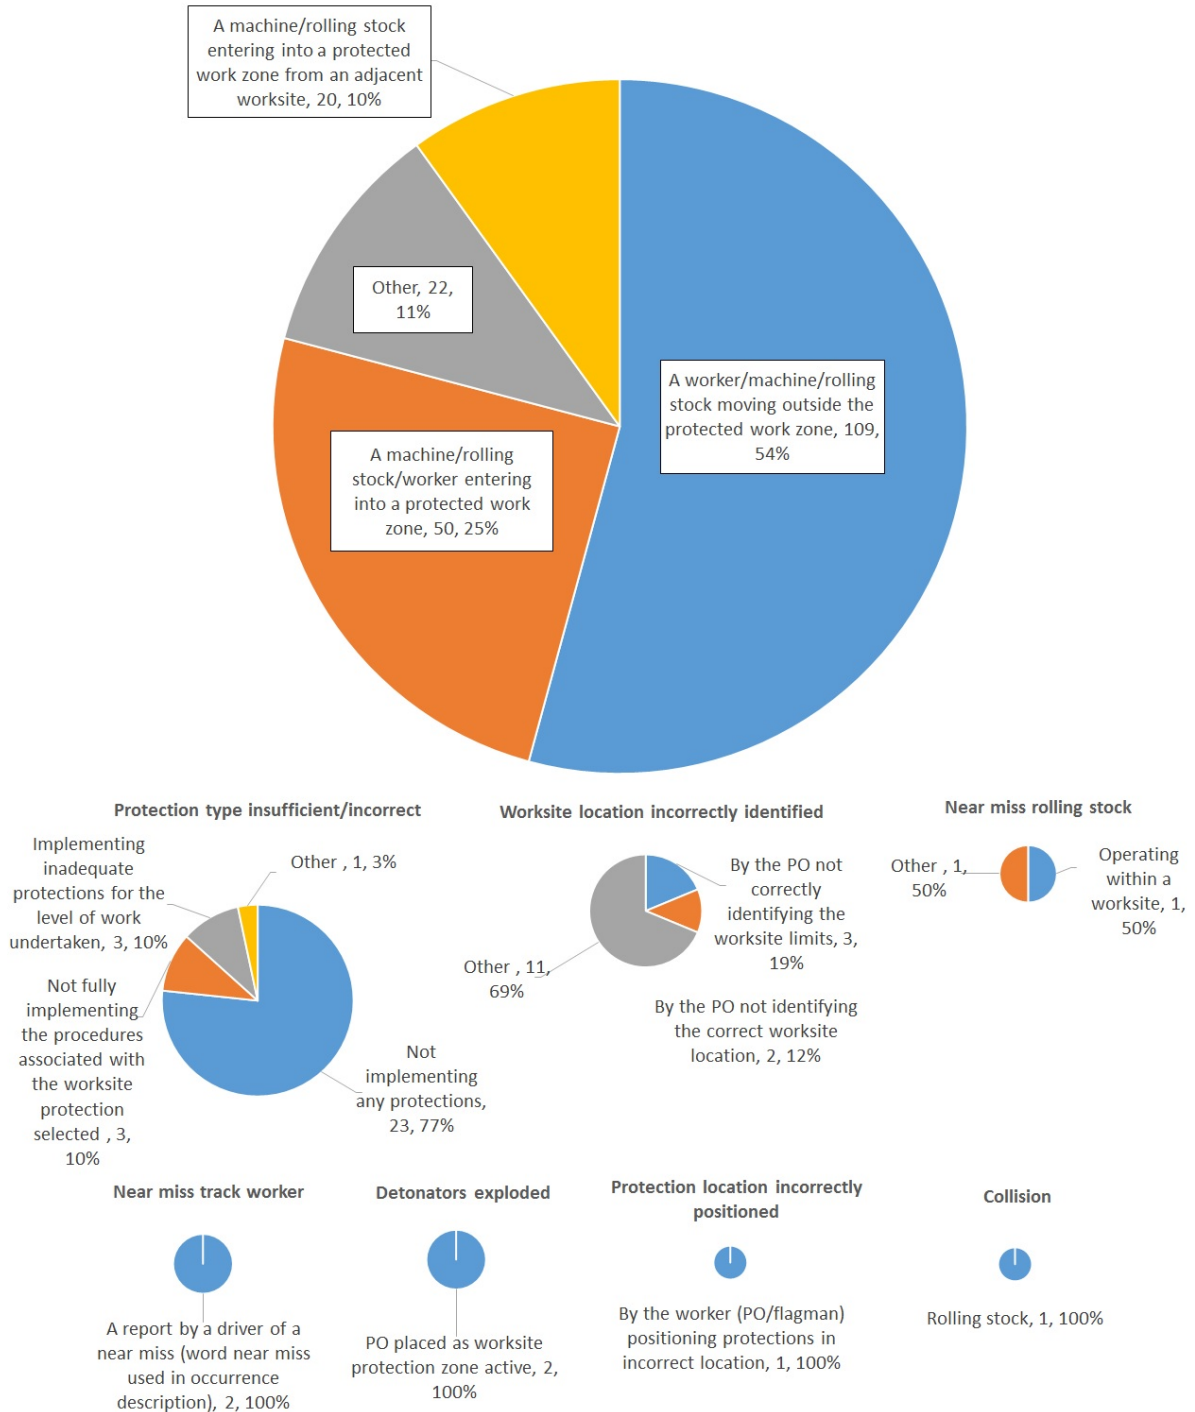
Figure 16: Protected work zone exceeded

Figure 16 illustrates the types of events (likely antecedents) which resulted in occurrences (201) where workers, machines or equipment were in the danger zone but outside of the protected area. The category also picked up occurrences where other workers or machines had entered a worksite without the knowledge of the PO. The diagram also illustrates the 54 recorded occurrences which featured in seven other occurrence categories.

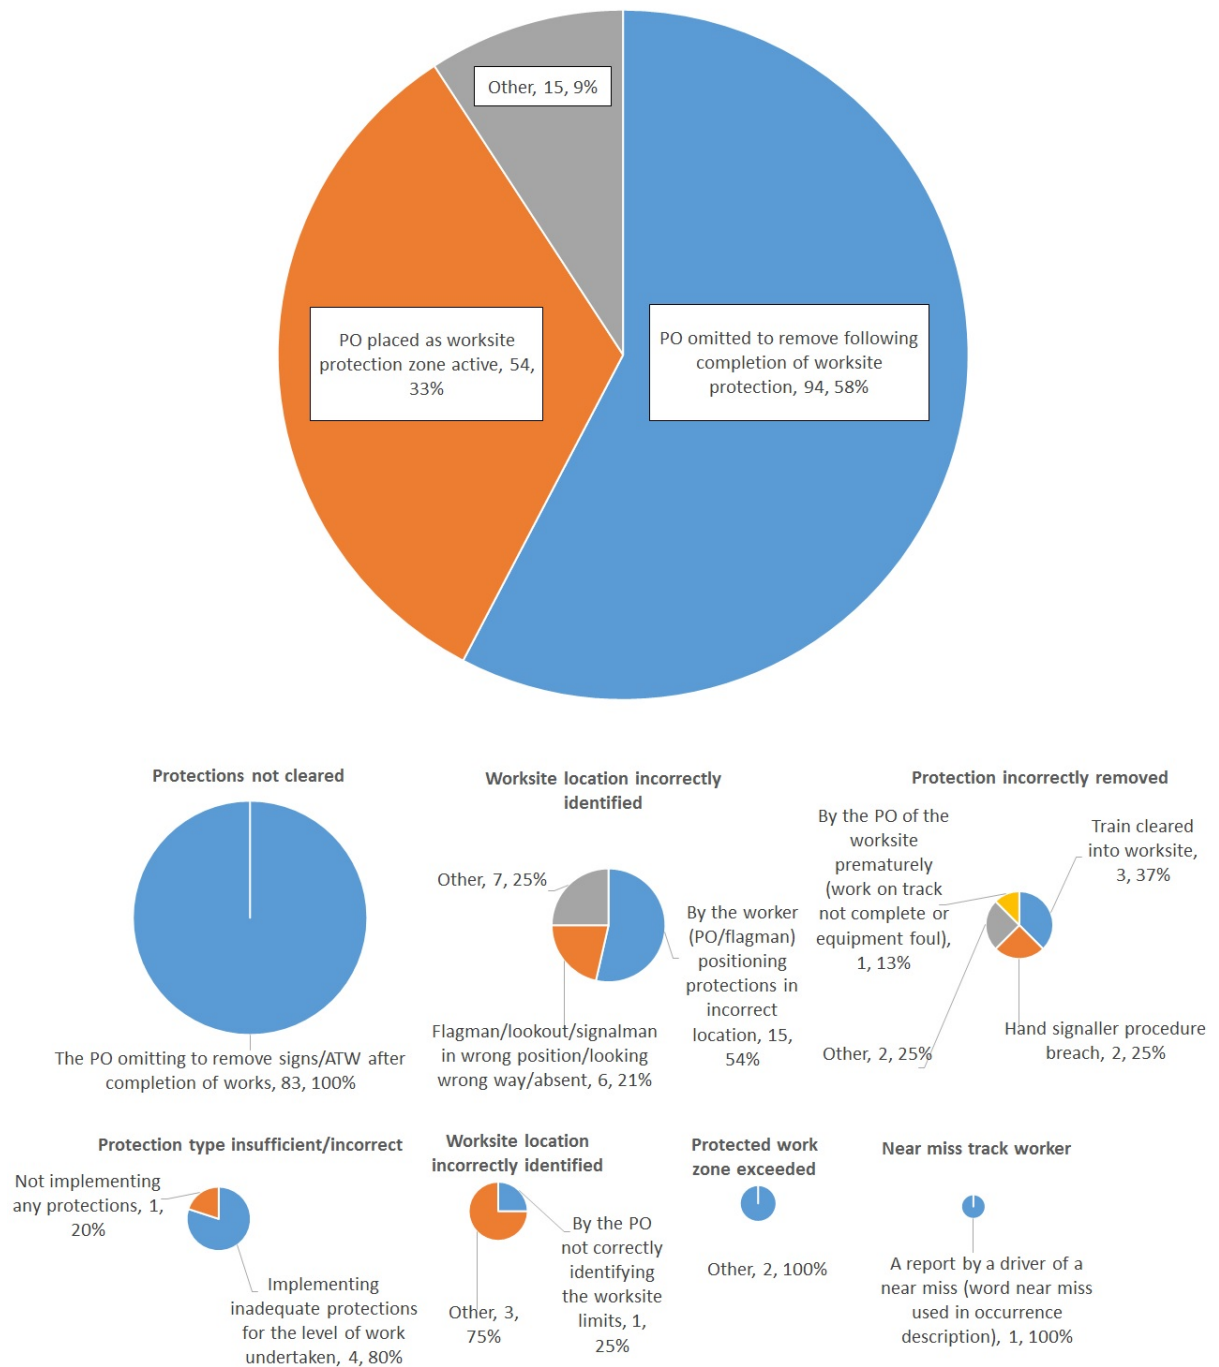
Figure 18: Detonators exploded

Figure 18 illustrates the types of events (likely antecedents) which resulted in occurrences (163) where detonators exploded. The diagram also illustrates the 131 recorded occurrences which featured in seven other occurrence categories.

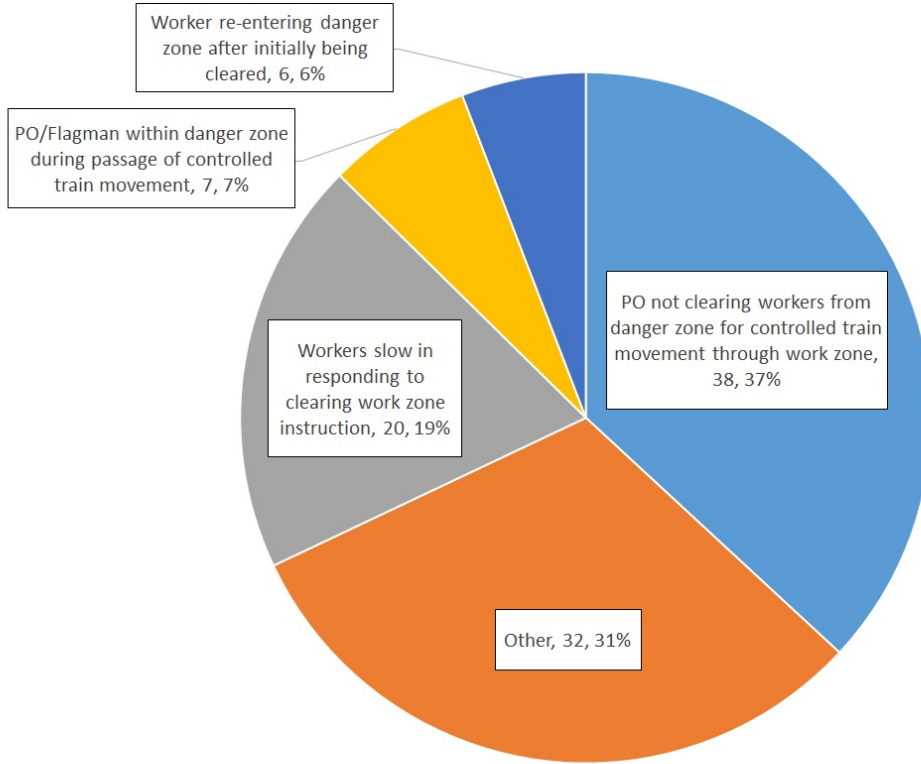
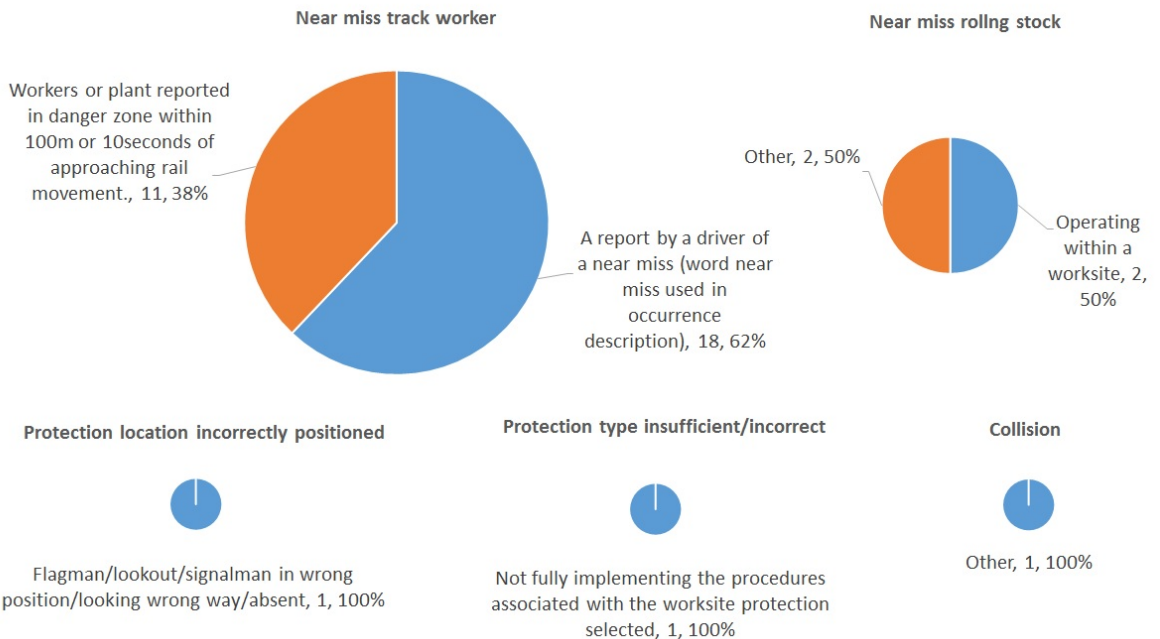
Figure 19: Danger zone not cleared

Figure 19 illustrates the types of events (likely antecedents) which resulted in occurrences (103) where the danger zone had not been cleared when required. The diagram also illustrates the 36 recorded occurrences which featured in five other occurrence categories.

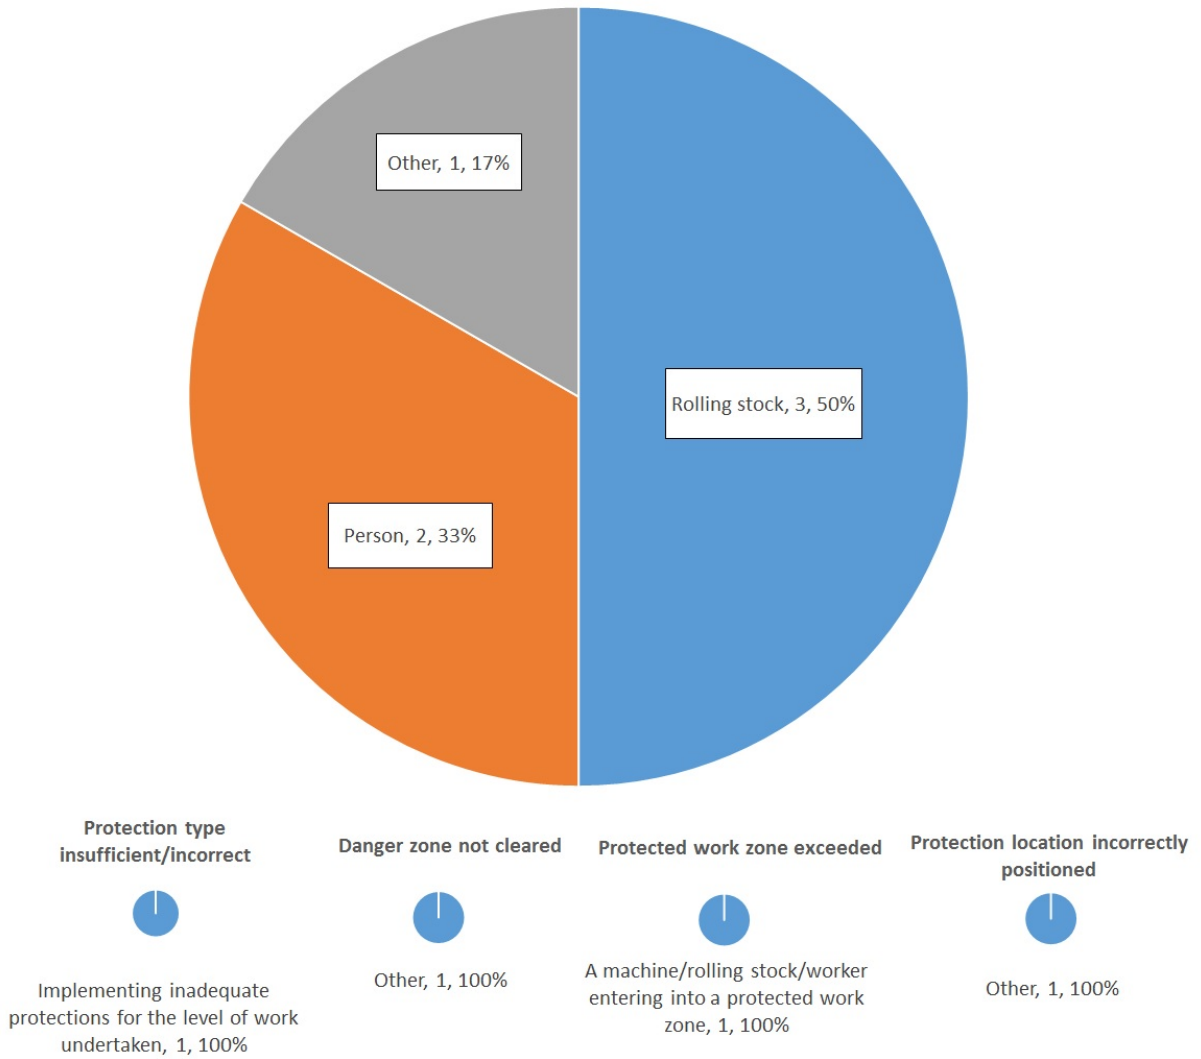
Figure 20: Collision occurrences

Figure 20 illustrates the types of events (likely antecedents) which resulted in reported collisions (6). The diagram also illustrates the four recorded occurrences which featured in four other occurrence categories.

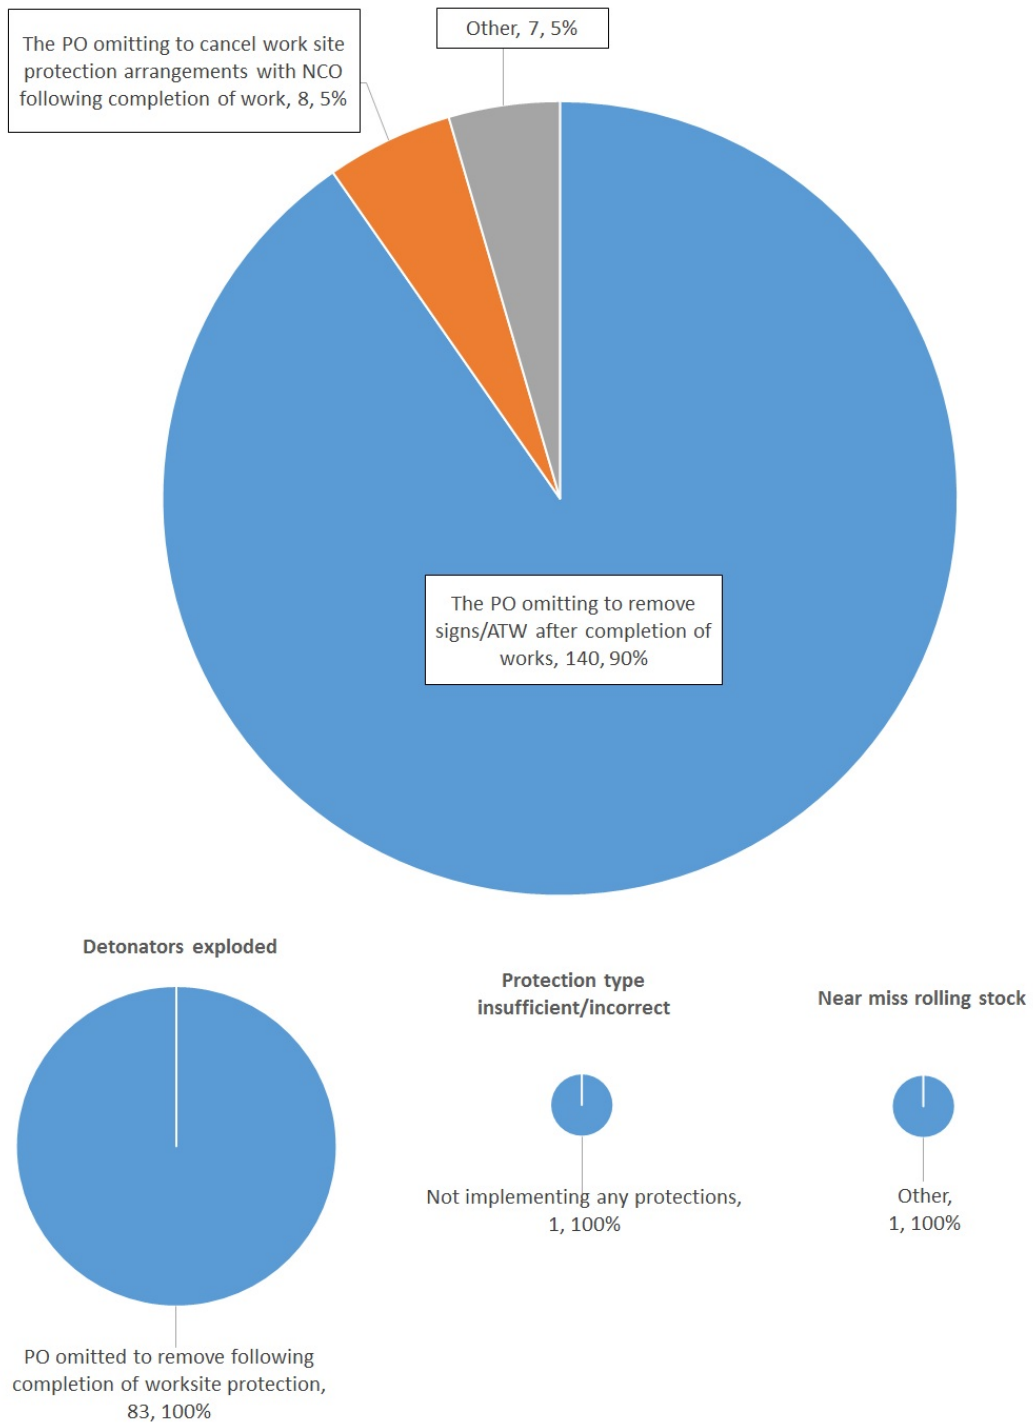
Figure 22: Protections not cleared

Figure 22 illustrates the types of events (likely antecedents) which resulted in reported near misses with rolling stock (155). The diagram also illustrates the 85 recorded occurrences which featured in three other occurrence categories.
