Aviation Safety Digest

103/1978

Contents

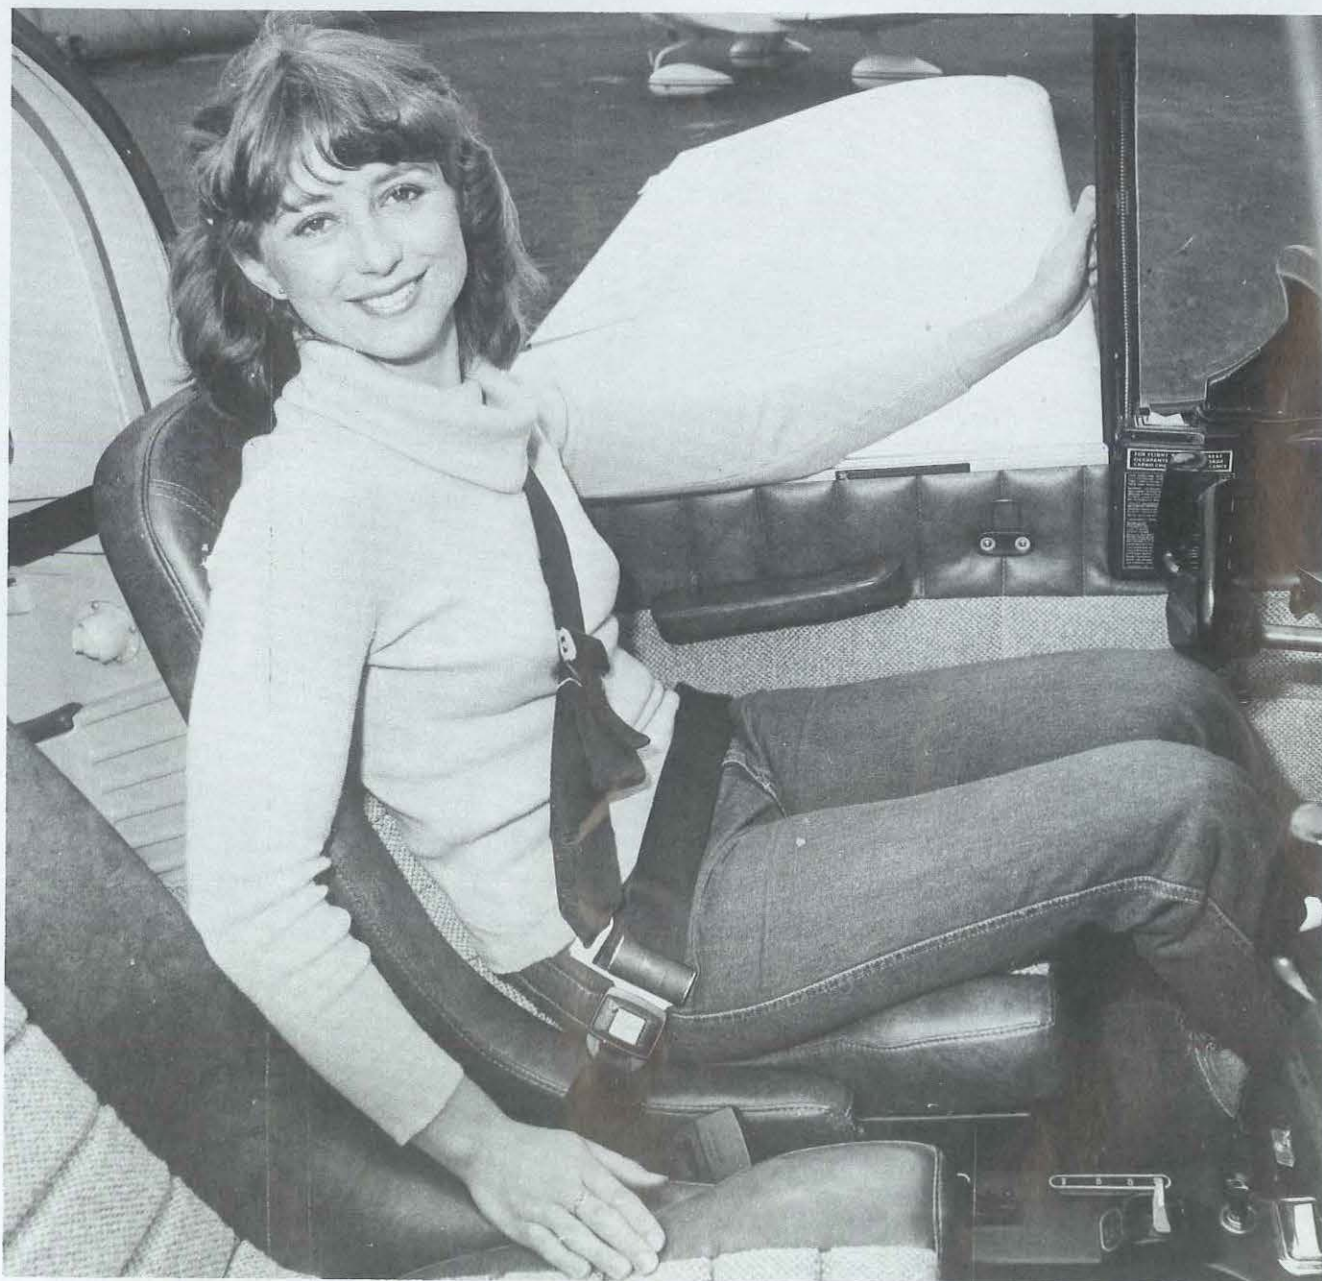
- Buckle by your side
- Belt not twisted
- Fastened firmly

For the lap belt to be fully effective it needs to act on the basic structure of the human body and is best positioned on the hip bones, thus transferring the belt loads to the bony skeleton of the body and holding it firmly in the seat. Impact loads transmitted by a poorly positioned belt can cause serious internal injuries. Most modern aircraft are so equipped that the lap belt is always correctly positioned but on older aircraft it may be necessary to adjust the anchorage points to achieve the optimum positioning.

The positioning of the buckle on lap-sash belt combinations should be such that the sash crosses diagonally from the outboard shoulder to an attachment point as low on the inboard hip as possible. This diagonal configuration places the body's centre of gravity inside the triangle formed by the sash and lap belt. The body is thus prevented from rolling out upon forward impact. Positioning the buckle towards the front of the body increases the possibility of 'fallout' from the sash as well as the risk of injuries caused by the buckle itself. It also has the undesirable effect of pulling the lap belt upwards. Later style seat belts have the buckle position fixed, but on aircraft with an adjustable belt attached to the buckle, the belt should always be adjusted to ensure the buckle is at the side of the hip — not across the stomach.

Remember — try to position the belt below your stomach and the buckle right at the side of or below your hip joint. This will help to avoid injury caused by compression of the abdominal area in the event of an accident.

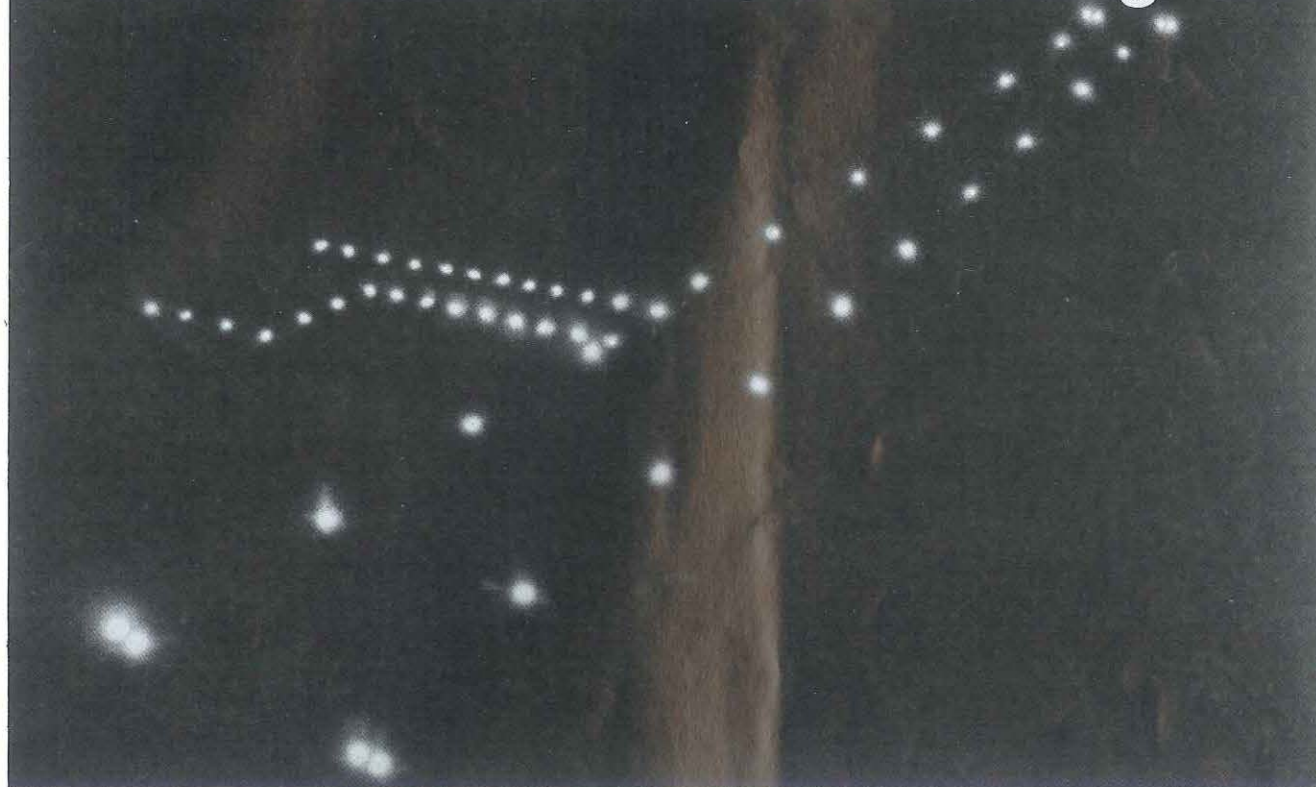
During the last two years VHF-activated runway and associated aerodrome lighting has been introduced at a number of licensed and government aerodromes throughout Australia. There are now about 30 installations listed in the Aeronautical Information Publication (AIP) and the Visual Flight Guide (VFG). As widespread as the use of the equipment is becoming, a recent incident report concerning a Night VMC flight in New South Wales revealed that the pilot, who held a Night VMC rating, did not know how to operate the lighting. While this knowledge is primarily of interest to pilots holding Night VMC and instrument ratings, it may also be of use to the VFR pilot who finds himself in an emergency situation requiring a landing after last light or in extremely hazy and dark conditions.

The lighting is operated by a transmission on a discrete VHF frequency from an aircraft within 15 miles of the aerodrome and above 1500 feet AGL. With the appropriate frequency selected, three transmissions of approximately three seconds duration spread over a period of not greater than 25 seconds will activate the lighting for 60 minutes. Each transmission activates a code element after approximately one second but cancels that element after five seconds. Three complete code elements within 25 seconds will activate the lights. For this reason it is important to limit each transmission to approximately three seconds. The system may be activated/re-activated by the appropriate transmission from an aircraft on the ground or in flight. Flashing white warning lights, located near the terminal building, indicate the last 10 minutes of the 60-minute cycle and, unless re-activated, the aerodrome lighting will extinguish.
