# Aviation Safety Digest

# Contents

# Single-engine performance of a light twin?

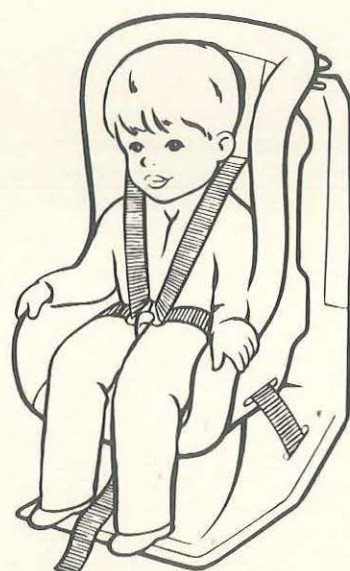
Child seat

Restraint devices approved for automobile use and complying with AS1754 carry a label displaying the

Standards Association of Australia (SAA) symbol and are therefore readily identifiable. A list of currently approved child restraints is available from the SAA Office in the capital city of your state.

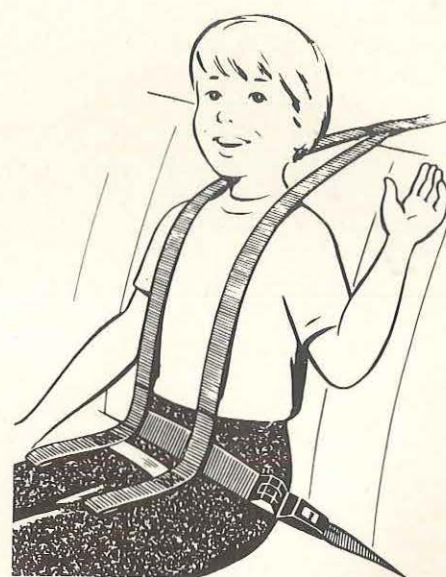
Child harness
