Aviation Safety Digest

ASD 138
SPRING 1988

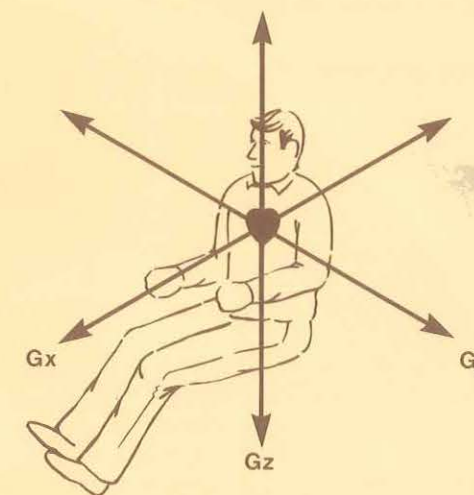
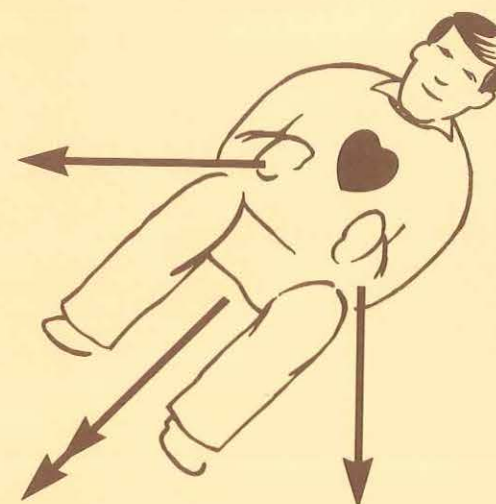
Acceleration may be applied in any direction. Linear accelerations are usually described in relation to the human body, by reference to three orthogonal (right angled) axes passing through the heart — lateral, longitudinal and vertical. Vertical acceleration is correctly abbreviated as Gz but more commonly, 'g' is used.

Vertical acceleration is what you feel when you go over a bump in the car. Lateral acceleration is felt when you go around a corner. Longitudinal 'g' is felt when you accelerate or brake. You rarely feel lateral 'g' in an aircraft because it is banked like a motor-cycle — so the resultant acceleration is felt as a vertical acceleration.

The vertical axis is the most significant in terms of physiological effects (except perhaps for the massive longitudinal deceleration experienced in a sudden stop!). With positive acceleration (+g) the inertial reaction (the tendency to 'slump') is away from the head and is often known as 'eyeballs-up' acceleration.

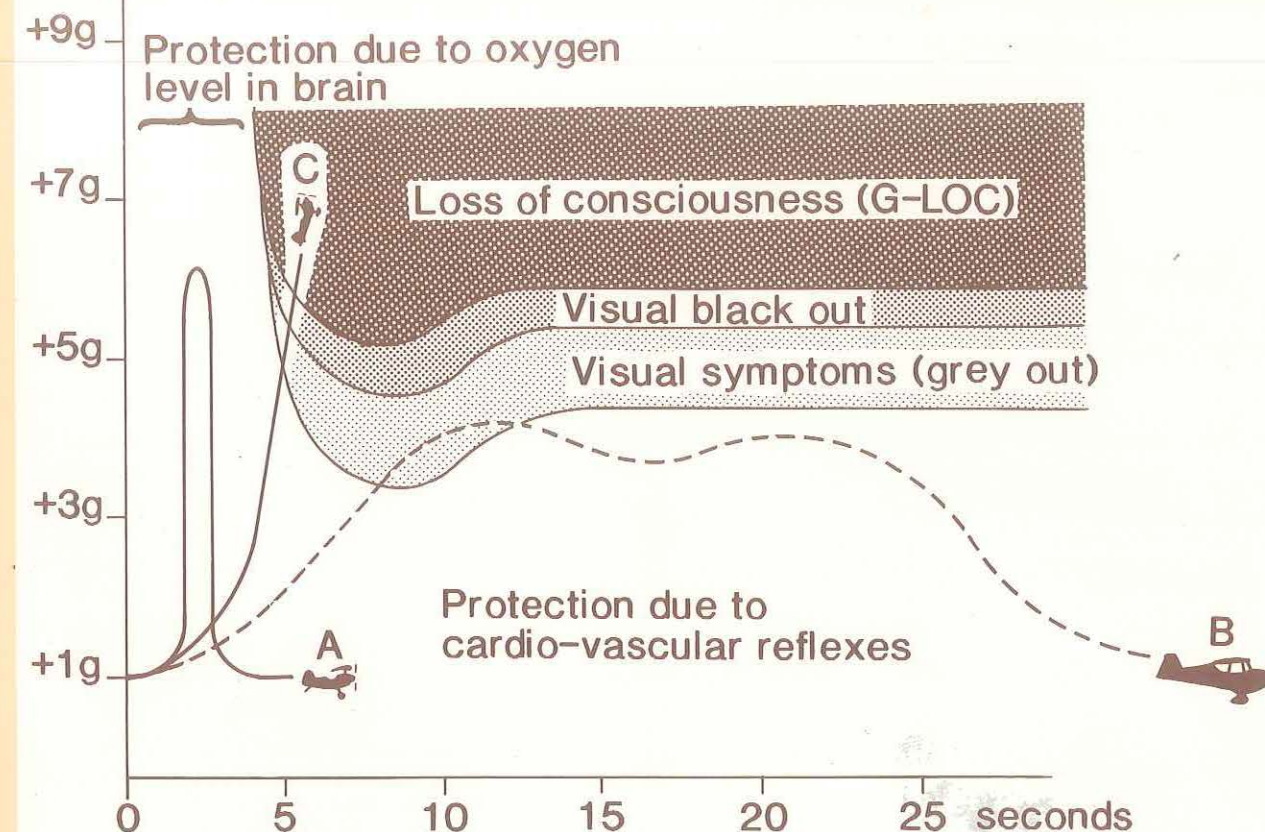
A. rapid onset, brief period 'snatch-pull' such as corner or square loop.

B. smooth onset - sustained such as normal loop normal symptoms

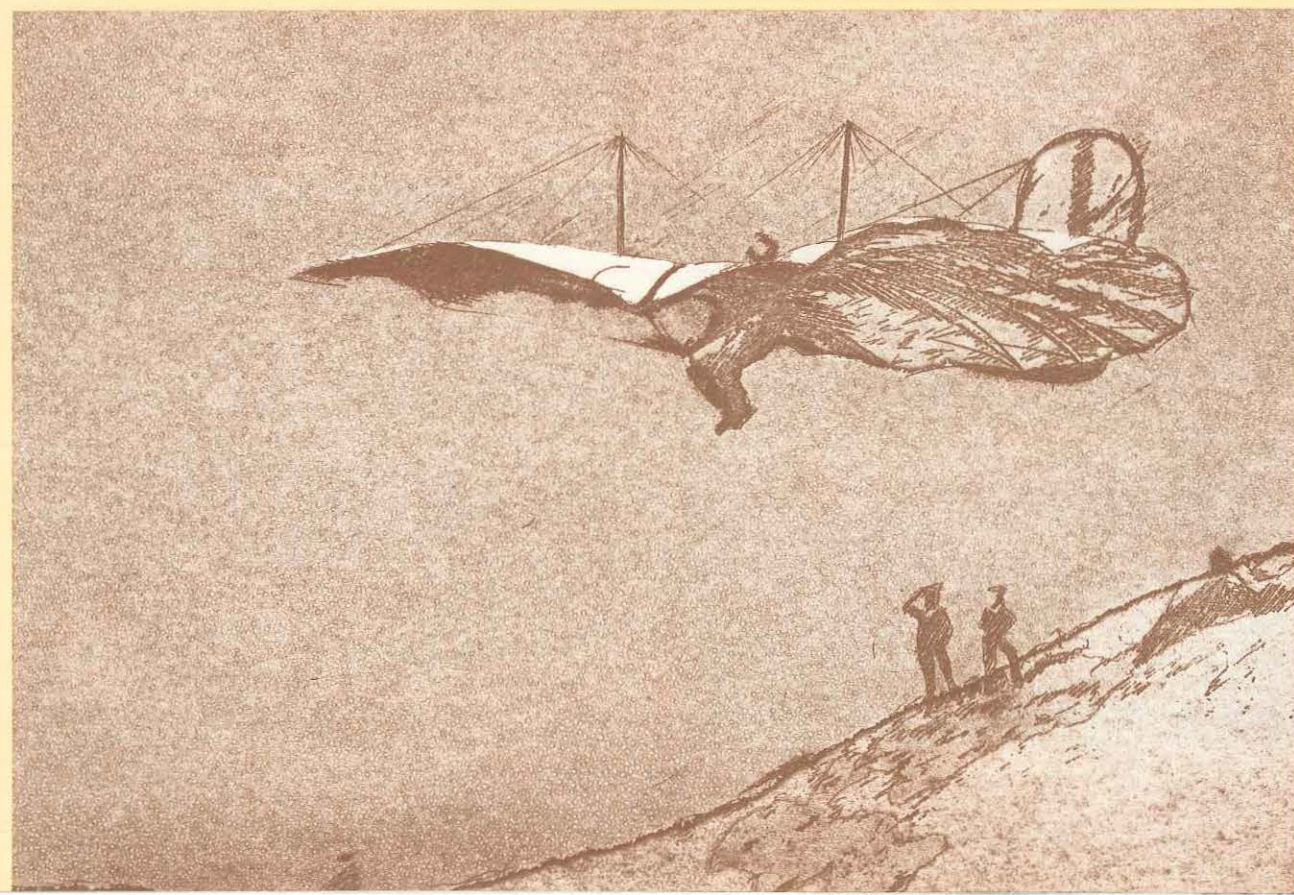
The adjustment had improved the trim problem but had still not completely provided a fix. The pilot then readjusted the right wing warping wire to its original condition and added a D-shackle to the left wing warping wire, to increase its length. Another test flight was carried out and it was found that the aircraft could only be maintained in level flight with full right rudder and full right control stick applied. Unfortunately the aircraft was then struck by a wind gust and the left wing dropped. As no further control was available to correct this situation, the pilot grabbed a wing warping wire. As luck would have it he pulled the right wire instead of the left wire and was unable to correct his error before the aircraft struck the ground.

A subsequent inspection of the wreckage found that the right wing warping wire was 19 millimetres longer than the left. Also, all the dimensions of the right wing were slightly larger than that of the left wing, resulting in the right wing area being about 80 square centimetres greater.

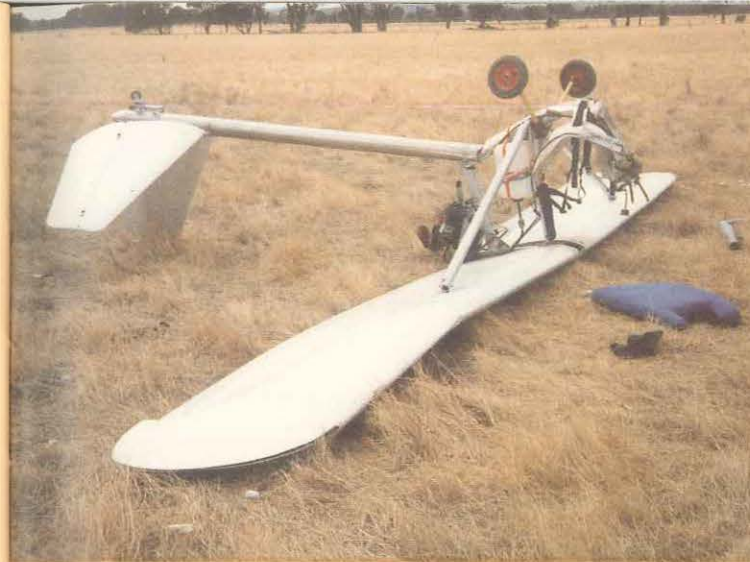
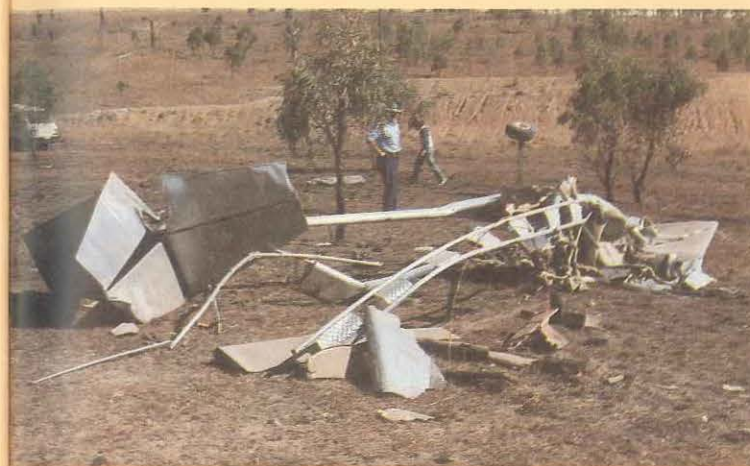
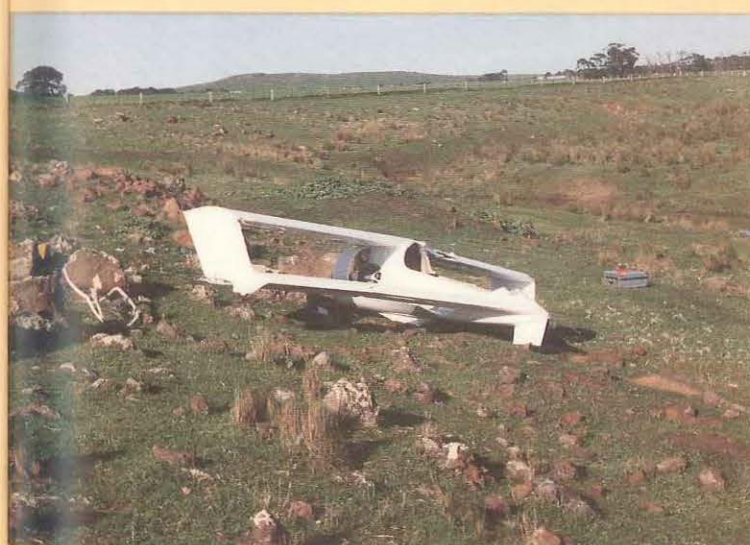
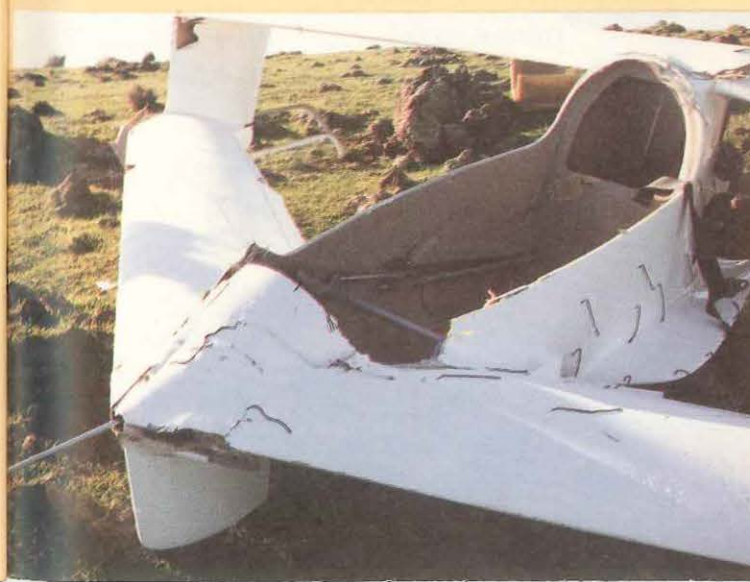
September 1987 Penfield Vic. Ligeti Stratos

This aircraft was intended to be the production version of the 'Stratos' aircraft. The prototype version had successfully flown some 340 hours. The production model incorporated significant changes made by the designer/pilot. These changes included the removal of the dihedral from the main wing, the use of full span elevators on the canard wing and full span ailerons on the main wing. The engine mounting was lowered such that the ducted propeller was totally below the main wing and the lower part of the propeller duct was extended well forward to form a 'channel wing' or strake.

The main purpose of the channel wing was an attempt by the designer to lower the stall speed of the aircraft and to consequently reduce both landing and takeoff speeds and distances. As far as the investigation could determine, the effect of these modifications had not been checked by wind tunnel or other methods prior to this flight.
