Aviation Safety Digest

ASD 142

SPRING 1989

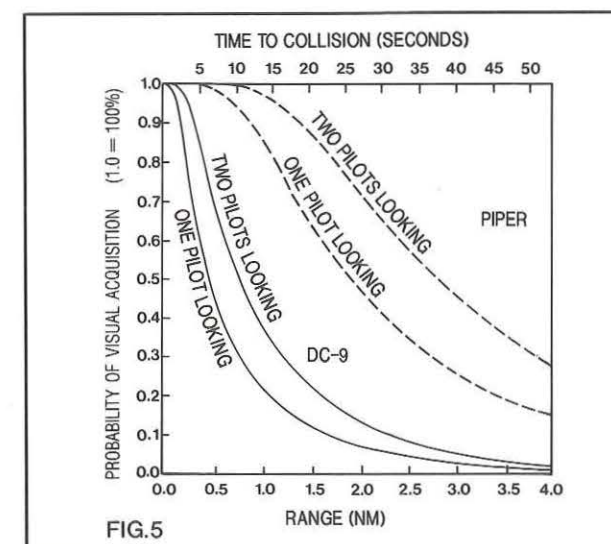
FIG.5

Using these tests and pertinent data from the Cerritos mid-air, Figure 5 was constructed. These graphs do not allow for limitations such as cockpit structure or the monocular regions.

Previous studies by the Massachusetts Institute of Technology had been conducted to determine target acquisition parameters for pilots. Sixty four tests were conducted with pilots who did not know the test objectives. Intercepting aircraft were flown head-on, at 90 degrees and 135 degrees, predominantly from the left, and visual acquisition was achieved in 56%, the median range being 0.99 miles. The greatest acquisition range was 2.9 miles.
