# Loss of control involving a Robinson R22, VH-YLP

Orange Airport, New South Wales, on 10 February, 2015

ATSB Transport Safety Report Aviation Occurrence Investigation AO-2015-016 Final –10 June 2015 Released in accordance with section 25 of the Transport Safety Investigation Act 2003

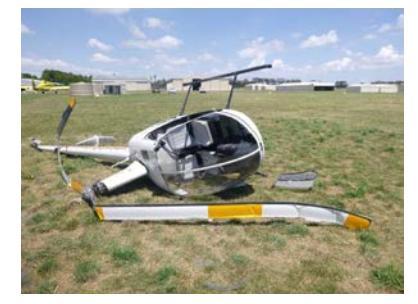
### **VH-YLP** damage

The student and instructor exited the helicopter and moved clear. The instructor was not injured, however the student received minor injuries and the helicopter was substantially damaged.

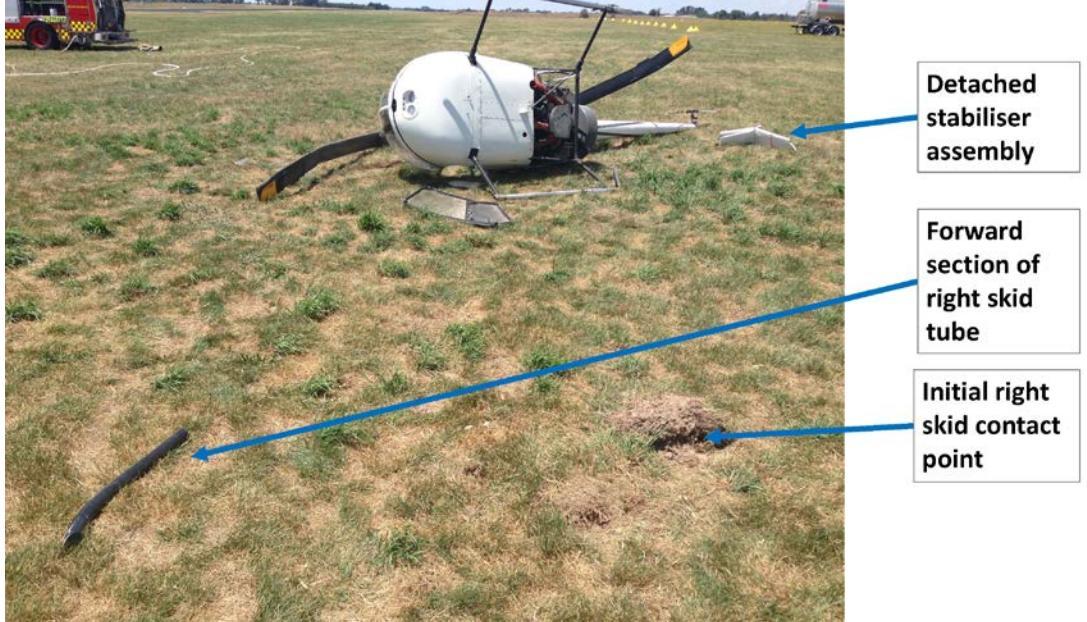
Due to the hot and dry conditions in the previous few weeks, the ground was very hard and dry and caused the helicopter to bounce when the skid first impacted the ground. This further exacerbated the helicopter's instability.

The instructor felt that as soon as the helicopter tilted to the right, the blades probably struck the ground; the instructor also commented how quickly the whole event happened.

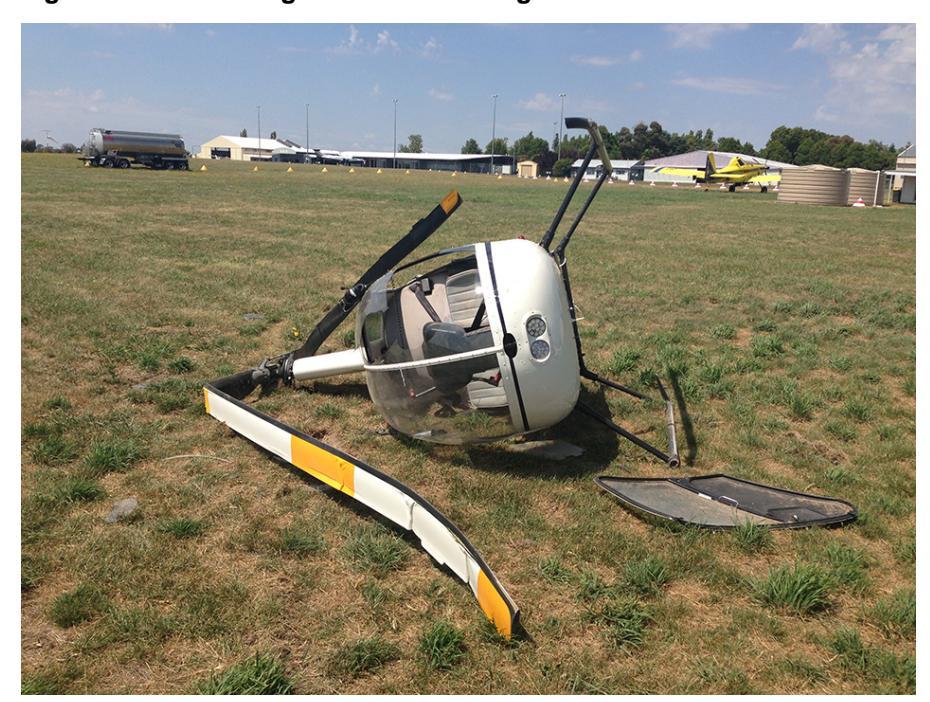
Figure 2: Detached right door and damaged rotor blades

During the last ten minutes of the dual lesson, the heel of the right skid contacted the ground and the helicopter moved approximately 4 m to the right before coming to rest on its right side.

As noted by the instructor and the operator, the pivoting roll by the helicopter to the right, around the skid in contact with the ground, and subsequent loss of control is consistent with the phenomenon known as dynamic rollover.
