Safety Advisory Notice

Number: AO-2016-028-SAN-006

Coordination is key to airside safety

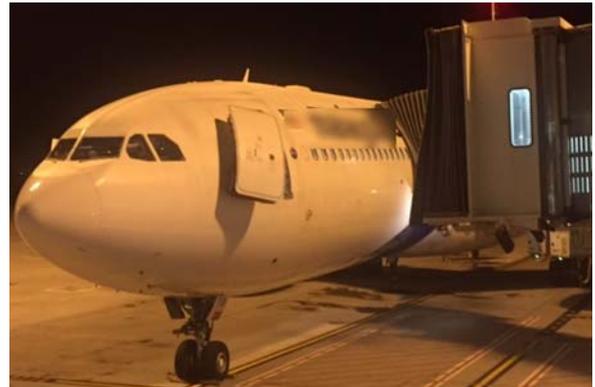
On 31 March 2016, an Airbus A330 was being boarded at Melbourne Airport, Victoria. Seeing that the parking brake was on, a maintenance engineer removed the main chocks early. The crews removed the nose gear chocks to dock the towbarless tractor without checking the main gear chocks. The captain, unaware that no chocks were in place, released the park brake and the aircraft rolled back, striking the aerobridge. There were no injuries and the aircraft door and aerobridge were damaged.

Damaged forward-left door (Source: Melbourne Airport, modified by the ATSB)

AO-2016-028-SAN-006: Effective coordination and communication between airside crews can prevent or detect mistakes that could otherwise lead to damage or injury. The ATSB advises organisations that work airside to ensure that ground and flight crew activities are harmonised, and to foster active communication and coordination between working crews.
