**DOT/FAA/AR-09/49**

# **Detection and Prevention of Carbon Monoxide Exposure in General Aviation Aircraft**

October 2009

Final Report

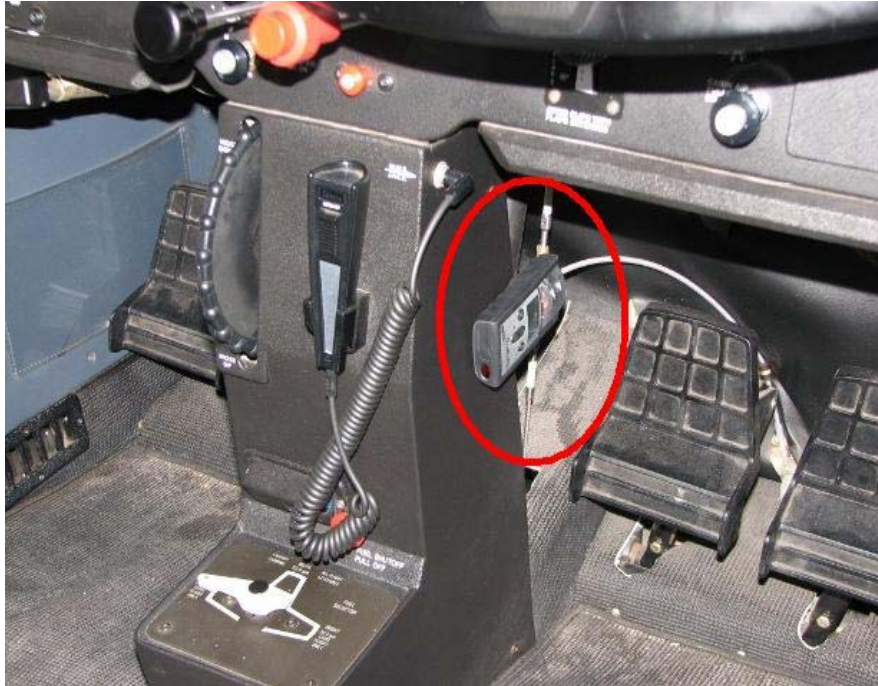
The instrument panel CO detector was attached to the instrument panel with a belt clip, whereas the other four CO detectors were attached to their respective locations using a suspender wire clip. All five locations are shown schematically in figure B-4.

Figure B-1. Carbon Monoxide Detector Attached to the Instrument Panel With a Belt Clip

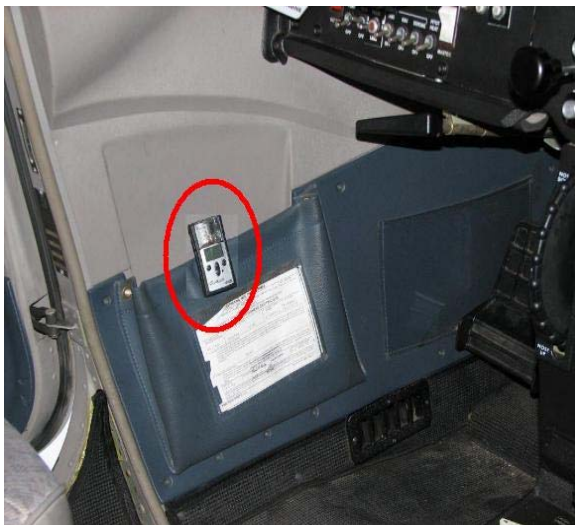
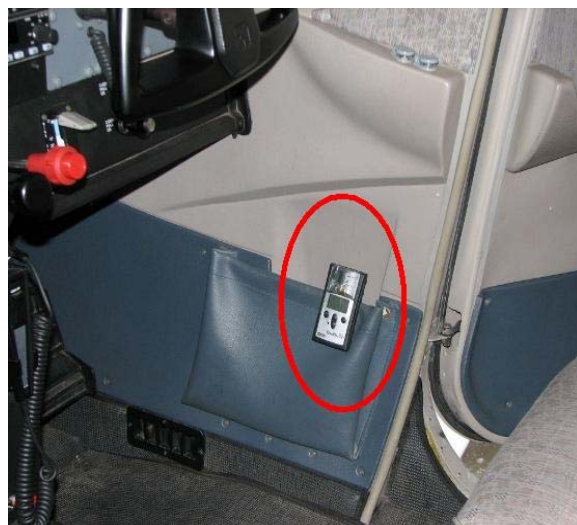
Figure B-2. Carbon Monoxide Detectors Attached to the Left-Door Pocket (a) and Right-Door Pocket (b) With Suspender Clips

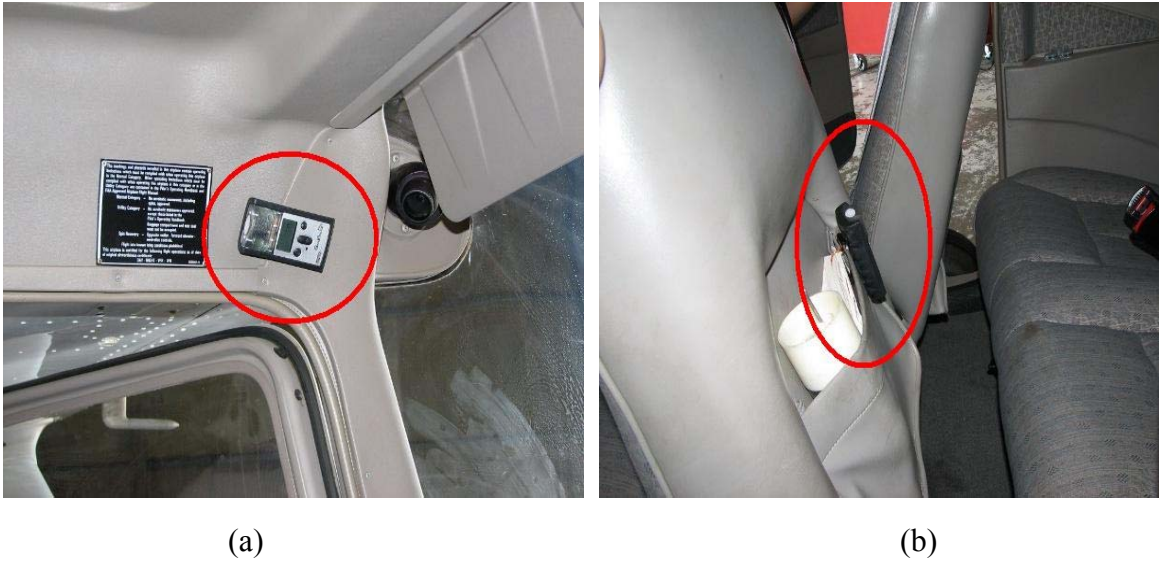
Figure B-3. Carbon Monoxide Detectors Located (a) Near the Pilot-Side Visor and (b) the Back-Seat Area With Suspender Clips

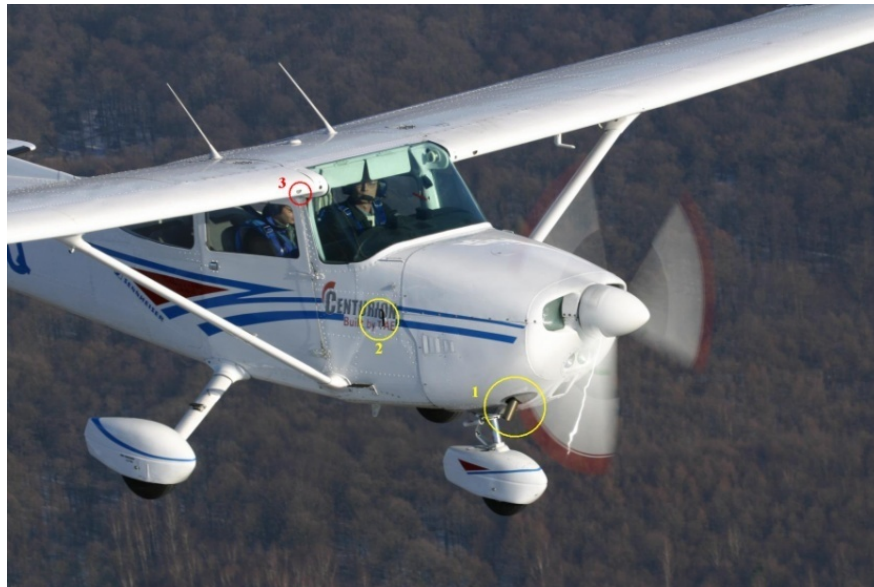
Figure C-10. Cessna 172 Locations for the Exhaust Tailpipe (1) and Fresh Air Inlets (2 and 3) [C-18]

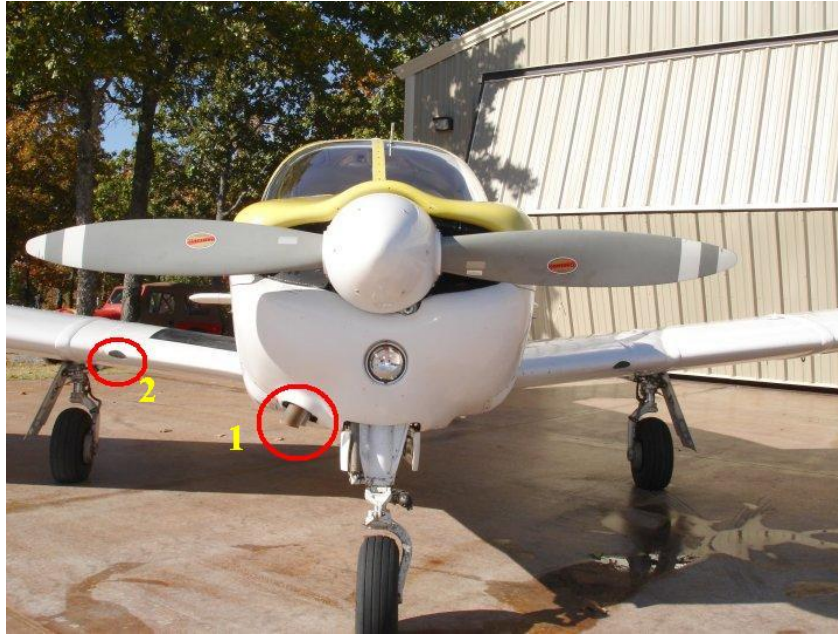
Figure C-11. Piper PA-28 Locations for the Exhaust Tailpipe (1) and Fresh Air Inlet (2) [C-19]

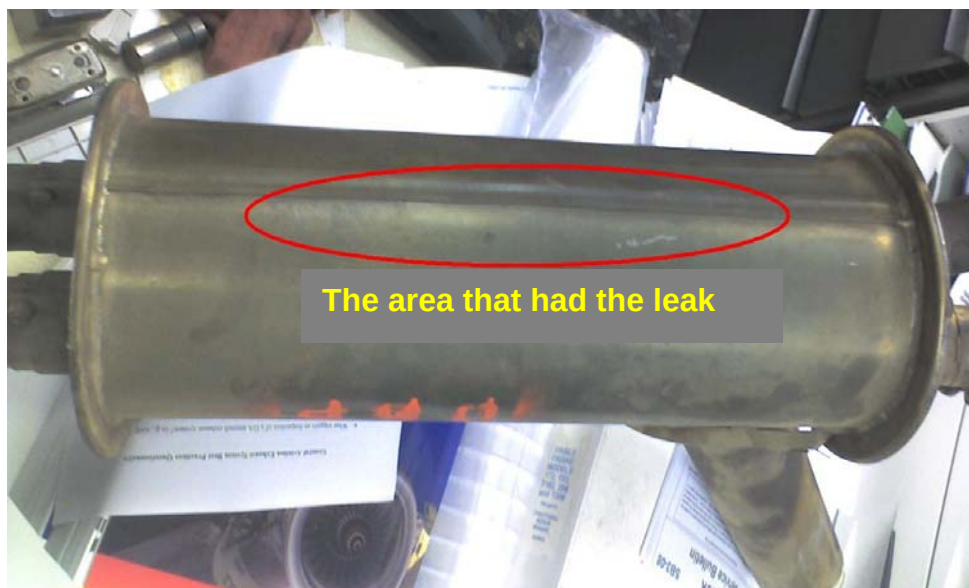
Figure D-7. The Muffler That had the Leak but was not Detected by Visual Check
