Fuel-related event

50 km south-west of Canberra

21 May 2009

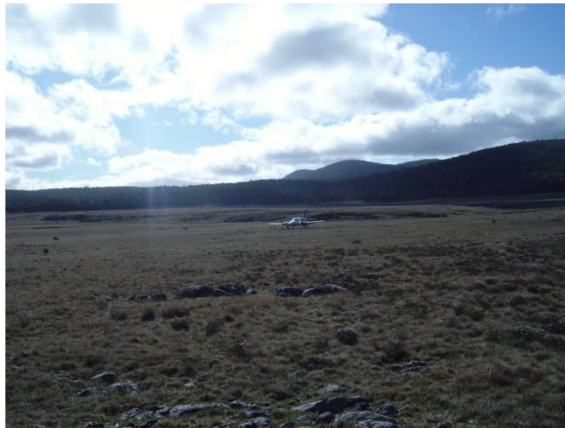
assessed that the aircraft may not have sufficient fuel to reach Canberra or to return to Albury. The pilot assessed that the second half of the flight would mostly pass over inhospitable terrain, where a safe landing would not be possible. Instead of risking fuel exhaustion over inhospitable terrain, the pilot elected to conduct a precautionary landing on the Coleman Plains in the Snowy Mountains. The aircraft was subsequently landed safely in a paddock about 50 km south-west of Canberra. There was no reported damage to the aircraft or injuries to the occupants.

Figure 1: Aircraft after precautionary landing

In response to this occurrence, the aircraft operator advised the Australian Transport Safety Bureau that a company requirement has been implemented for all pilots to use a documented fuel plan in all circumstances when flying from one location to another.
