Airspace related event – Amateur Built Van's RV-8, VH-YGY

near Redcliffe aerodrome, Queensland, 13 May 2012

ATSB Transport Safety Report
Aviation Occurrence Investigation
AO-2012-067
Final

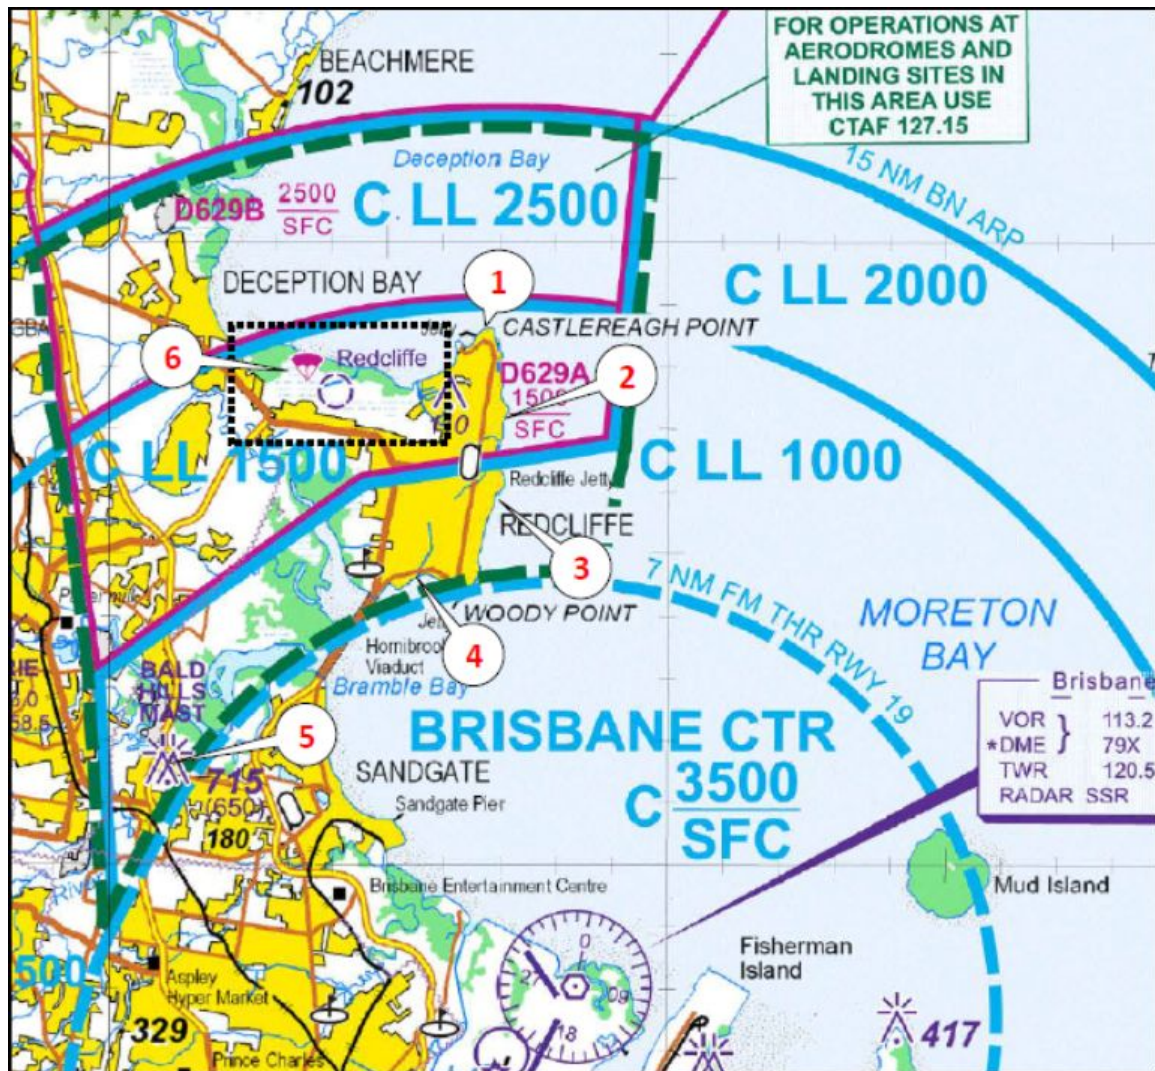
Figure 1: Diagram of the Redcliffe CTAF area

The pilot further stated that there was no NOTAM⁶ issued about parachute operation on Bells Beach and that the drop zone location was not marked with a parachute symbol on the Brisbane Visual Terminal Chart (VTC)⁷ (Figure 1).

Airservices Australia (Airservices)⁹ had a Letter of Agreement (LOA)¹⁰ with the parachute operator in relation to the drop zones in the Redcliffe area. There were four approved drop zones – Castlereagh Point, Queens Beach, Suttons Beach and Bells Beach (Figure 1).

Of the four drop zones, only Castlereagh Point was marked on the VTC. Further, the four drop zones were not marked with parachute symbols on the VTC. The only parachute area marked with a symbol in the Redcliffe area, to the west of the Redcliffe aerodrome, had not been used for at least eight years (Figure 1).

- 1. Castlereagh Point (27°11' 30"S; 153°06' 38"E)
- 2. Queens Beach (27°12' 25"S; 153°06' 59"E)
- 3. Suttons Beach (27°14' 07"S; 153°06' 55"E)
- 4. Bells Beach (27°15' 26"S; 153°05' 25"E)
- 5. Bald Hills Mast
- 6. Parachute symbol near Redcliffe aerodrome

- On the VTC, remove the parachute symbol to the west of Redcliffe aerodrome and add symbols to denote the drop zones detailed in the Airservices LOA; and
- In the En Route Supplement Australia (ERSA)¹⁴, amend the location of skydiving operations in the vicinity of Redcliffe aerodrome in the entry for that aerodrome.
