Aviation Research and Analysis Report –B20050205

# How Old is Too Old?

## The impact of ageing aircraft on aviation safety

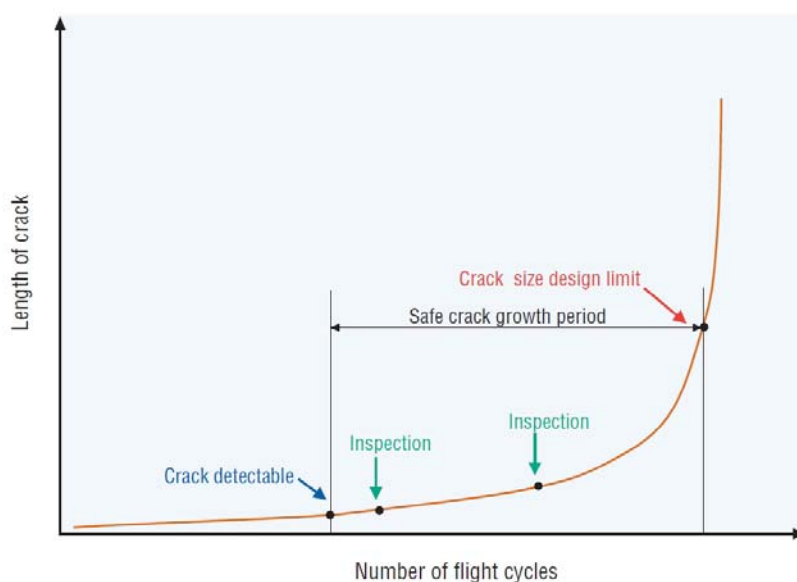
**Figure 1: Theoretical damage tolerance inspection regime to detect cracks before they become critical**

A damage tolerant design should allow cracks to be detected before they reach the critical length that will lead to failure. To ensure that this occurs there should be at least two opportunities to detect the crack prior to it reaching its critical length (FAA, 2005b).

The damage tolerance philosophy uses testing and analysis to determine the critical crack length, the residual strength, and the inspection intervals. Tests include flight testing to determine the loads on the structure, and ground testing to determine the fatigue and crack growth characteristics. From the testing and analysis, the critical sites and components susceptible to fatigue can be determined. Fatigue analysis based on flight, ground, and pressurisation loads can then be used to determine crack growth performance and residual strength.

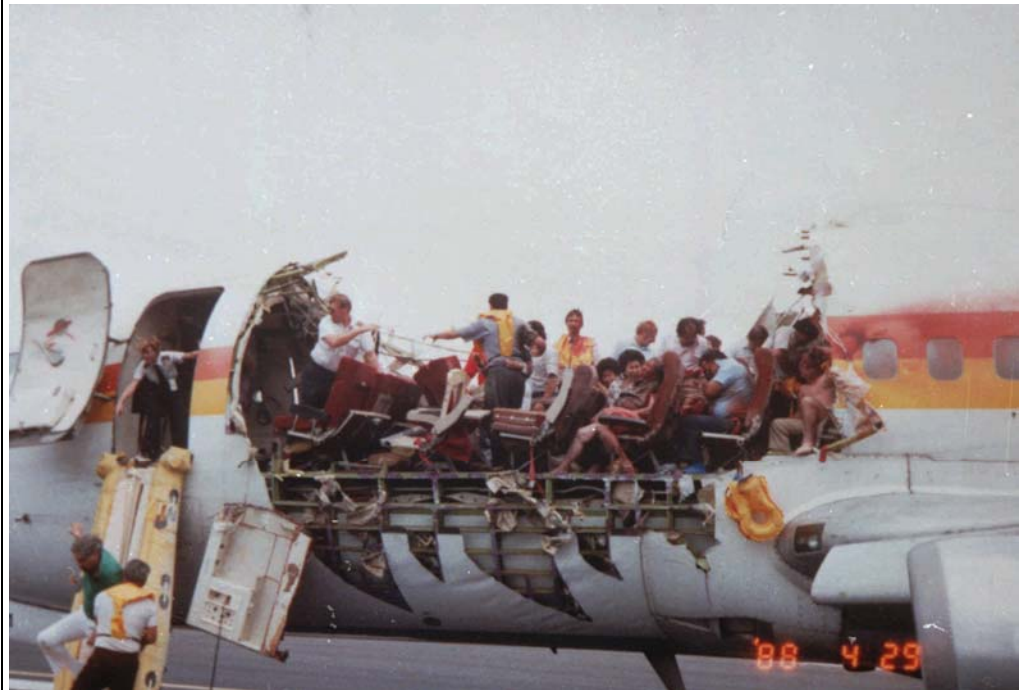
**Figure 2: Aloha Airlines flight 243**

As the rivets were not designed to be load bearing, knife-edges in the aircraft skin where the skin meet the rivet were deemed acceptable (Wanhill, 2002). However, problems with the cold bonding process meant loads were transferred through the rivets. Hence, the design of the rivets became a problem as knife-edges acted as fatigue crack initiation sites.

An additional factor was the design of one type of joint (or skin splice) used in the construction of the fuselage. The joint was cold bonded, using an epoxy impregnated scrim cloth, as well as riveted. The cold bonding was designed to transfer the pressure loads evenly across the joint rather than through the rivets.

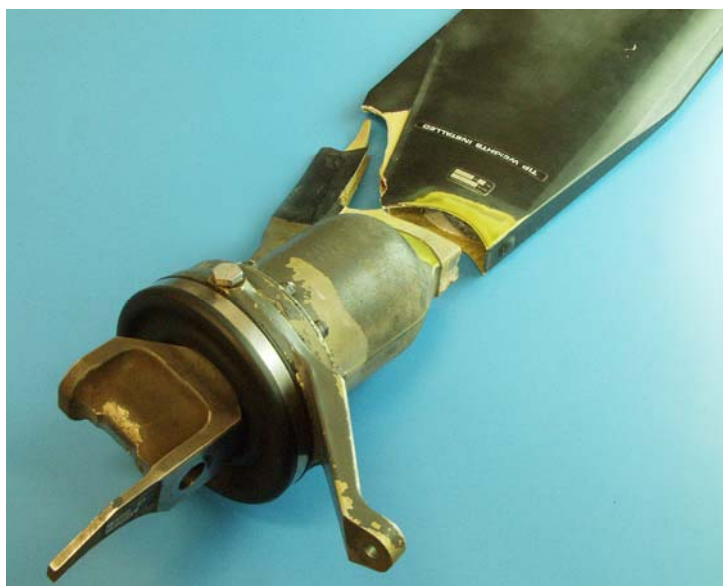
On 20 June 2003, a Robinson R22 helicopter, registration VH-OHA, sustained a catastrophic failure of one of the main rotor blades. The two occupants of the helicopter, a flight instructor and student, were fatality injured in the accident. The main rotor blade of the accident aircraft had been in-service for approximately 2,050 hours and for 11 years and 9 months (ATSB, 2005b). The fractured blade is shown in Figure 3.

**Figure 3: The fractured main rotor blade of VH-OHA**

Prior to the accident (in April 2003) the helicopter had been taken in for maintenance, due to a rapid onset of vibration in the main rotor blade. At this time, the 100 hourly inspection and an engine overhaul were also carried out. The maintenance organisation followed the maintenance instructions but was unable to rectify the vibration problems. The problem was discussed with a number of experienced maintenance engineers, however, the source of the vibrations could not be determined. Eventually, the vibration was reduced to within tolerance levels and the helicopter returned to service. It has since been established that this type of vibration is a warning sign of fatigue in the main rotor blades (ATSB, 2005b).

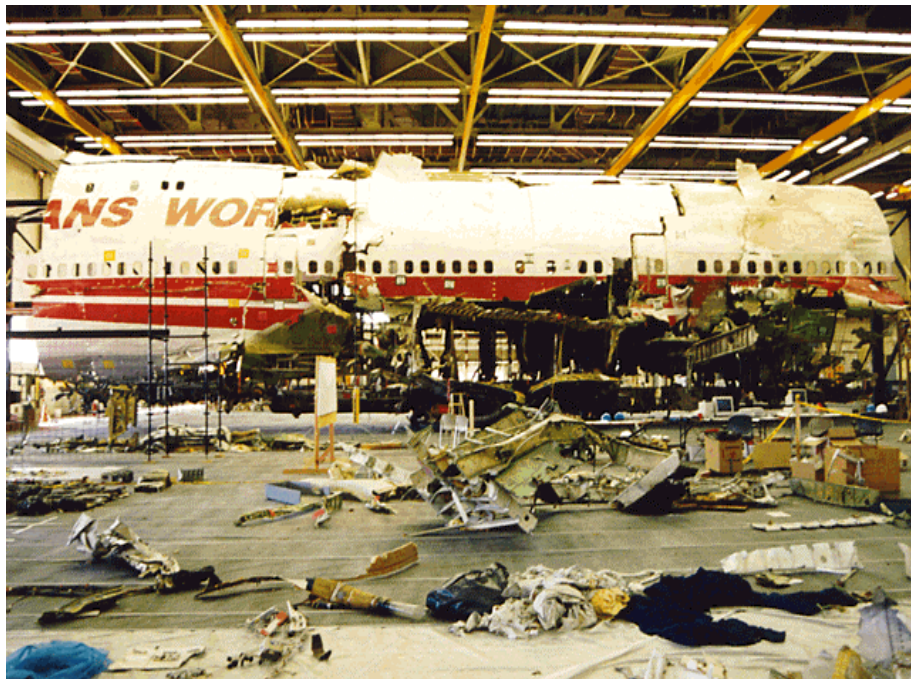
On 17 July 1996, TWA flight 800 impacted the water in the Atlantic Ocean near New York (Figure 4). All 230 passengers and crew on-board the aircraft were fatally injured. The accident aircraft, a Boeing 747-100, was 25 years old and had accumulated 90,000 flight hours and 18,000 flight cycles.

**Figure 4: Reconstruction of TWA flight 800**

The NTSB investigation report stated that the accident was probably due to an explosion of the centre wing fuel tank, when the flammable fuel/air mixture in the tank ignited (NTSB, 2000). While the reason for the ignition could not be conclusively determined, the NTSB report stated that it may have been due to a short circuit outside the fuel tank. This short circuit allowed excessive voltage to enter the tank through electrical wiring, which ignited the fuel/air mixture. The report further stated that the condition of the wiring in the aircraft was not atypical for an aircraft of its age (NTSB, 2000).

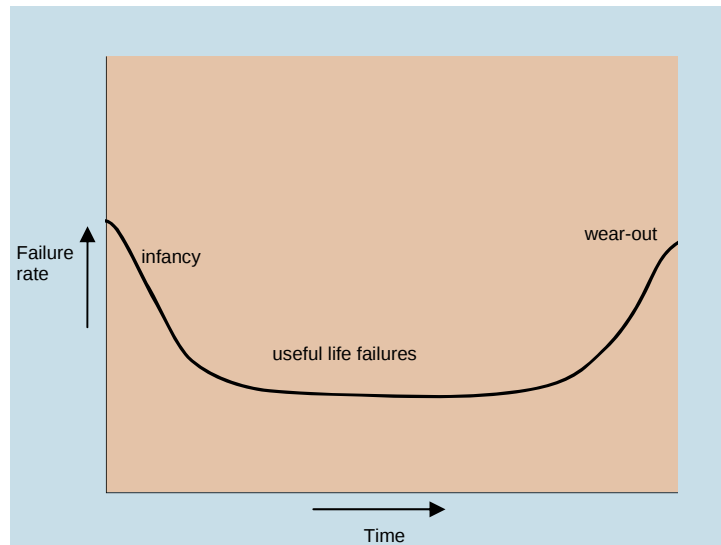
During infancy, the failure rate decreases over time, as many failures are due to material flaws or problems in manufacture. This phase is less relevant when considering ageing aircraft. In the useful-life phase, failures due to initial flaws gradually decrease while failures due to wear-out gradually increase. Therefore, the average number of failures remains relatively constant throughout the useful-life phase. During the wear-out phase, failures will increase as the product reaches the end of its useful life.

**Figure 5: Bathtub curve**

The bathtub curve is only a simplified form of reality. For example, the curve does not take into consideration that even while the failure rate is constant, ageing is occurring (Caruso, 2005).

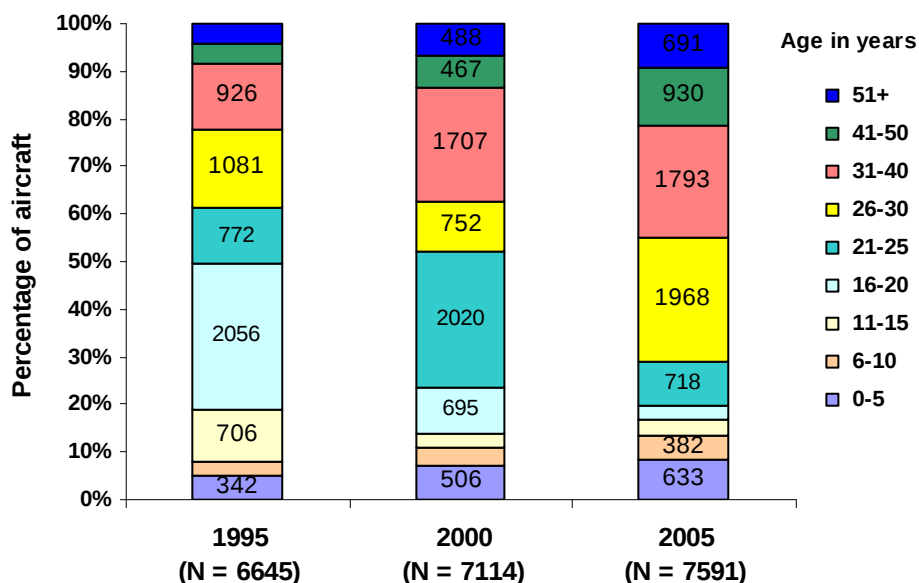
**Figure 6: Age of single-engine piston fixed-wing aircraft with an MTOW of 5,700 kg or less**

The percentage of aircraft aged over 20 years, the typical design life for an aircraft, has increased from 50% to 80% over the 10-year period. The concern is that many aircraft in this category do not receive continuing airworthiness support from the manufacturer. Continuing airworthiness support and adequate maintenance are essential to ensure the flight safety of ageing aircraft (see Section 7).

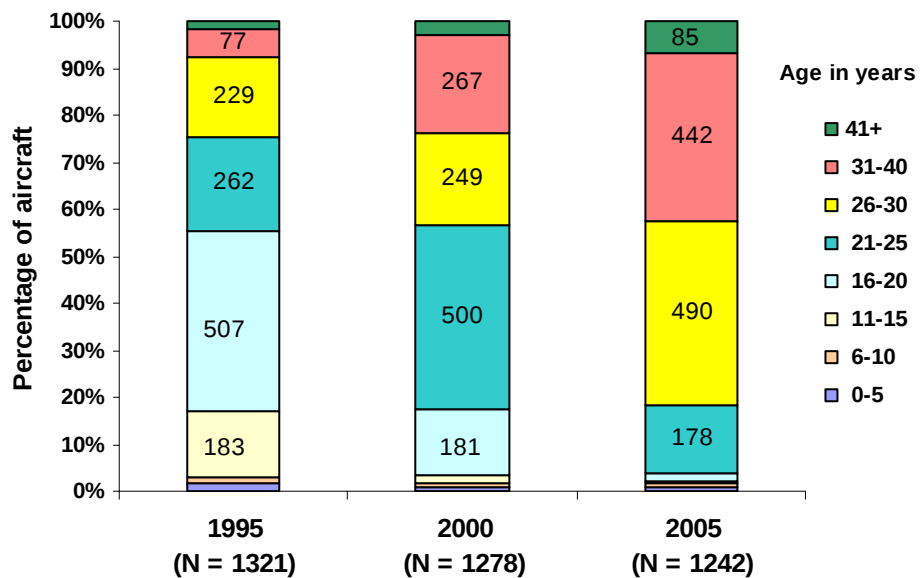
**Figure 7: Multi-engine piston fixed-wing aircraft with a MTOW of 5,700 kg or less**

Over the 10-year period, the number of aircraft in excess of 20 years has increased considerably. In 1995, 44% of aircraft were over 20 years, while in 2005 that figure had increased to 97%.

Like the single-engine piston fleet, the average age of multi-engine piston aircraft has steadily increased between 1995 and 2005 (see Figure 7 and Figure 9). In 1995, the average age of multi-engine piston aircraft was 21 years. By 2005, this had increased to 31 years. Very few new aircraft have entered the register, while older aircraft continue to operate.

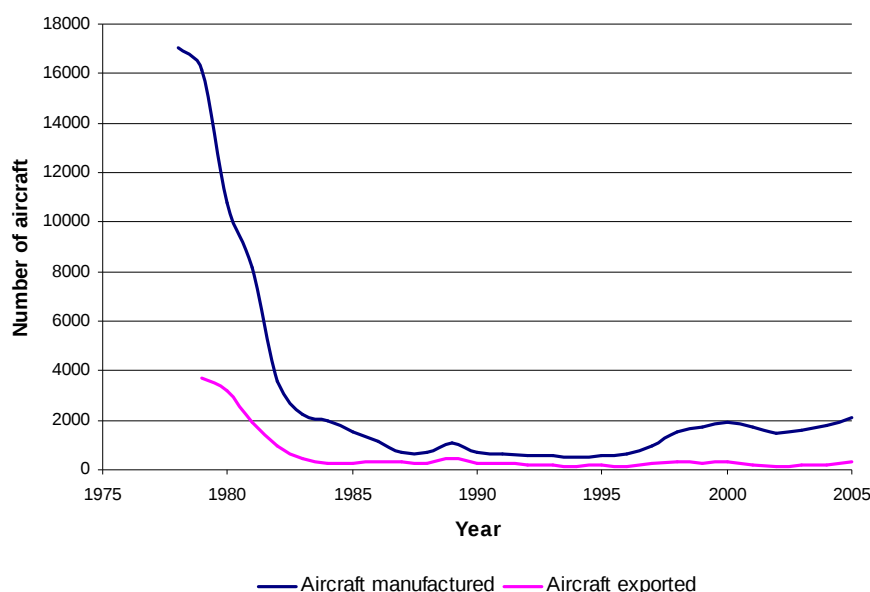
The majority of Australian registered general aviation aircraft were produced in the United States. Therefore, manufacturing output in the United States and exchange rate fluctuations directly affected the Australian general aviation industry. From 1982 to 2004 there has been a significant increase in the purchase price for new general aviation aircraft in the United States. In US\$2004 a new Cessna 172 cost approximately \$100,000 in 1982 and over \$150,000 in 2004. The increase in the purchase price of new general aviation aircraft has been attributed to liability issues in the United States. As a consequence of litigation in the 1980s and early 1990s, Cessna ceased production of single engine piston fixed-wing aircraft and the Piper Aircraft Company went into bankruptcy. The United States Congress responded by passing the *General Aviation Revitalization Act* in 1994, which limited liability for general aviation aircraft manufacturers to 18 years. Since then, the production of general aviation aircraft in the United States has started to recover (BTRE, 2005a). The situation is illustrated best is Figure 8, showing the delivery of new aircraft over the thirty years. In 1978, 17,032 piston aircraft were delivered but production levels dropped quickly and have remained low since the early 1980s. By 1994, only 499 piston aircraft were delivered, of which 126 were exported. Since then production has increased, but numbers are still far below the production levels of the late 1970s (GAMA, 2006).

**Figure 8: New general aviation fixed-wing aircraft manufactured in the United States**

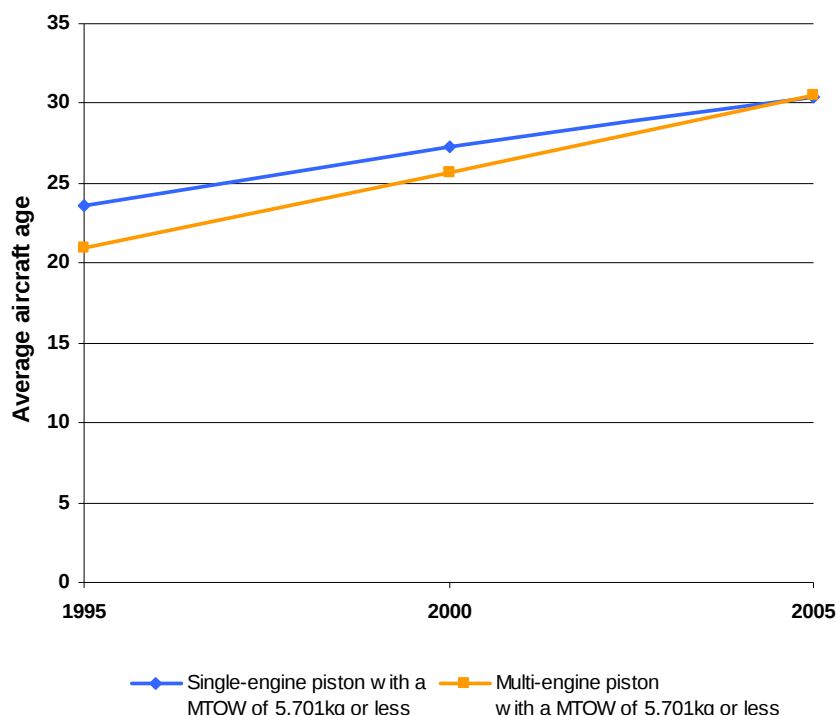
In 2005, the average age of both categories of piston engine fixed-wing aircraft was over 30 years. Of the two piston engine fixed-wing aircraft categories, the multi-engine piston aircraft weighing less than 5,700kg had the highest average age, making it the oldest category of aircraft on the Australian register.

**Figure 9: Change in average chronological age of piston fixed-wing aircraft from 1995 to 2005**

The average age and the number of aircraft aged over 40 years of both piston single-engine and multi-engine fixed-wing aircraft categories is likely to continue increasing. If the current trends continue, by 2015 the average age of the single-engine fleet will be 37 years and the average age of the multi-engine fleet will be 40 years.

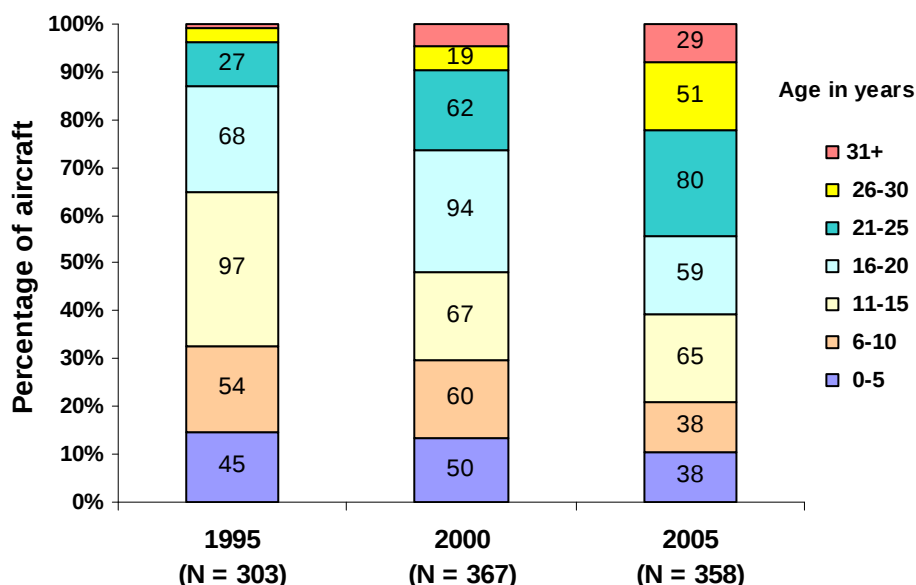
**Figure 10: Multi-engine turboprop fixed-wing aircraft with a MTOW of 27,000 kg or less**

The percentage of aircraft aged over 20 years has increased over the 10-year period. In 1995, 13% of aircraft were over 20 years; increasing to 44% in 2005. The

percentage of aircraft aged 5 years or less declined from 15% in 1995 to 11% in 2005.

As with the Australian piston-engine aircraft fleet, the average calendar age of turboprop-powered aircraft has increased during the period 1995 to 2005, albeit by less than piston engine aircraft (see Figure 10). In 1995, the average age for multi-engine turboprop aircraft was 14 years while in 2005 the average age was 18 years.

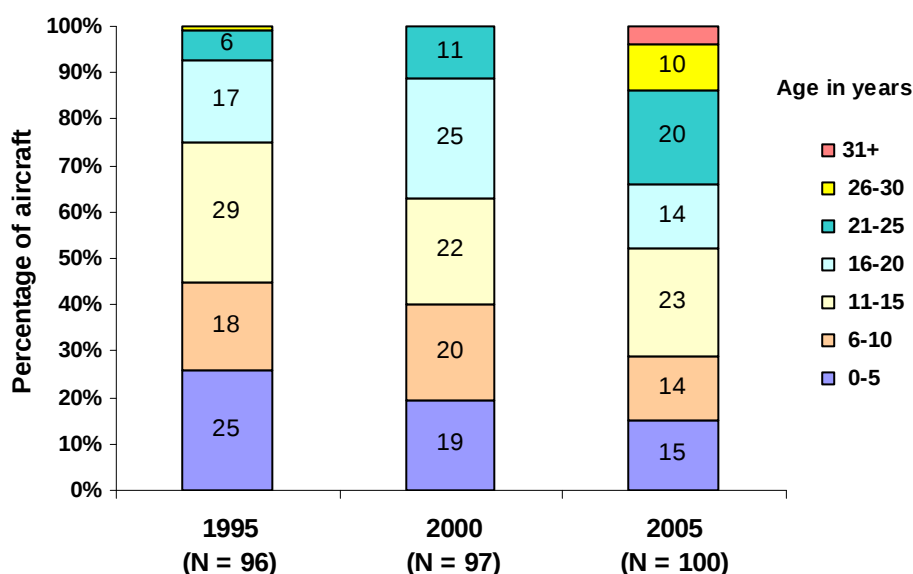
**Figure 11: Multi-engine turbofan fixed-wing aircraft with MTOW of 50,000 kg or less**

The percentage of aircraft aged over 20 years increased over the reporting period from 7% in 1995 to 34% in 2005. The percentage of aircraft aged 5 years or less decreased from 26% in 1995 to 15% in 2005.

The average age of this fleet increased from 11 years in 1995 to 16 years in 2005 (see Figure 11). This increase in average age is similar to that of the other aircraft categories. In particular, it is comparable to the turboprop aircraft category, which contains aircraft of a similar size.

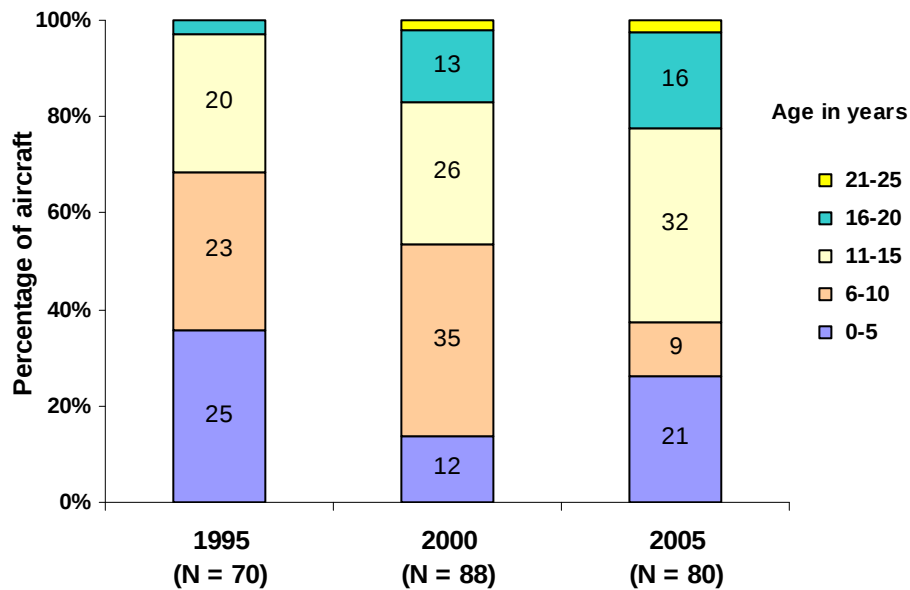
**Figure 13: Multi-engine turbofan fixed-wing aircraft with a MTOW greater than 100,000 kg**

There are very few aircraft aged over 20 years in the large turbofan fixed-wing aircraft category. This ranged from zero in 1995 to 3% in 2005. In 2005, the aircraft aged over 20 years were between 21 and 22 years of age.

The percentage of aircraft in this category aged 5 years or less fluctuated over the period. The peak occurred in 1995 with 36%, dropping to 14% in 2000 and in 26% in 2005.

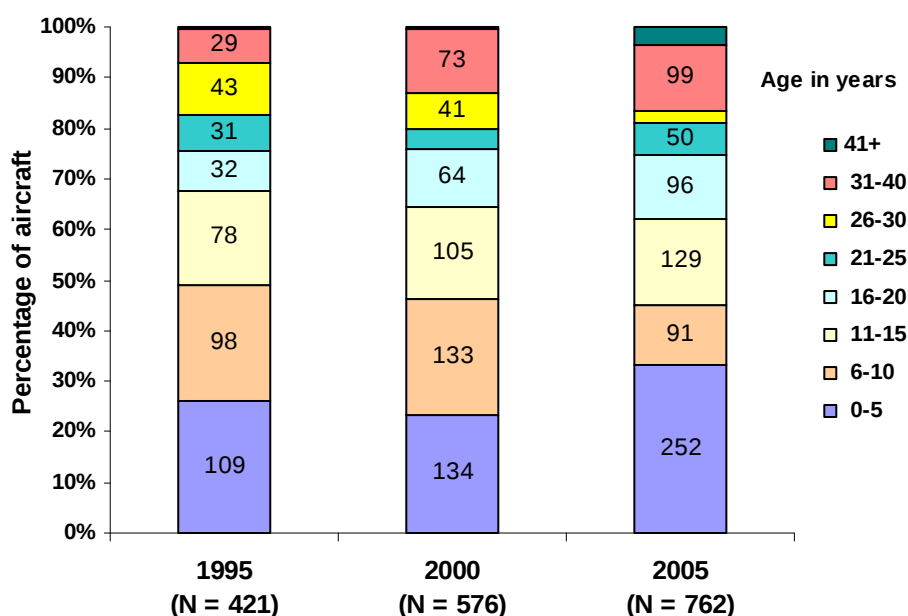
**Figure 15: Single-engine piston helicopters with a MTOW of 5,700 kg or less**

Over the 10-year period, the percentage of helicopters aged over 20 years increased from 25% in 1995 and 2005 to 30% in 2000.

In 1995, 26% of the fleet was aged 5 years or less compared with 33% in 2005. This increase indicates that as the fleet size increased, the majority of the helicopters that entered the fleet were aged 5 years or less, rather than helicopters aged over 20 years.

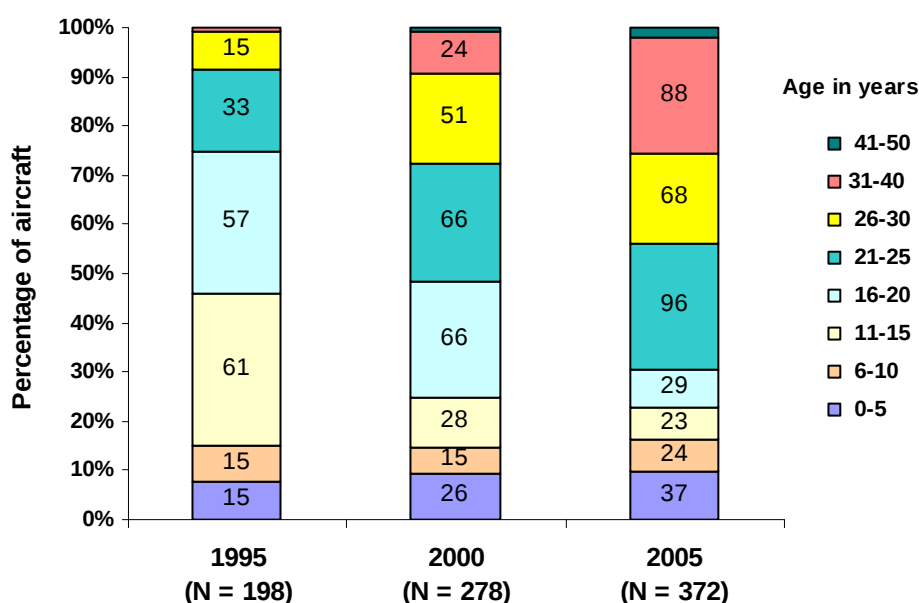
**Figure 16: Single-engine turboshaft helicopters with a MTOW of 5,700 kg or less**

From 1995 to 2005, the percentage of helicopters aged over 20 years increased three-fold from 25% to 76%. The percentage of helicopters aged 5 years or less increased slightly from 8% in 1995 to 10% in 2005. The percentage of helicopters in the fleet aged over 40 years increased from zero in 1995 to 2% in 2005.

Even though the number of helicopters in the fleet increased substantially over the 10-year period, the percentage of helicopters aged 5 years or less increased only slightly. At the same time, the average age of the fleet is increasing. These changes indicate that operators are purchasing second-hand helicopters aged over 20 years rather than helicopters aged less than 5 years.

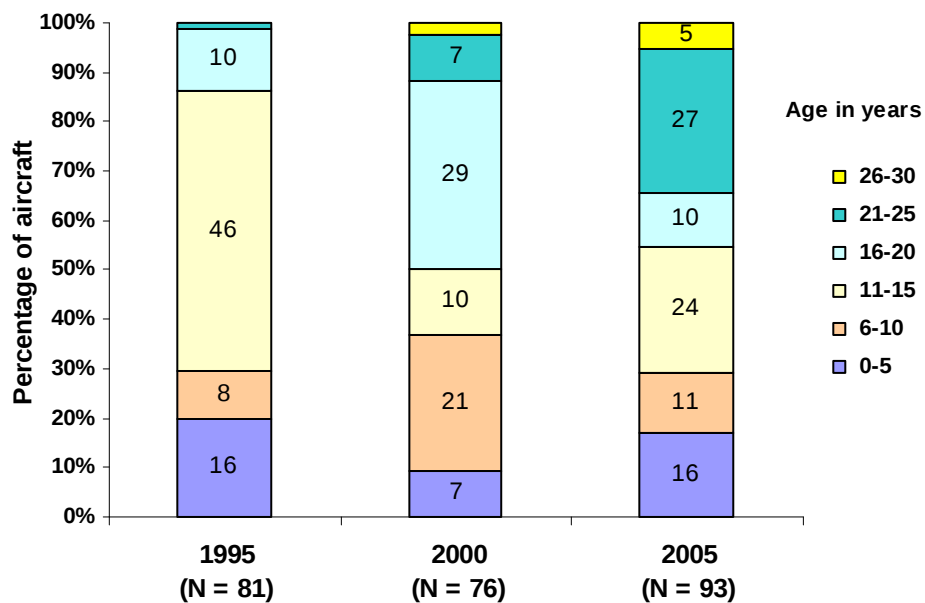
**Figure 17: Multi-engine turboshaft helicopters with a MTOW of 5,700 kg or less**

The proportion of helicopters in the fleet aged over 20 years has increased from 1% in 1995 to 34% in 2005. As these helicopters age, the cost and amount of maintenance required to ensure their airworthiness will increase.

Over the period, the percentage of helicopters aged 5 years or less has fluctuated from 20% in 1995, to 9% in 2000, and to 17% in 2005. Even though the percentage of helicopters aged 5 years or less entering the fleet is higher than for piston fixed-wing helicopters, it has not been high enough to reduce the average age of the fleet. This may be partly due to the small increase in the size of the fleet over the 10-year period.

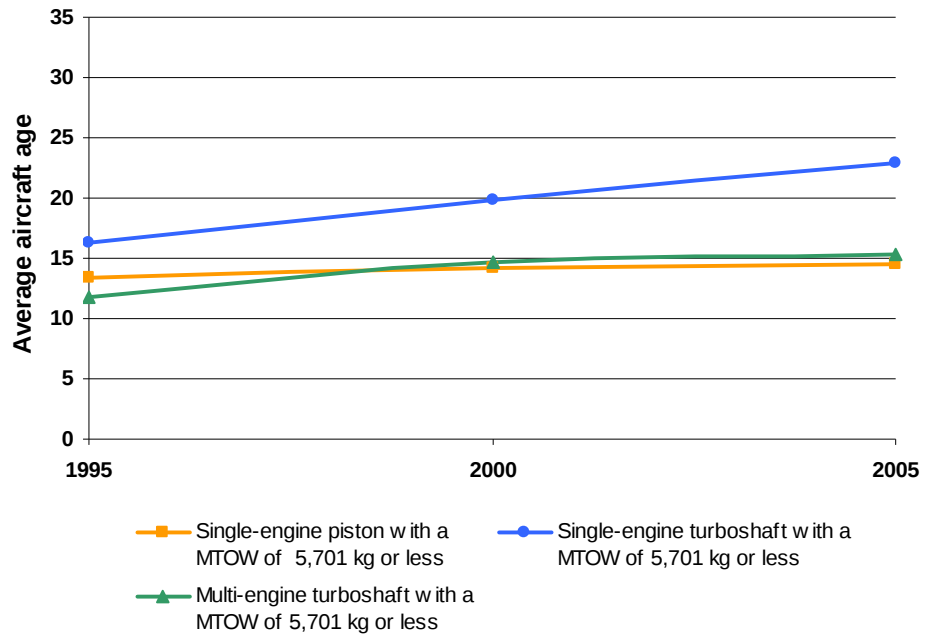
**Figure 18: Change in average chronological age of helicopters from 1995 to 2005**

The total size of the helicopter fleet increased by 175% over the 10-year period from 1995 to 2005. During the same period, there was actually a small increase in the average age, as many of the helicopters introduced to the Australian register were second-hand, including some over 20 years old.

In the single-engine turboshaft category, the fleet size increased by 187% (174 helicopters) from 1995 to 2005. However, the data indicate that there were 26 helicopters in 2000, and 37 helicopters in 2005, aged 5 years or less. The remaining 111 helicopters, therefore, have been added to the fleet as older second-hand helicopters.

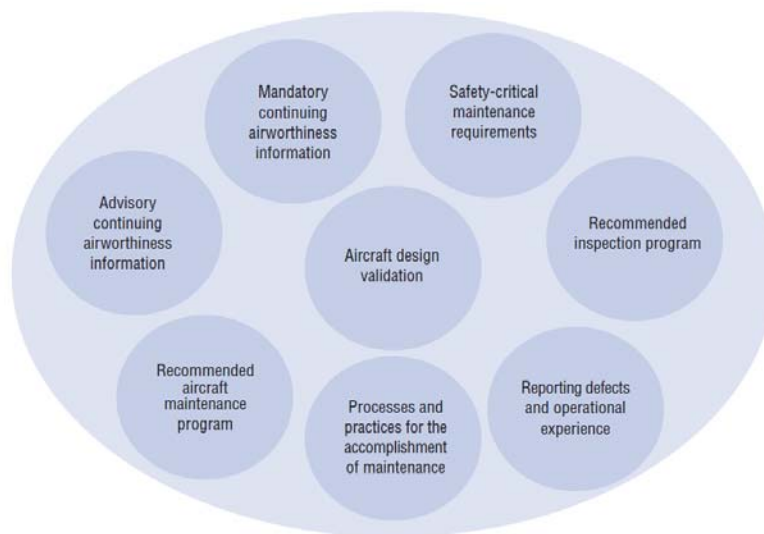
**Figure 19: Basic elements of the continuing airworthiness system**

The continuing airworthiness system evolves over the life of an aircraft. The system takes into account the in-service data and defects found by operators. This information is then used to improve the maintenance system, for example by providing fixes for the in-service defects.

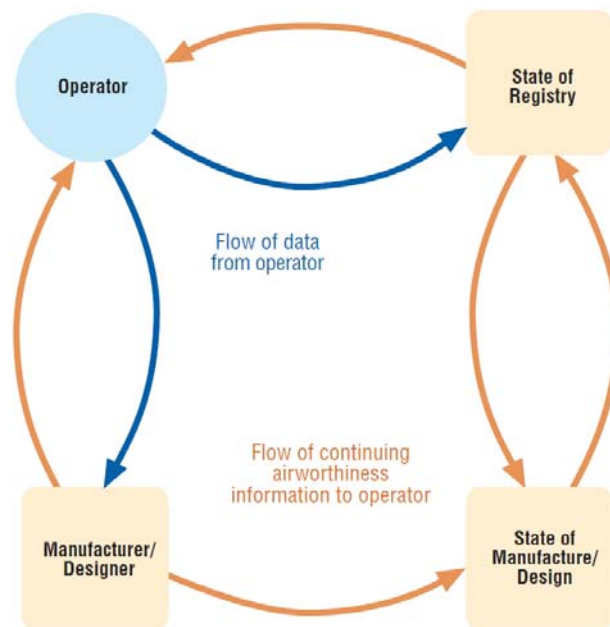
**Figure 20: Information flows associated with continuing airworthiness**

Continuing airworthiness information is produced in the form of service bulletins that have varying levels of safety implications and require different actions. Maintenance service bulletins may require inspections, repair, rework, or modifications to the aircraft. The State of Registry is the only agency that can mandate the requirements contained in the continuing airworthiness documentation for aircraft under their jurisdiction. In addition, they are likely to be in the best position to understand their particular operating environment and the issues affecting operators.

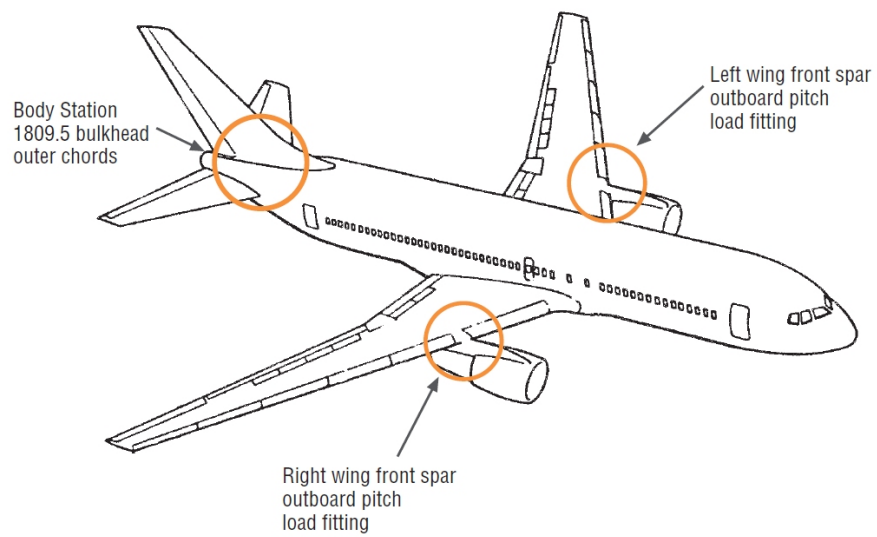
**Figure 21a: Location of Boeing 767 Body Station 1809.5 bulkhead and wing front spar pitch load fittings**

Ansett management became aware of the oversight in December 2000, when seven aircraft were found to have exceeded the inspection intervals. Ansett withdrew the affected aircraft from service, due to concern about their continuing airworthiness status. Once the required inspections had taken place, the aircraft were reintroduced to service.

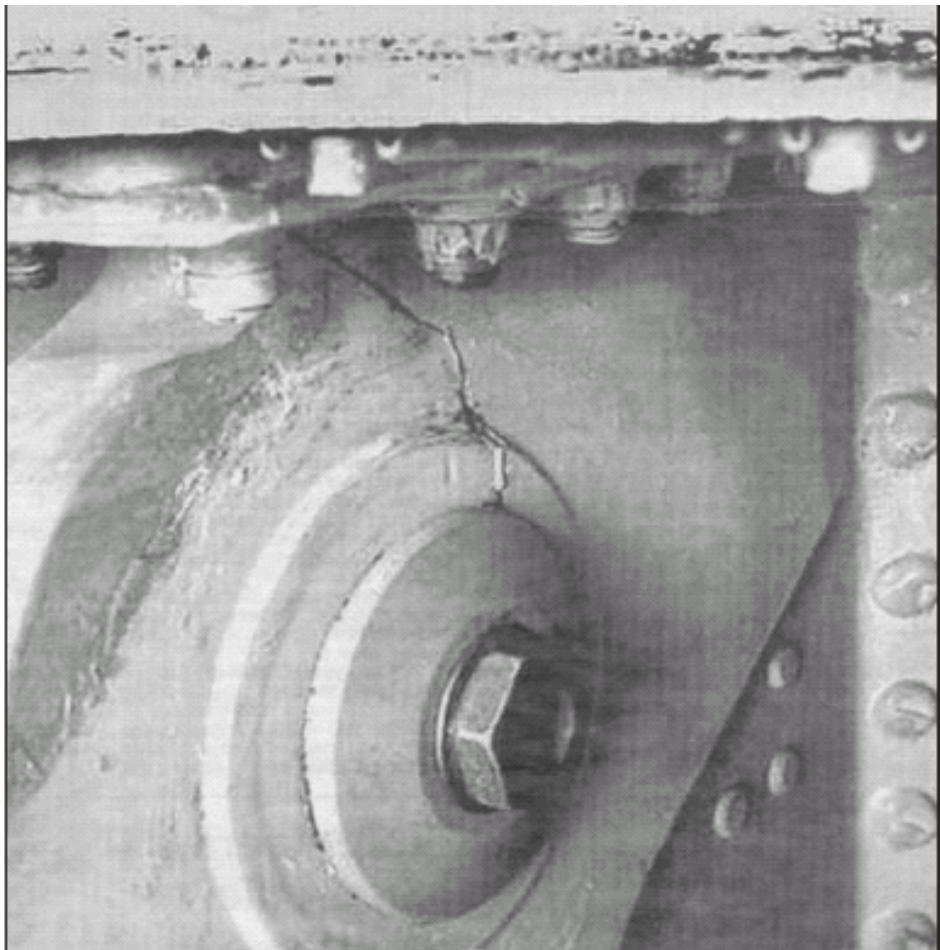
**Figure 21b: Cracks found on the front spar outboard pitch load fitting**
